Charlotte County Utilities Department

2017 Annual Report
April 2018

2017 ANNUAL REPORT

Jones Edmunds Project No.: 03405-029-01

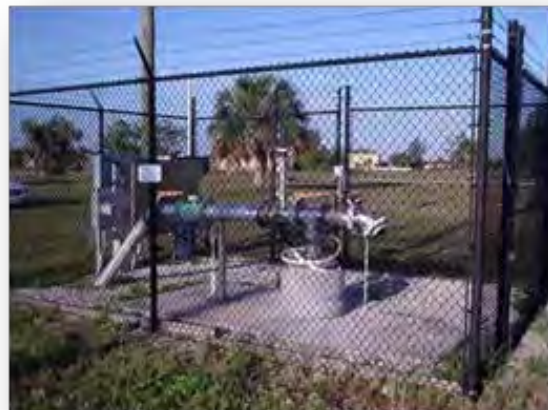
- Well No. 16 is a 12-inch-diameter well located on the east side of the site. The skid-mounted generator has been moved to a mobile trailer for multiple site use. The well pump is in excellent condition.

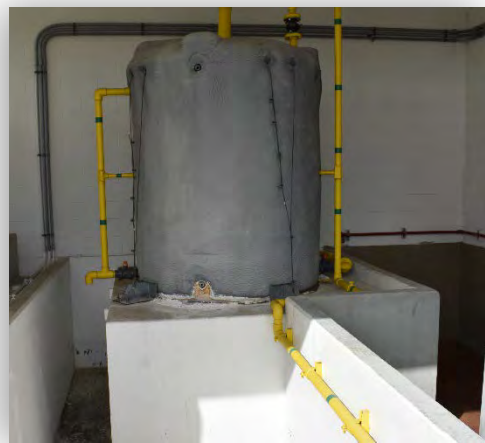
system consists of a 1,100-gallon bulk storage tank, a chemical feed skid with two metering pumps, and a 90-gallon chemical feed tank. The skid and smaller storage tank are in the RO process room and are in good condition. The bulk storage tank is outside near the other bulk chemical storage tanks, which poses operational issues during cold weather. When temperatures are less than 45 degrees Fahrenheit (°F), operators install heat lamps to prevent the sodium hydroxide viscosity from increasing. The current sodium hydroxide dosing rate is small enough that the bulk storage tank is not being used. The site glass gauge is broken off at the connection point at the bottom of the 1,100-gallon bulk storage tank and the ball valve on the transfer line from the bulk tank to the day tank is

leaking. The ball valve should be repaired and the site glass gauge replaced before the bulk tank is placed into service.

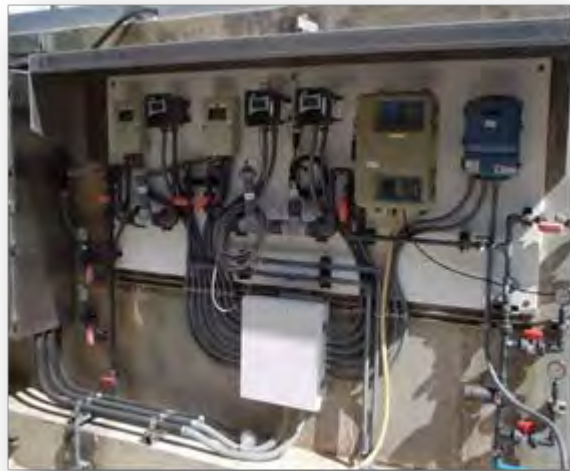
Redundant analyzers that monitor all post-treatment conditions of the water are on the wall of the clearwell. The instruments are well organized with SCADA connections to the Wonderware program, which can be monitored from the operations building. Instruments and chemical feed rates can be adjusted to obtain the proper water quality. All instrumentation is calibrated and up to date.

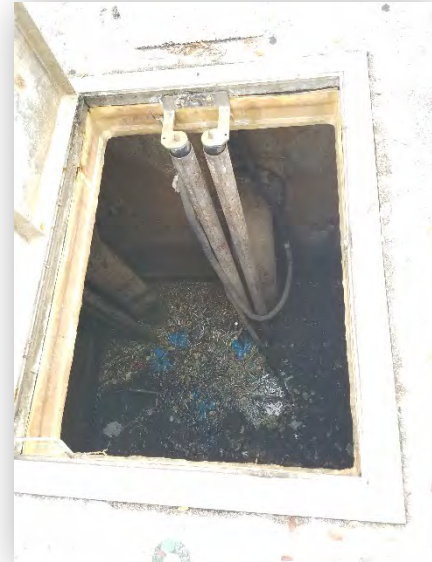
- The wet well is heavily matted with rags and other debris, requiring frequent maintenance.

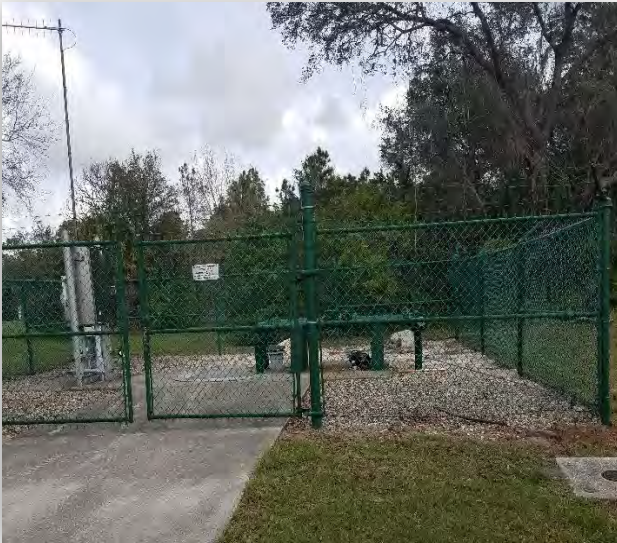
The lift station was constructed in 2006. The overall condition of the station is well maintained with all equipment and structures in good condition. The station contains two 23-HP submersible pumps in a 6-foot-diameter concrete wet well. The wet well hatches are in good condition and provide adequate access to remove the pumps that are on a rail retrieval system. The discharge isolation valves and emergency pump connection are above ground and in good condition. Power service to the station is 230 volt, 3-phase. The main control panel is solid state and in good condition.

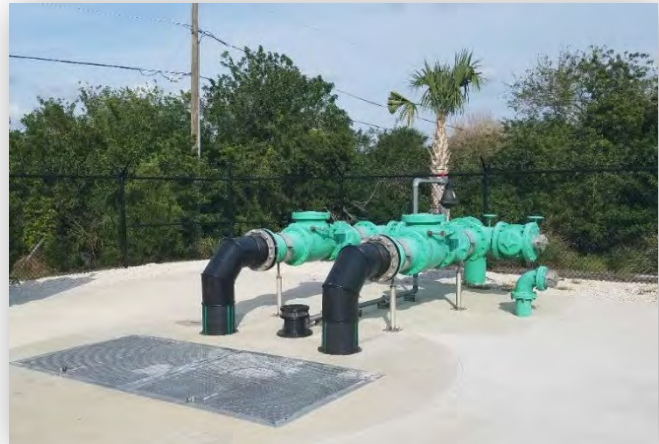
The lift station was constructed in 2017. The overall condition of the station is very good with newly installed equipment and structures. The station contains two 47-HP submersible pumps in a 12-foot-diameter concrete wet well.

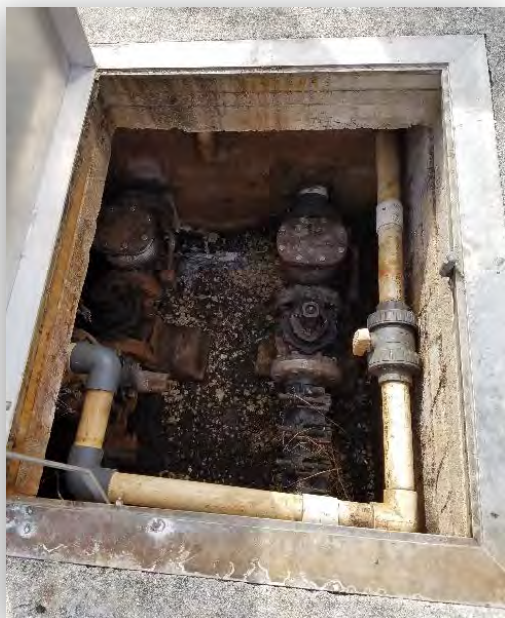
properties. The 6-foot-diameter 21-foot-deep wet well has cracks and shows signs of corrosion around the top of the slab. It appears to have a high concentration of hydrogen sulfide inside the wet well for a prolonged period of time that has caused inner wall spalling and severe corrosion. Many plant roots have protruded into the wet well and may be creating a high-inflow condition. The discharge isolation valves, check valves, and fittings inside the valve vault are also corroded.

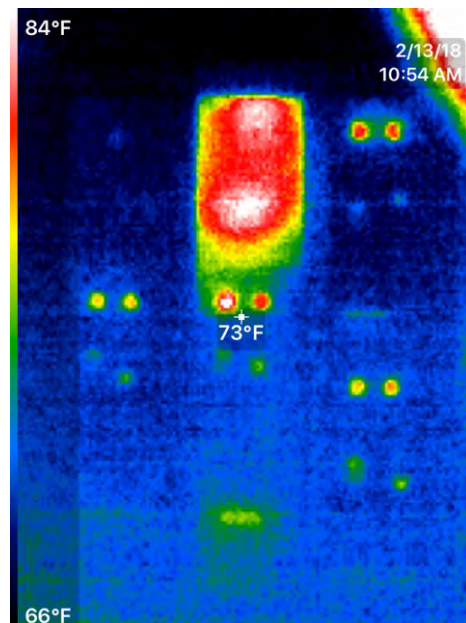
- The switchgear contains warning labels identifying parts and components behind blank cabinets as being energized. However, none of the equipment includes the appropriate arc flash labeling as required by NFPA 70E.

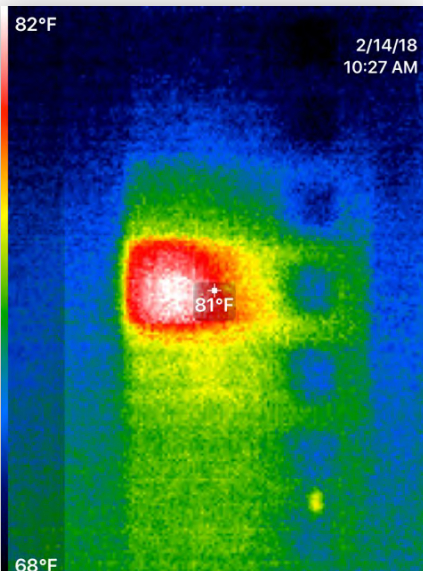
The switchgear includes complete arc flash labeling as required by NFPA 70E. A thermographic survey indicated no issues. Overall, the electrical equipment is in excellent functioning condition based on information from the Operations staff (see photograph at left). The blower building is an existing building with older equipment and upgraded installations. The existing switchgear appears to be in good condition, whereas the newly installed equipment is in excellent condition. A thermographic survey indicates no anomalies or issues.

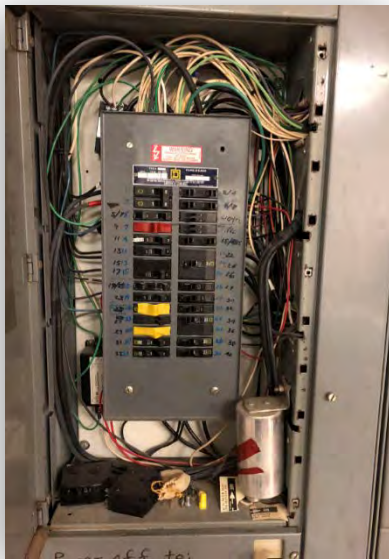
The incoming switchgear and distribution transformer appear in good condition with no obvious signs of significant concern. The incoming power via overhead aerial is new and was installed within the past year. The WRF is served from two 400-kilovolt-ampere (kVA) generators connected in parallel that are fed from a subbase tank and an auxiliary tank adjacent to them (see photograph). Operations staff indicates that a new 6,000-gallon fuel tank and pad for the generators will be installed in 2018. That upgrade may eliminate one of the deficiencies (see below). Overall, the electrical equipment is in good functioning condition based on information from the Operations staff, with the exception of those deficiencies listed below. Thermography scanning of the equipment showed no anomalies.
