# Charlotte County Utilities Department

2018 Annual Report  
March 2019

Jones Edmunds & Associates, Inc.  
824 S. Hyde Park Avenue  
Tampa, Florida 33606

Jones Edmunds Project No.: 03405-029-02

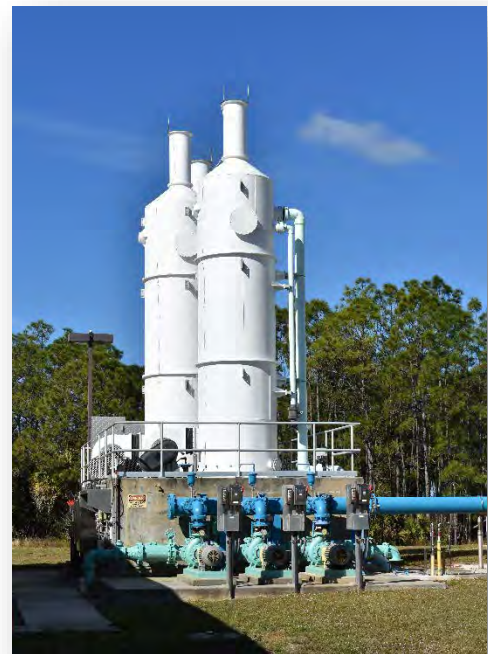
Hydrogen sulfide is removed from the RO permeate via packed-tower degasification. Three packed-tower degasification units are on top of the concrete clearwell and can be operated automatically or manually. One of the degasifier blowers was repaired in February 2017. The degasifier media is expected to be in good condition, and the units are performing as designed. In 2014, the clearwell was temporarily taken out of service for inspection. The clearwell inspection report noted for staff to paint and exercise the isolation valve between the two tanks. Painting was completed in 2018.

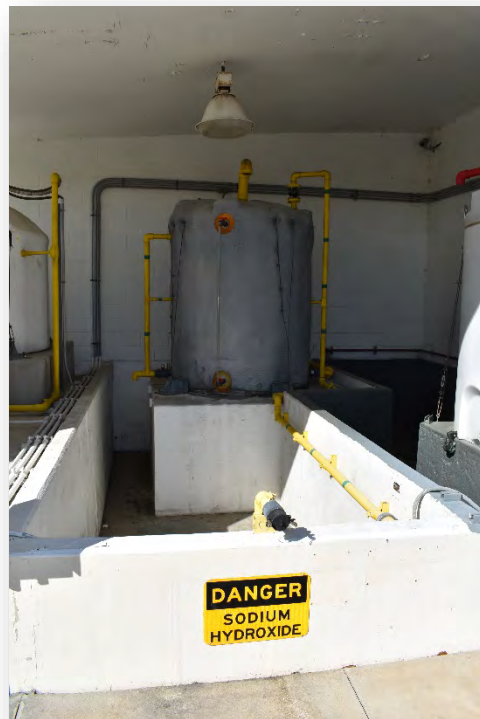
Sodium hydroxide is used to adjust the pH of the finished water before pumping it into the distribution system. The sodium hydroxide system consists of a 1,100-gallon bulk storage tank, a chemical feed skid with two metering pumps, and a 90-gallon chemical feed tank. The skid and smaller storage tank are in the RO process room and are in good condition. The bulk storage tank is outside near the other bulk chemical storage tanks, which poses operational issues during cold weather. When temperatures are less than 45 degrees Fahrenheit (°F), operators install heat lamps to prevent the sodium hydroxide viscosity from increasing. The glass sight gauge on the bottom of the 1,100-gallon bulk storage tank and the ball valve on the transfer line from the bulk tank were replaced in 2018 and are functioning properly.

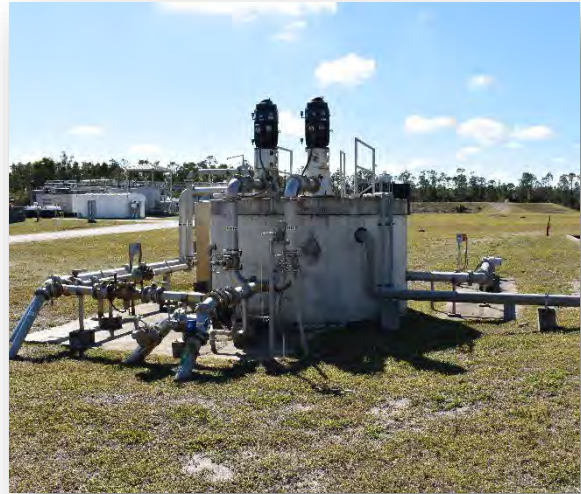
Concentrate from the RO process is disposed of by means of the on-site Deep Injection Wells IW-1 and IW-2. Both wells are permitted to accept concentrate and treated wastewater effluent. Concentrate is transferred to the deep well pumping station clearwell by latent pressure in the RO trains. There it is combined with wastewater effluent and injected into the deep wells. The maximum capacity of IW-1 is 0.564 MGD at a maximum rate of 392 gallons per minute (gpm). The maximum capacity of IW-2 is 2.88 MGD at a maximum rate of 2,000 gpm.

Both injection wells have flow meters and pressure gauges that can be monitored in the control room. Both wells undergo mechanical integrity testing every 5 years. A mechanical integrity test was successfully performed on IW-2 in 2013. A vibration analysis was also conducted for the vertical turbine injection well pumps in 2017. Due to the test results, the pumps were reprogrammed to minimize wear and appear to be functioning properly at the time of the site visit. The pumps at the station were painted in 2018 but the concrete wetwell needs to be painted.

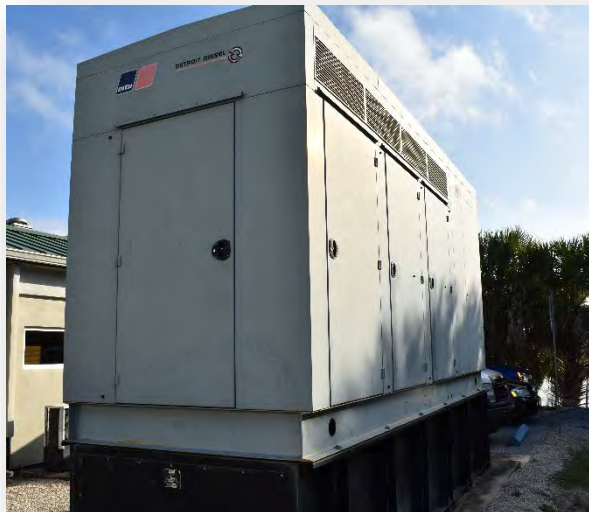
The incoming switchgear and distribution transformer appear in good condition with no obvious signs of significant concern. The generator and enclosure are mounted outside on an elevated sub-base fuel tank. They are in good condition. However, the height of the elevated generator may pose an issue (see notes below). Overall, the electrical equipment is in good functioning condition based on information from the Operations staff.

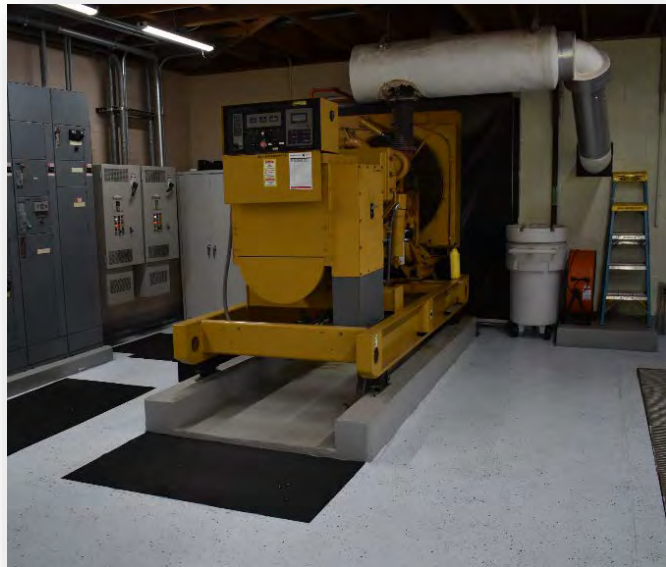
The incoming switchgear and distribution transformer appear in good condition with no obvious signs of significant concern. CCU Operations staff reported that whenever the emergency generator is placed into operation, the power demand is usually greater than its rated capacity of 350 kW. The generator is inside the building that also contains the electrical switchgear. Overall, the electrical equipment is in good functioning condition based on information from the Operations staff.

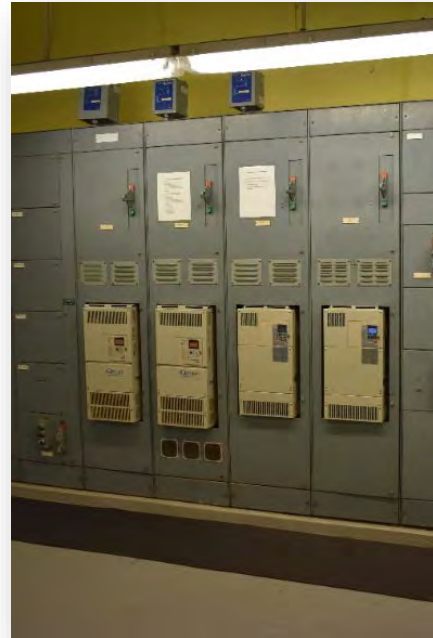
The incoming switchgear and distribution transformer appear in fair condition. The incoming power company transformer did show signs of surficial rust. The standby generator reportedly functions properly and has no issues. The generator equipment inside the enclosure showed signs of light surface corrosion and wear. Overall, the electrical equipment is in good functioning condition based on information from the Operations staff. The equipment is quite dated with several components no longer manufactured. Several of the drives have been updated to Yaskawa VFDs and were retrofitted into the existing cabinets. However, the spaces provided did not match the drives, and there is now a gap between the drive and the enclosure (see photo at right) which may be problematic. Although no life parts appear to be exposed, this does raise a maintenance concern and the possibility of exposed parts.

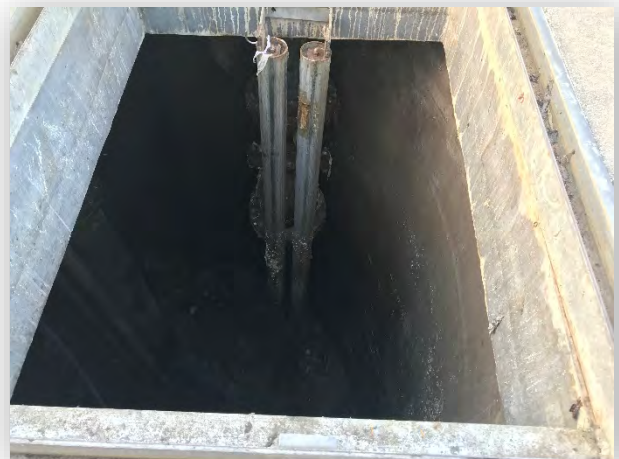
Due to the high inflow of this station and the relatively shallow wet well, the system capacity is extremely limited. The time between a high-water alarm and sewage spill is estimated at less than 10 minutes.

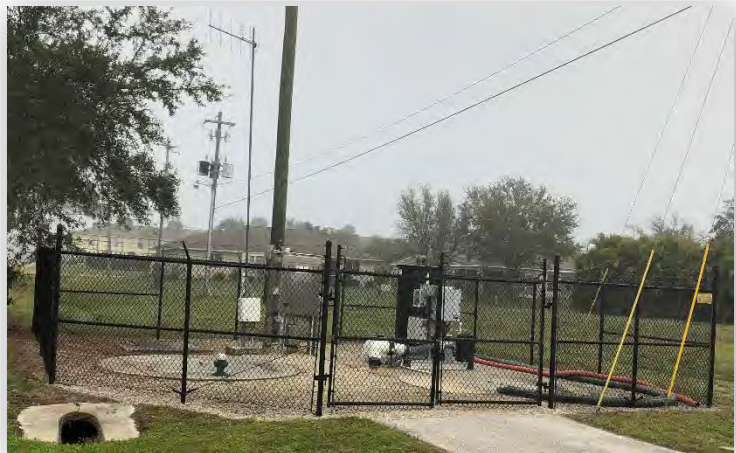
The station is fenced and generally well kept. Power is provided by a 480-volt, three-phase power service. The station had two 10-foot-diameter wet wells; however the southeast wet well was converted to a manhole without replacing the lid. Wastewater flows through the manhole directly to the wet well containing the pumps. The wet well hatches are in good condition and provide adequate access to remove the pumps that are on a rail retrieval system. The discharge isolation valves and emergency pump discharge connection are in an underground concrete vault. The pump discharge pipes in the wet well were replaced with high-density polyethylene (HDPE) pipe in 2010. The pump discharge check valves were also rebuilt at the same time. The wet well was last coated in the 1980s.

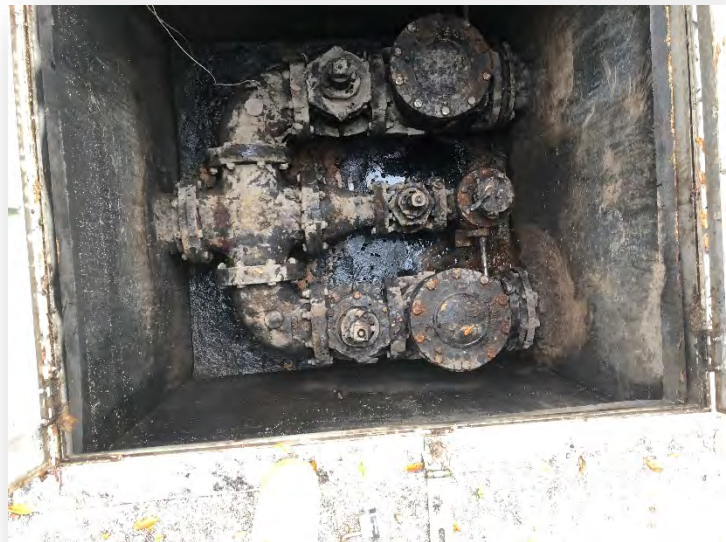
- Signs of corrosion on the wet well interior wall likely due to high hydrogen sulfide concentration.
- Corrosion of piping and valves in the underground vault.
- Seepage under the west discharge pipe in the wet well.
- No dedicated suction bypass piping.
- Substantial concrete wear around the odor-control intake piping.
- Substantial wear of the concrete control panel posts allowing rebar exposure.
- Minor wear of the fence barbed wire due to local vegetation.

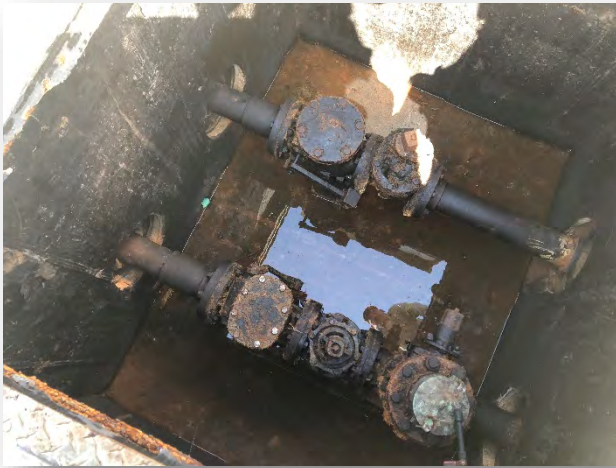
Signs of hydrogen sulfide corrosion or wear exist on the influent manhole and in areas where the wet well coatings are separated or where pipes penetrate the walls. The station is not fenced and does not have odor control. The valve vault had standing water despite an open drain port and no recent rainfall.

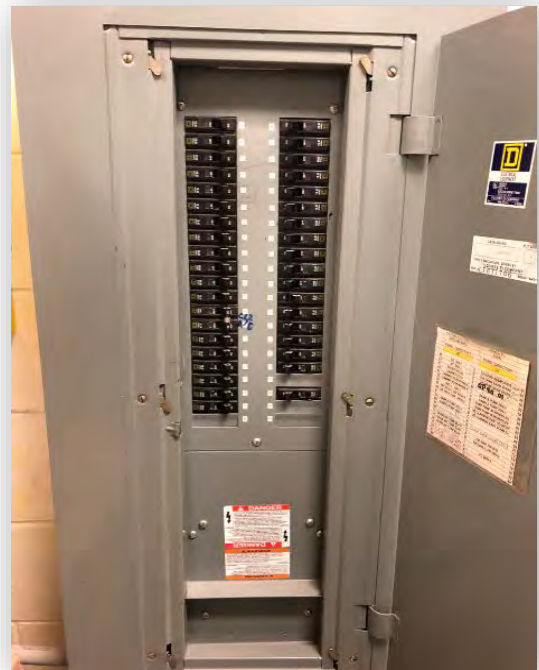
The switchgear is in excellent condition. Staff report that the sound level within the building is extraordinarily high and they have posted signs requiring hearing protection in this facility. Since this facility contains only electrical switchgear, there is some concern over what is causing the high sound level (see below).

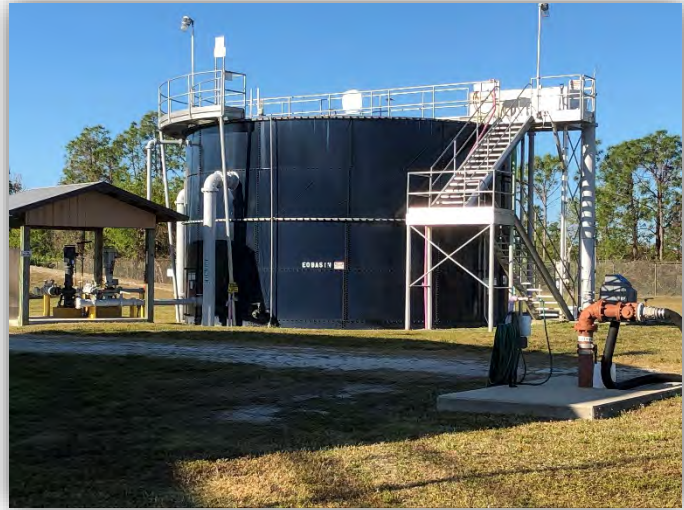
The EQ tank has signs of rust around the upper steel rim. Removing rust and painting rusted areas was not done in 2018 as scheduled and is rescheduled for 2019. Internal piping is in poor condition with leaks at flanged fittings. The leaks do not pose an environmental hazard because they are inside the tank. The piping should be replaced as part of a plant upgrade.

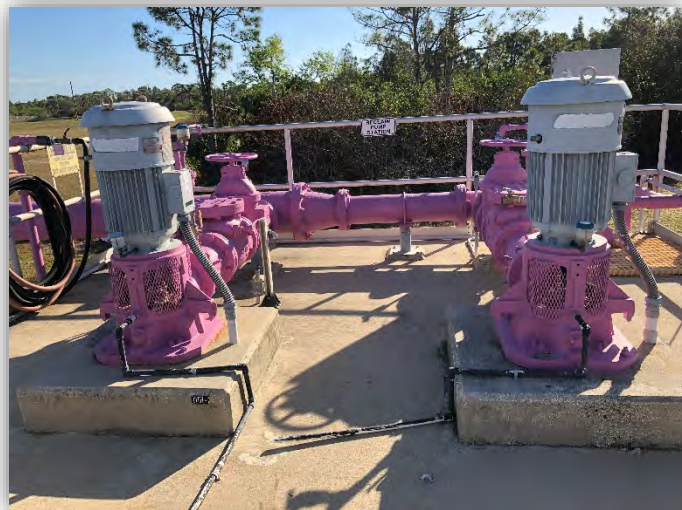
deep well overflows to the percolation ponds. This situation impacts the plant's ability to handle peak flows and makes it impossible to use the full capacity of the deep wells. The ability to transfer higher flows by gravity or pumping should be investigated as part of the plant upgrade design.
