Charlotte County Utilities Department

2021 Annual Report
March 2022

2021 ANNUAL REPORT

Jones Edmunds Project No.: 03405-029-05

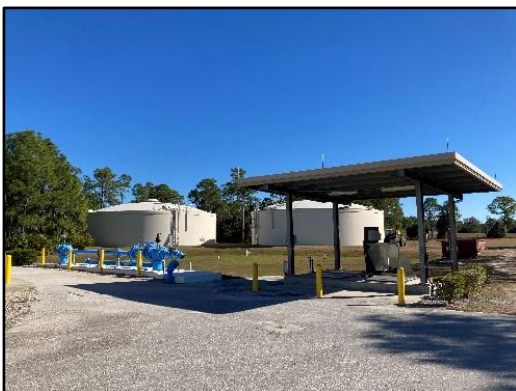
The Burnt Store RO WTP contains three 0.5-MG concrete GSTs housing a total of 1.5 MG of finished water. GSTs A and B were cleaned, inspected, and received new interior coating in FY 2022; GST C was inspected in FY 2019. No sedimentation or defects were found in any tank. The outside of GST B was painted in 2019. The outside of GST A was cleaned and painted in 2020.

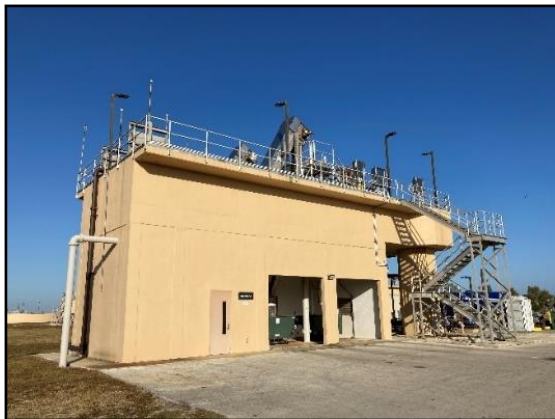
The overall condition of the headworks is good. The adjacent old grease dewatering building is now demolished, and the piping from the new GMLS and Interceptor has been connected to the existing headworks. The screening and grit bagging system that was attached to the chutes that discharge into the dumpsters has significantly reduced the water on the floor, flies, and odors that usually accompany headworks' dumpster areas. The floor is clean and dry. At the top of the headworks, the hose bibb was disconnected and no longer in use.

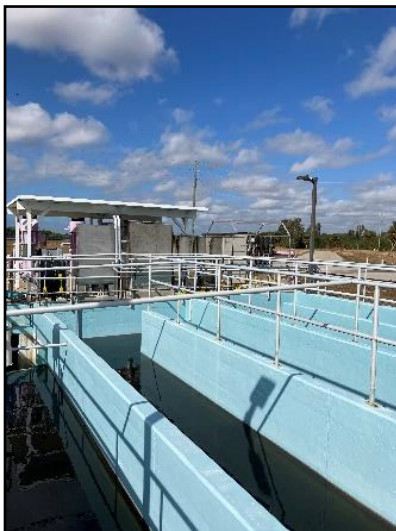
The CCCs are in good condition, well maintained, and operated to produce reclaimed water for unrestricted public-access reuse. CCC No. 1 was recently painted to improve high-level disinfection. CCC No. 2 was drained during the time of the site visit. Liquid sodium hypochlorite (12.5 percent) is stored in a 6,000-gallon dual-containment tank and is used for disinfection to maintain a residual of ≥ 1.0 mg/L to meet unrestricted public-access reuse standards. In 2018, the old liquid reagent chlorine residual analyzer was replaced with a non-reagent analyzer to control chlorine feed rates. Another non-reagent analyzer is used for chlorine residual compliance measurement. The new skid-mounted chlorine feed system is encased in a clear plastic enclosure to control the spray of liquid chlorine for safety purposes. The overall chemical feed systems and instrumentation are well operated and

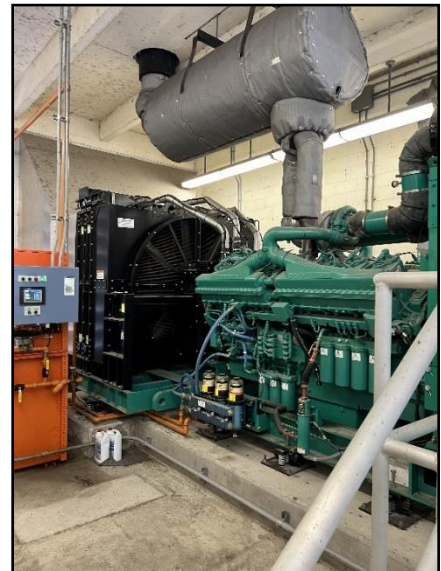
The incoming service and distribution transformers at the Administration building are relatively new and in excellent condition with no obvious signs of concern. The standby generator functions properly and is in good condition. Since it was relocated from another location, it does show signs of wear and deterioration but with no major issues to interfere with its function. The distribution switchgear of the Administration building was in excellent condition with minor issues (see below). Overall, the electrical equipment is in good functioning condition based on information from Operations staff.

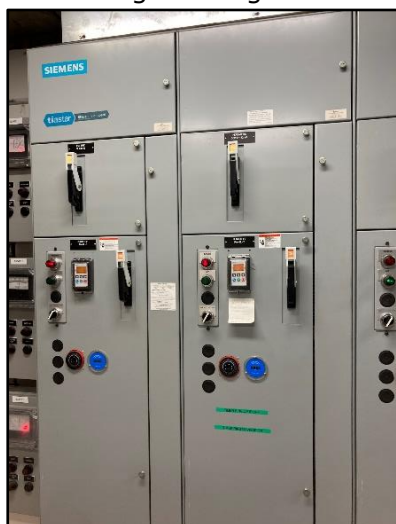
The incoming switchgear and distribution transformer appear in good condition with no obvious signs of significant concern. The incoming power via overhead aerial was installed a few years ago. The WRF is served from two 400-kVA generators connected in parallel that are fed from a subbase tank and an auxiliary tank adjacent to them. A new 6,000-gallon fuel tank and pad for the generators was installed in 2020. Overall, the electrical equipment is in good functioning condition based on information from the Operations staff, except for the deficiencies listed below. Additionally, an electrical equipment site visit assessment was conducted by the Jones Edmunds electrical engineer on February 17, 2022. No specific issues were reported by operations staff. The incoming power to the plant was upgraded a few years ago and would have sufficient capacity for a significant plant upgrade; however, it was noted that the internal power systems would require upgrades.

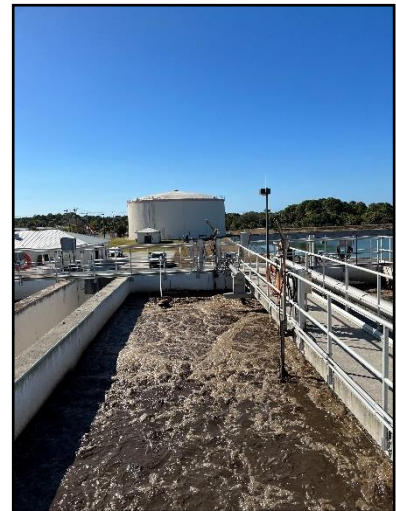
One of the DO probes in the aeration basin was replaced in 2017. All four probes are functioning properly. One DO probe controller screen was severely faded and degraded by UV from the sunlight, and other screens showed similar signs of UV damage. The controllers with the damaged screen likely transmits data to plant operations staff via SCADA; however, the damaged controllers should be replaced for field operational purposes. We also recommended to install sun shields on the front of all the controller three sided enclosures to extend the life of existing equipment.

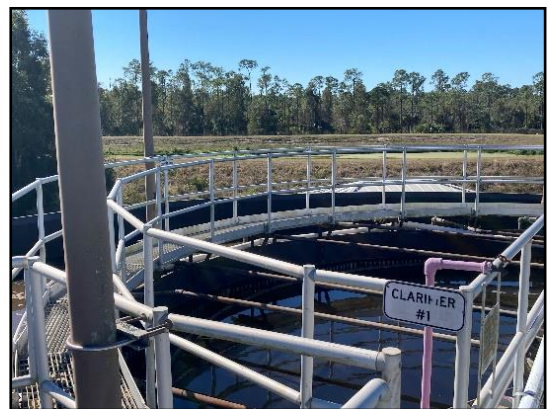
Overall, the tanks appear to be in good condition and were recently painted. The Burnt Store WRF expansion project has identified that these tanks could likely be repurposed during the preliminary design discussions.

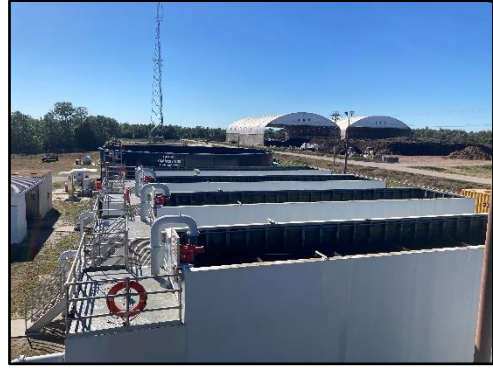
The three PACT units are in good-to-poor condition. The tanks' exteriors and interiors are in good condition since they were partially painted in FY 2017 and completed in FY 2018. Surfaces were pressure washed and rust and lost paint were removed and primed before painting was completed. The polymer feed systems and blower air intakes for the treatment trains should be replaced.

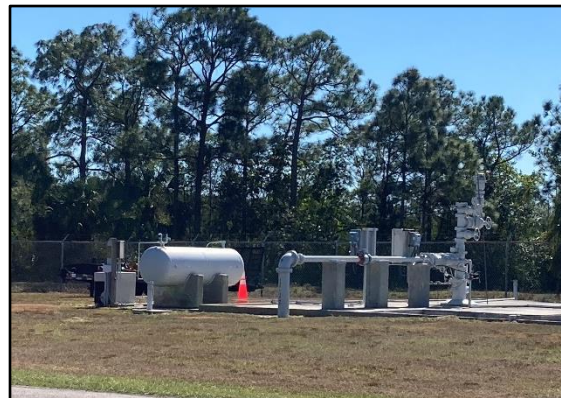
The effluent storage and disposal systems are in fair condition and are properly maintained to meet the facility needs. The effluent storage tank has minor degradation toward the top of the tank that needs to be repaired but remains operable. The existing 12-HP pumps were
