2016 Annual Report

Prepared for:
Charlotte County Utilities Department
25550 Harborview Road, Suite 1
Port Charlotte, FL 33980

Prepared by:
Stantec Consulting Services Inc.
5172 Station Way
Sarasota, FL 34233
Florida Certificate No. 27013

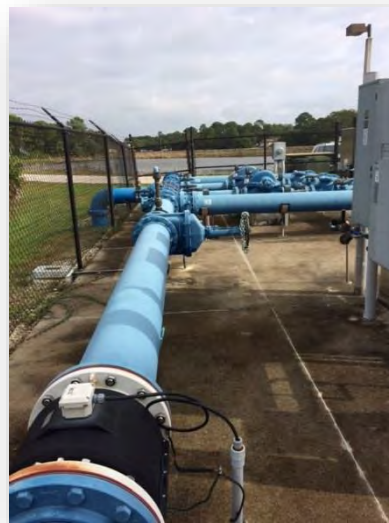
In FY 2015 Charlotte County completed minor modifications to the pumps and piping system that allows this facility to increase water circulation in the extreme western portion of Charlotte County Utilities Department's **service area**. **This** increased circulation at 750 gallons per minute has increased system pressure and chlorination residual levels in the area that are required to meet State delivery disinfection requirements.

Future improvements include covering the pumps and piping with a roof to protect equipment.

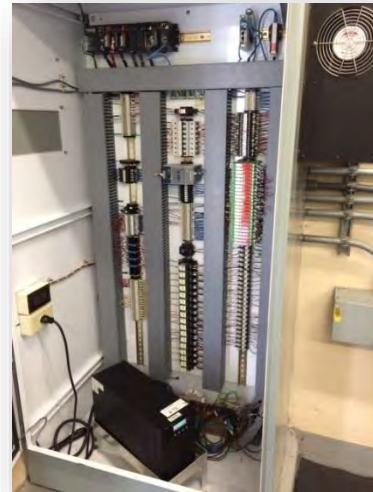
The following deficiencies were noted:

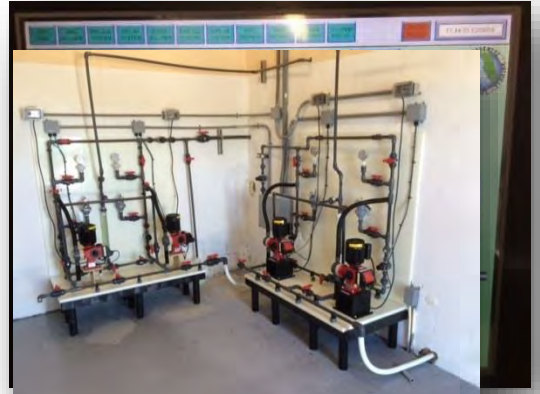
- 2013 - New sodium hypochlorite tanks were installed.
- 2015 - 16-inch discharge flow meter was replaced.
- 2015 - Discharge isolation valve was installed to allow complete isolation of the pumping station from the distribution system.
- 2015 - New access gate was underway on the day of the visit.
- 2015 - Replace Sodium Hypochlorite tank.
- 2015 - New chlorine feed pump skids, one for pre-storage tank disinfection and one for post-storage tank disinfection of water.
- 2016 - A new PLC was constructed by CCUD personnel to collect data for reports. The new PLC is connected to SCADA and controls, all pumps, and chemical feed system.
- 2016 - Storage tank was drained, cleaned, and inspected per FDEP protocol of every 5 years.

- The exterior of the tank should be repainted (currently scheduled for 2017).
- Install monochloramine and ammonia analyzer as is currently installed at all of the other pumping stations.
- Remove old water plant that is adjacent to the water storage tank. A contract was awarded for demolition of old plant. Start early 2017.
- Complete 24-inch water transmission main from Ingraham Street to the Rotonda storage tank.
- Add two new shelter roofs for ammonium tank and equipment storage.

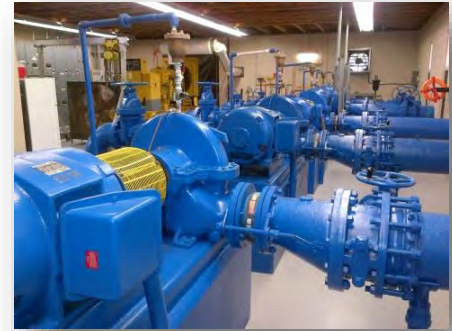
The general condition of the station is good. The discharge water of the station had the following conditions at the time of the site visit:

- Flow = 3,900 gpm (max. capacity 5,200 gpm)
- Pressure = 82 psi, the pressure setting controls the speed of the pumps
- Chlorine disinfection concentration = 3.99 ppm
- pH = 7.38

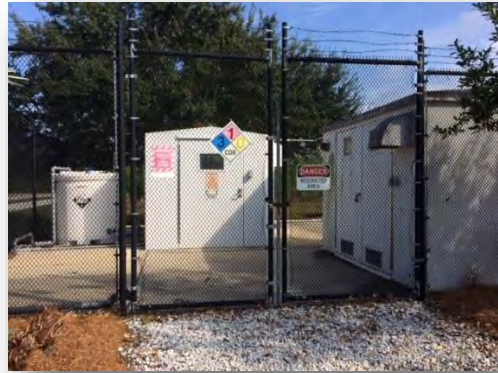
The Central/West County distribution system contains one disinfection booster station in a remote area of the West County. The Ingraham Boulevard chlorine/ammonia injection station monitors chlorine residual and injects additional disinfection chemicals to maintain the FDEP required levels. The injection station is enclosed in a six (6) foot chain link fence with barb wire on top.

A total chlorine residual of 4.0 milligrams per liter (mg/L) is maintained by injecting chlorine at a rate that is paced by the flow passing the station. The chlorine level and local water pressure is monitored continuously. A new chloramine addition control was installed in FY 2016.

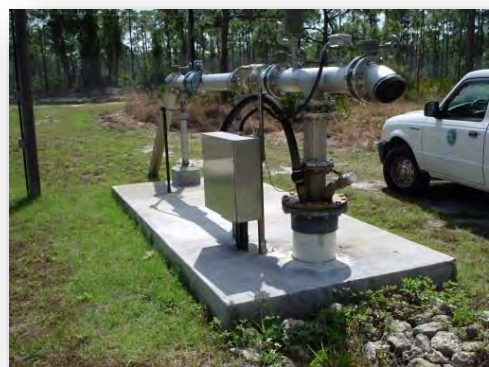
- Well No. 7 - On-site, adjacent to generator. This is the oldest well and is in good condition. Minor rust was found on the stainless steel wellhead and a rusted butterfly valve operator should be painted. This well and is one (1) of the three (3) 8-inch diameter wells on-site that produce lower flows than the 12-inch wells on and off the plant site.

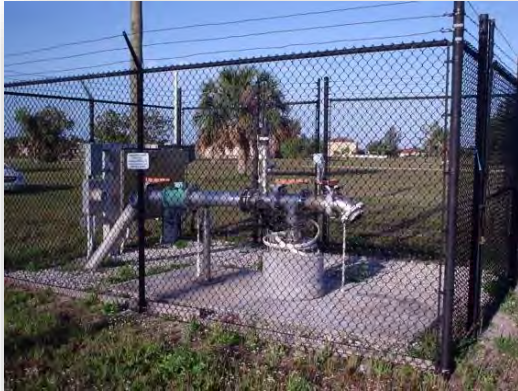
- Well No. 8 - On-site, near entrance. Condition is good. The pressure transducer saddle is beginning to rust and needs to be painted. The well pump was replaced in February 2015.
- Well No. 9 - On-site, near storage tanks. Condition is good. Minor rust on wellhead and BFV operator. A new well pump and motor was installed in 2016.

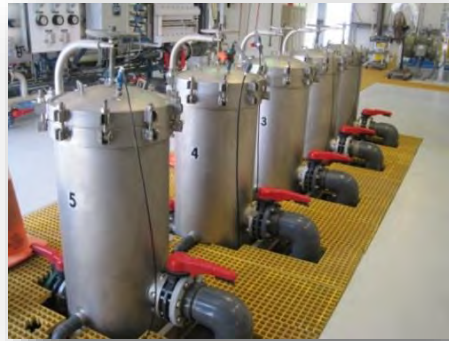
The RO treatment process requires the addition of anti-scalant and reduction in pH by sulfuric acid addition to the raw water prior to beginning the treatment process. These two (2) chemicals are injected into the raw water pipe before it enters the treatment building.

The pH-adjusted raw water passes through one (1) of five (5) stainless steel, pressurized cartridge filters that are in excellent condition. Staff changes the 1-micron filters every six (6) months. This change is made well within the differential pressure loss across the filters that are the recommended condition to replace the filter material. No irregularities were reported and the equipment appeared to be in excellent working order at the time of site visit.

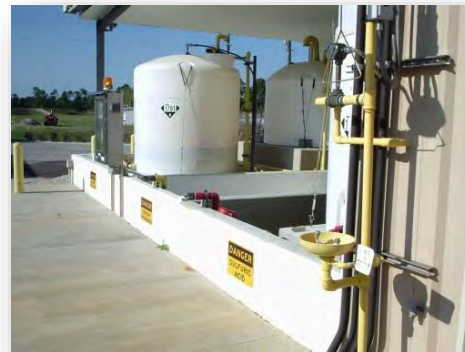
Bulk storage of chemicals is in a covered area that is attached to the east end of the treatment plant building. All tanks are housed in containment areas. The tanks and piping are painted and well-marked.

Chemical feed pumps and piping are located inside the building along the wall that is common to the bulk storage area. The chemical feed pump area requires constant maintenance as would be expected for any chemical feed system. The area is inspected daily for leaks.

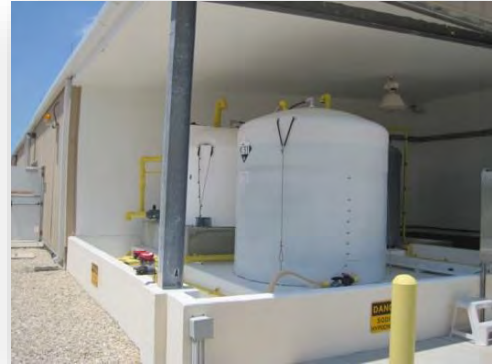
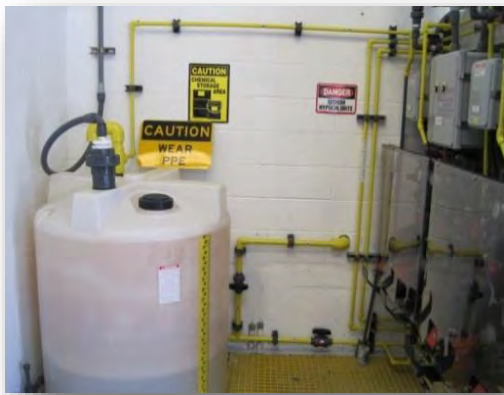
The bulk sulfuric acid containment area was painted in FY 2011. The containment area is scheduled for repainting in the future.

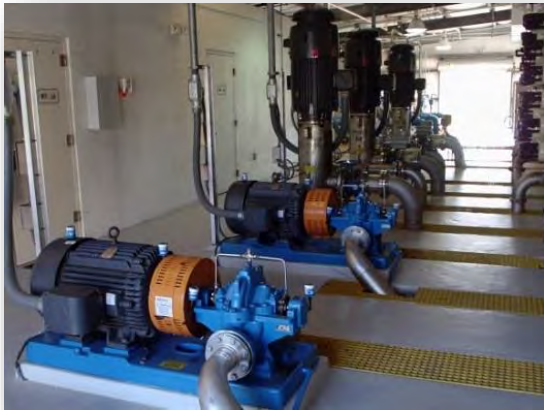
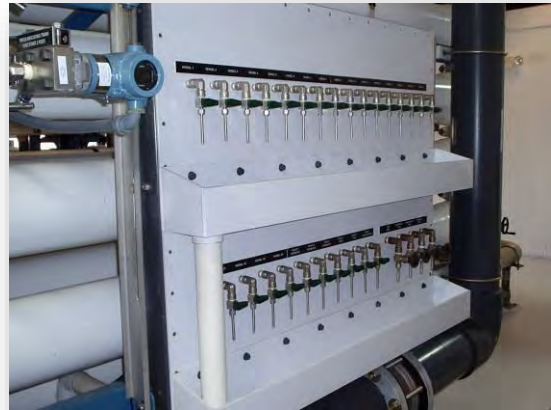
RO trains C, D, and E were new in 2009. Trains A and B are older (2007) and produce less water with higher pressure required, but are still producing good quality RO water.

Raw water is blended with RO water to produce the desired conductivity and chemical composition to improve taste. The blend valve is a 4-inch BFV that can be modulated from the operations control room.

Treatment components were found to be in good condition with the following exception: some concentrate port seals on Trains C and D leak. A membrane company technician replaced one seal and trained staff to replace other leaking seals. The leaks pose no environmental hazards or water quality issues. As part of the daily inspection, staff examines the plant pipes and tightens down pipe fitting bolts when necessary.

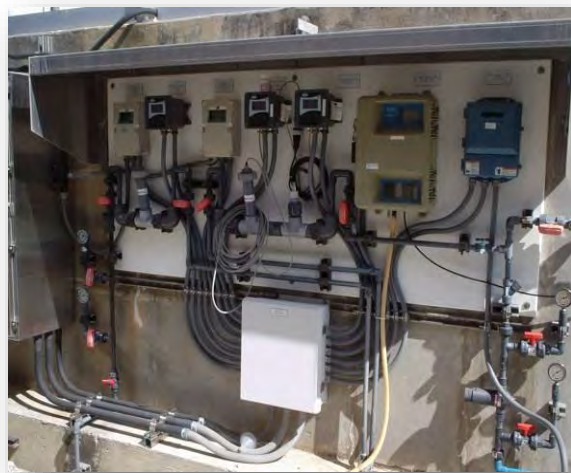
Post treatment consists of removing hydrogen sulfide from the RO water and adding NaOH for pH adjustment and sodium hypochlorite for disinfection. Post treatment processes were found to be in good condition.

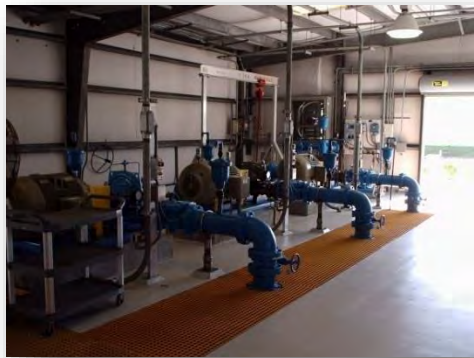
There are two (2) medium flow pumps, one (1) high flow high service pump, and one (1) jockey pump providing flow to the distribution system. The two (2) medium flow pumps were installed in early 2012 to more accurately match the system flow needs.

Normally, the jockey pump and either of the two (2) medium flow service pumps are all that is needed to supply water and pressure to customers. The high flow service pumps are necessary for fire flow demands and are exercised when system flushing is performed.

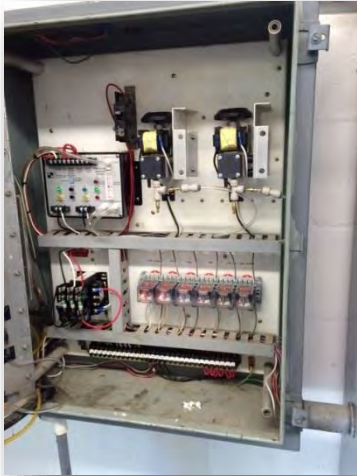
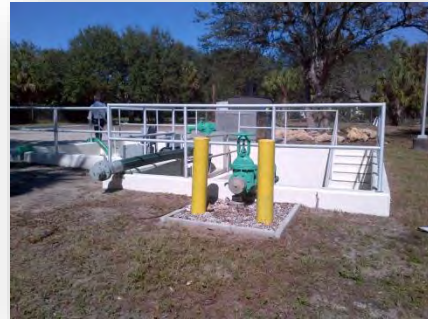
The Quesada Wastewater Lift Station (Lift Station No. 37) is a master station that receives wastewater from many neighborhood stations. It has three (3) submersible, 88 HP

pumps that pump directly to the East Port WRF through a long force main. The station is in good/fair condition due to its age and continual maintenance. The station contains a telemetry transmitter that allows monitoring to occur from the Charlotte County Utilities Department central office and treatment plants.

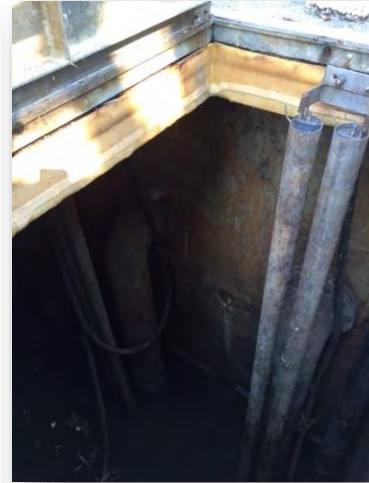
- The wet well is constantly subject to high levels of corrosive hydrogen sulfide gas. The T-lok wet well liner is pulling away from the wall of the wet well and the concrete is exposed to the hydrogen sulfide gas. Since the wet well cannot be taken out of service due to the high flows at the station, it is recommended that a second wet well be constructed at the station as a back-up and to allow the original wet well to receive a substantial rehabilitation. Note: The station evaluation in December 2016 did not show any appreciable increase in the lining deterioration.
- The wet well is heavily matted with rags and other debris, requiring frequent maintenance.

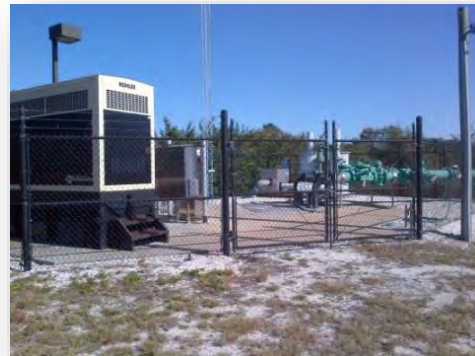
The Rotonda Master Lift Station (LS 801) is a relatively new station that includes the current Charlotte County Utilities Department design standards for master pumping stations. The station was reconstructed and upgraded in 2010 to increase reliability and capacity for population growth in the Rotonda residential development.

The Rotonda Master Lift Station discharges directly to the Rotonda WRF through a 1,950 foot long, 12-inch diameter force main that terminates in the headworks of the Rotonda WRF. The station contains one (1) 10-foot diameter wet well, receiving flow from a 36-inch gravity sewer that becomes partially submerged at the pump-on wet well elevation. The station contains two (2) 75 hp pumps that are speed controlled to match the incoming wastewater flow. The pumps still cycle on and off, which spikes flow through the Rotonda WRF headworks.

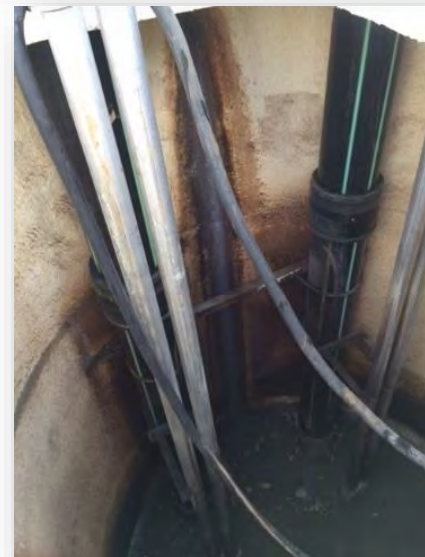
The station was found to be generally in excellent condition with no deficiencies noted. Above ground piping was last repainted in 2014 to help prevent corrosion. A forced air odor control system reduces hydrogen sulfide concentrations in the wet well. The pump discharge at the time of the site was 1,500 gpm.

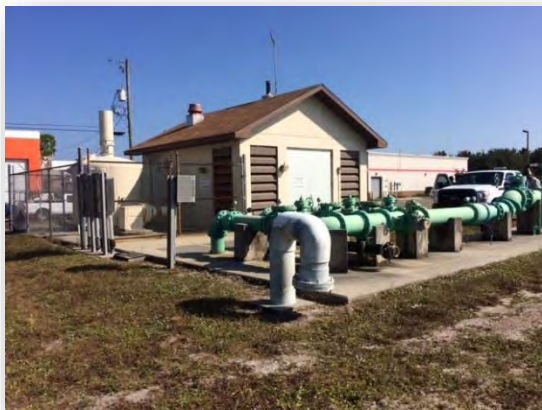
The station is not fenced, but the building is locked and all access hatches are locked. There is a carbon adsorption, forced air odor control system at the station, which has kept hydrogen sulfide level in the wet well to a low level. This has contributed to the good condition of the wet well even though the station has been in service for more than 20 years. The carbon adsorption unit is within a locked, fenced area.

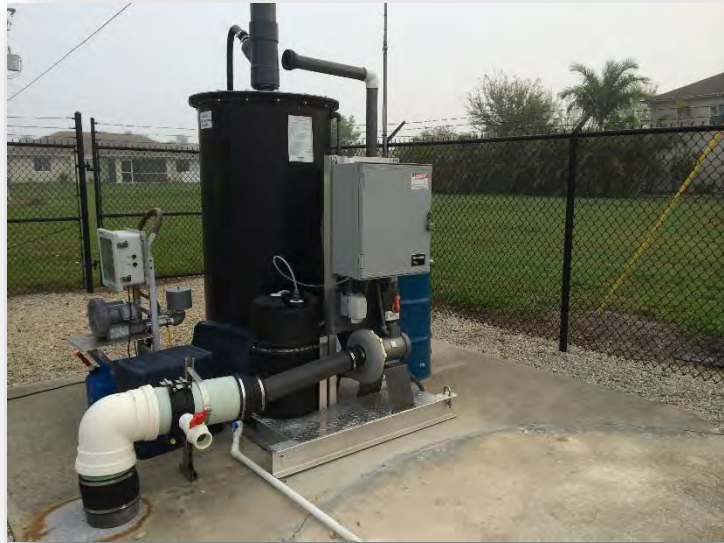
Lift Station 309 is in good condition due to constant maintenance since it was purchased by Charlotte County in 2003.

It is recommended that the condition of this critical station be kept at a high level through planned equipment upgrades. An on-site generator with automatic transfer switch would be a good addition. The addition of a protective coating in the wet well would also help prevent future degradation due to high levels of hydrogen sulfide.

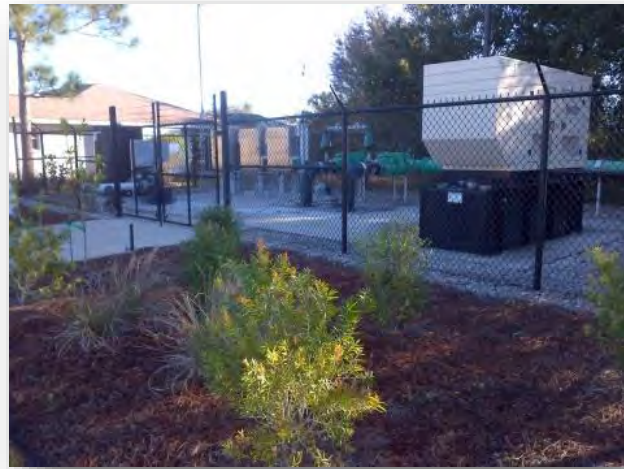
The station is fenced and well landscaped due to its location on a lot between two residences. The rectangular wet well contains two (2) submersible pumps. Flow enters the wet well through a gravity sewer that terminates in a vertical drop pipe below the low water elevation in the wet well. The wet well hatches are in excellent condition and provide adequate access to remove the pumps that are on a rail retrieval system. There is a generator on site with an automatic starter and transfer switch should FPL power fail. The discharge isolation valves, check valves, emergency pump connection and flow meter are all located above ground for easy access and maintenance. The pump discharge pipes in the wet well are constructed of corrosion resistant HDPE and the interior of the concrete wet well is coated with a corrosion resistant polyurethane coating system. The odor control system with fan draws air from the wet well and reduces hydrogen sulfide odor that is generated in the wet well. The odor control system was modified in FY 2016 to include:

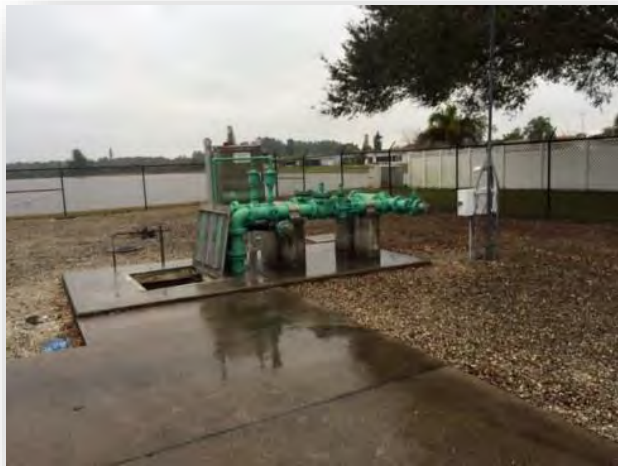
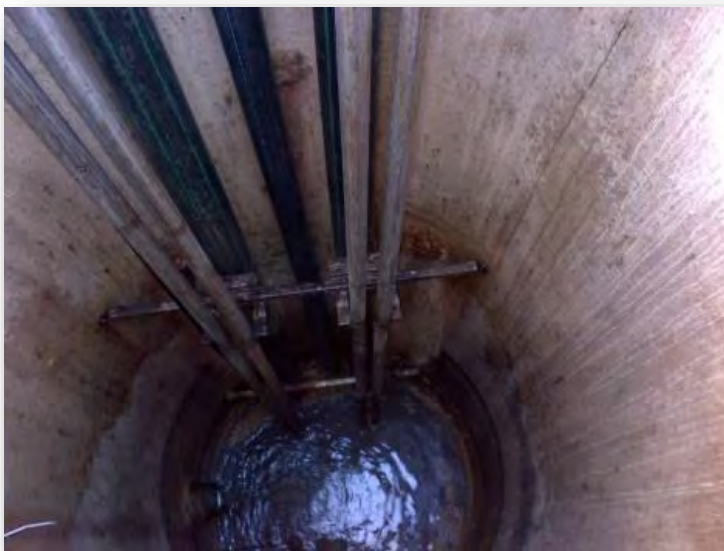
The station has two (2) 15 HP pumps, operating without soft starts or VFDs. The

site is fenced with all piping and valves located above ground. The circular wet well is approximately 30 feet deep which is deeper than most Charlotte County Utilities Department lift station wet wells. Flow enters the wet well through a gravity sewer that terminates below the low water elevation in the wet well. The wet well hatches are in excellent condition and provide adequate access to remove the pumps that are on a rail retrieval system. There is no generator on the site, but the main control panel includes a connection for a portable standby generator.

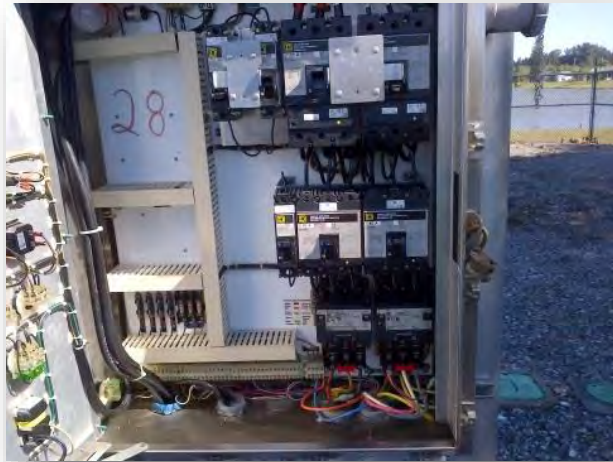
The electrical and control panels are in good/fair condition. The station contains a telemetry transmitter that allows monitoring to occur from the Charlotte County Utilities Department central office and treatment plants.

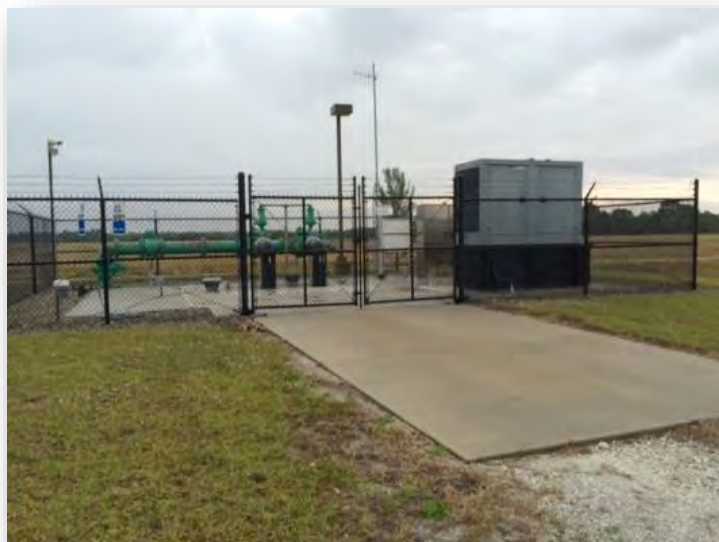
The station contains two (2) submersible 35 HP pumps in a 10-foot diameter wet well. The wet well interior is coated with an epoxy coating. The station slab is raised approximately 4-feet above surrounding grade to protect it from the 100 year flood. Electrical service to the station was extended from CR 771 a considerable distance. Flow enters the station from low pressure, septic tank effluent pumps at residences. The service area is sparsely developed at this time, but water and sewer utilities are available for the lots in this subdivision.

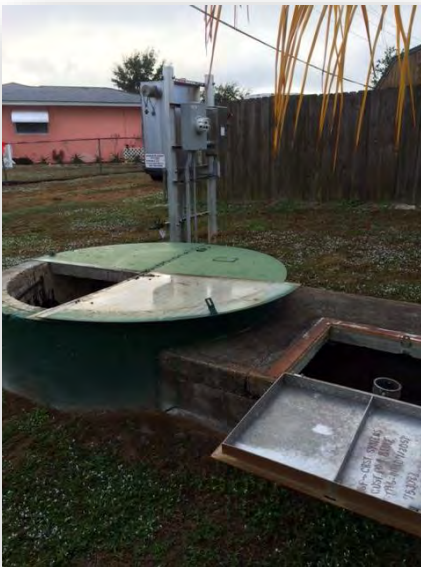
approximately 12 feet deep which is shallower than most Charlotte County Utilities Department lift station wet wells. It is in fair condition with some concrete deterioration on the walls of the wet well. Flow enters the wet well through a gravity sewer. Piping in the wet well is all PVC and pump removal

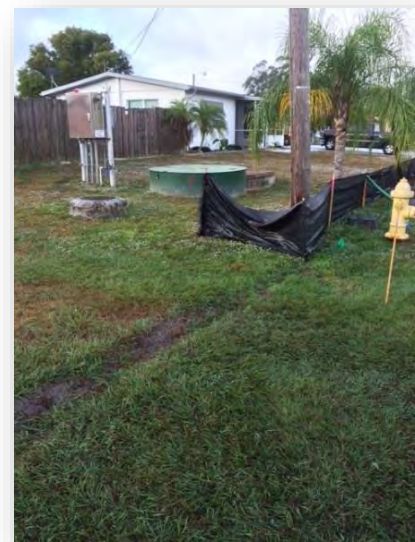
guide rails are stainless steel. The wet well cover is in fair condition and covers the entire top of the wet well. There is no generator on the site, but the main control panel includes a connection for a portable standby generator.

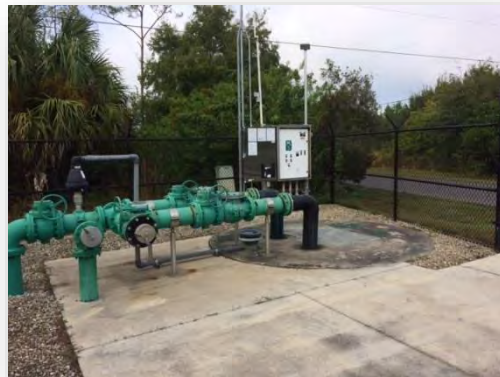
There is a generator connection receptacle on the side of the control panel. In addition, there is a permanent suction and discharge connection to accommodate a portable pump if power is lost at the station. The station is fitted with telemetry for monitoring 24 hours per day.

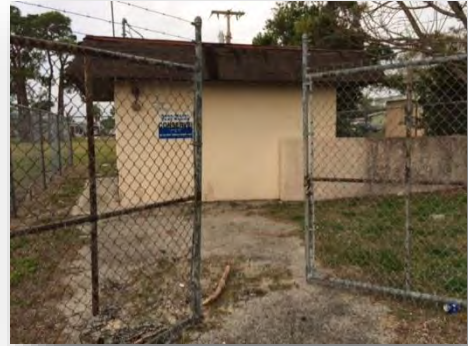
This lift station is located on Dalton Street in one of the oldest neighborhoods of Port Charlotte. The station was constructed in 1969. The overall condition of the station is fair/poor. The building needs a new roof and the concrete block building is deteriorating. Several cracks were seen in the building walls. The station is fenced and located on a vacant lot in a residential neighborhood. It contains two (2) above ground, self-priming 15 HP pumps located in the concrete block building erected adjacent to a 6-foot diameter wet well. The building also contains discharge valves and a control panel. The concrete wet well is unlined and is showing severe wearing of the surface due to years of high levels of hydrogen sulfide inside the wetwell. The station is scheduled to be replaced by a submersible pumping station. The replacement is included in the 2017 Capital Improvement Budget.

Flow enters the station via local gravity sewers. The pumps discharge into a 4-inch force main with aging steel pipe supports in the wet well. There is no odor control at the station.

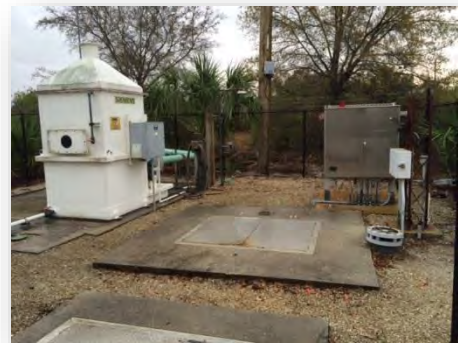
The station is fenced and well landscaped to make it nearly invisible to adjacent residences. Two 15 HP submersible pumps are installed in an eight (8) foot diameter wet well. A forced air, odor control system has been operating at the station since its construction. The odor control system is a biological tower that requires only liquid fertilizer to keep it in good running order. The continuous operation of a forced air odor control system has resulted in a good condition of the interior of the wet well after 21 years of operation. The inlet sewer pipe discharges below the water level in the wet well. This also keeps hydrogen sulfide dissipation to a minimum.

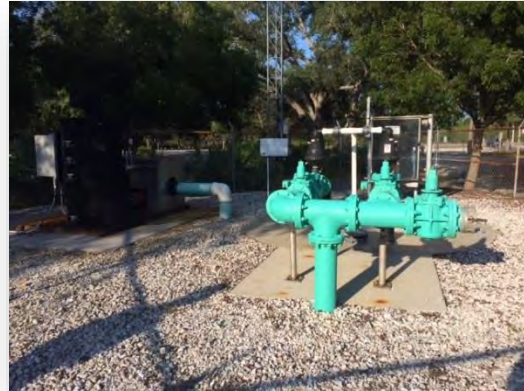
The pump discharge piping in the wet well is HDPE with the ductile iron piping and valves located above ground. The above ground piping was installed in late 2015 by CCUD staff, thereby replacing the previous valve vault.

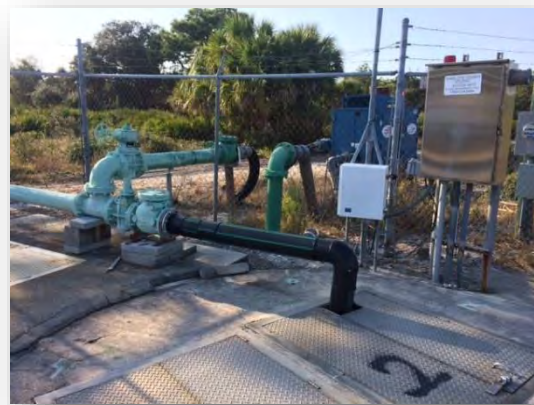
One 10 HP submersible pump is operating in the wet well. A stand-by, self-contained pump on a skid has been connected to a suction pipe that has been installed in the wet well. The discharge from the skid pump has been permanently connected to the discharge force main. This station has more than the usual amount of storage due to a second wet well that is connected to the adjacent operating wet well. The operating wet well is not plumb/level and the walls are highly corroded due to its many years of service.

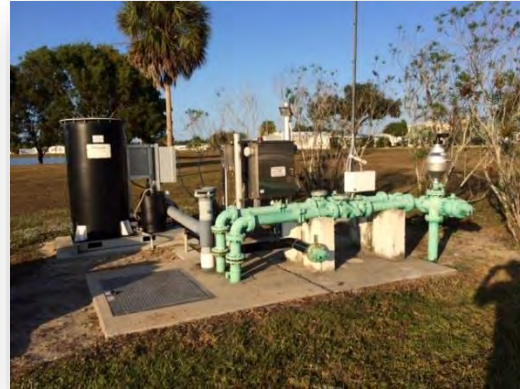
The wet well and control panels are locked. The 6 foot by 6 foot, 20 foot deep wet well is in good condition due to corrosion protection being applied in 2005. The discharge valves and piping are above ground. The station is fitted with an emergency pump suction pipe and discharge connection.

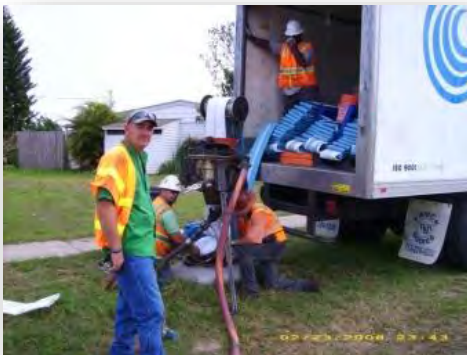
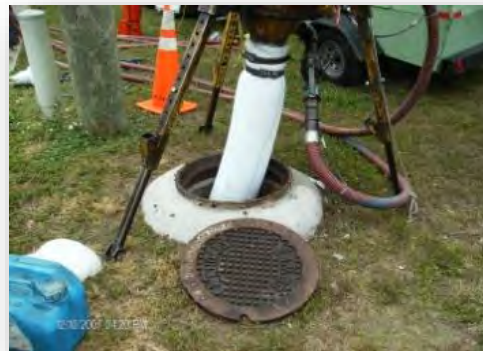
The older gravity sewer pipes are vitrified clay with frequent joints that are sources of infiltration. Vitrified clay pipe is resistant to corrosion but is more brittle than PVC and HDPE pipe. After many years of service, cracks develop and pieces of the clay pipe protrude into the flow stream. Although Charlotte County Utilities Department has relatively few plugged sewers, the broken clay pipe will cause blockage and must be repaired.

Charlotte County Utilities Department Wastewater Collections staff performs in-place pipe repairs to fix most of the broken pipes in the system. Most of these repairs involve a cured-in-place lining, fold-and-form lining, or PVC lining. These repair methods restore the integrity of the sewer system without requiring excavation.

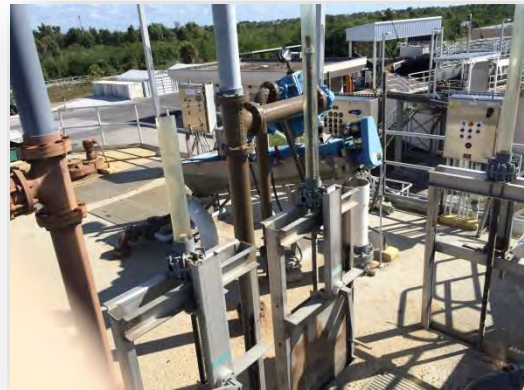
The Pista Grit removal system No. 2 (installed in 2011) received new gearbox and paddles in 2015. The No. 1 Pista Grit removal system was rehabilitated in FY 2014 and was in operation on the day of the visit. Present flow does not warrant the use of two (2) grit removal systems, however, there is now operating redundancy for screening and grit removal. A third grit pump was added to the grit removal system as part of Stage 2 of the upgrade construction in 2014.

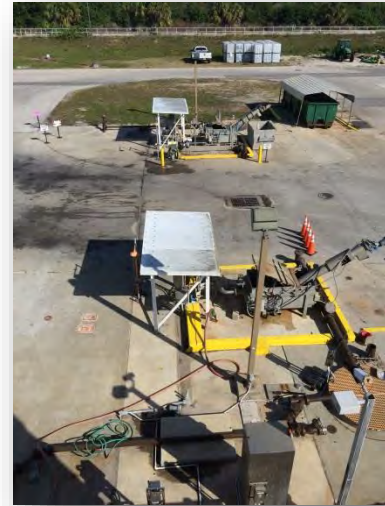
The two (2) septage pretreatment receiving stations require constant maintenance due to the high number of septage haulers that use the facilities and the nature of the waste. The septage receiving units are aging and need to be included in future capital replacement plans. Replacement of Septage Receiving Unit No. 1 moving parts was completed in FY 2016.

The septage receiving units and the adjacent driveway area collects grit and spillage of septic waste. A hose is used by the haulers to clean the area. The wash water is collected in the plant sewer system and pumped to the headworks for treatment. A steam cleaner is used by Charlotte County Utilities Department WRF staff for cleaning this area periodically.

Recommendation: Replace septage receiving pre-treatment units when repair is no longer cost effective.

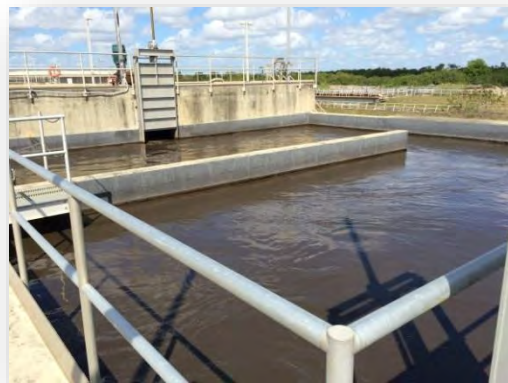
The overall condition of the activated sludge facilities is good. The concrete is in good shape for its age and showing very little cracking or spalling. Concrete near the sluice gate at anoxic influent splitter box is cracking and should be repaired. The recycle and return activated sludge pumps were replaced in FY 2014 and additional pumps have been added. Replacement of these pumps was made after more than 20 years of service.

The anoxic zone tank contents is thoroughly mixed by four (4) submerged mixers. All four (4) anoxic mixers in the two (2) anoxic tanks were operating. Grit was removed from both anoxic tanks as part of Stage 2 of the upgrade construction in FY 2014.

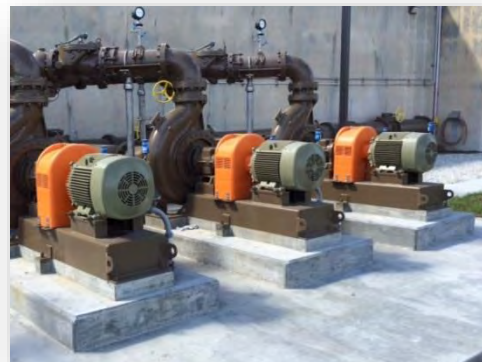
Six (6) new internal recycle pumps were installed in FY 2014 to replace four (4) pumps that had exceeded their useful life. These pumps are driven by VFDs that are under the control of operators in the operation room.

The return activated sludge pumps and the waste activated sludge pumps are located between the clarifiers. The three (3) old return sludge pumps were replaced with five (5) new pumps in 2014. The waste activated sludge pumps were replaced in 2016. All pumps were in working order at the time of the site visit.

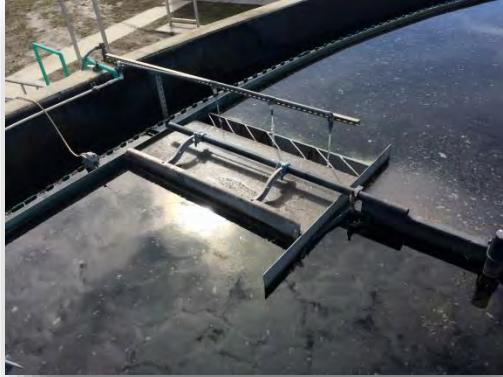
The overall condition of the sedimentation process is good after new sweeps and bottom units were replaced in both clarifiers in FY 2015.

At the time of the site visit, both scum ejectors were operating normally, however, the chief operator indicated that the highly mechanical ejector pumps require constant maintenance. They are scheduled to be replaced in later stages of the construction upgrade.

The rubber bottoms on the skimmers were replaced as part of the FY 2015 repairs.

Once per week, weirs are scrubbed with calcium hypochlorite (HTH) and rotating arms are hosed down. A

continuous chlorination system that is attached to the sweep arms has been researched and seen at another Florida treatment facility. The system was observed to keep the overflow weirs clear of algae growth without the operator performing a difficult task daily. Plans are to install the algae removal system in the future.

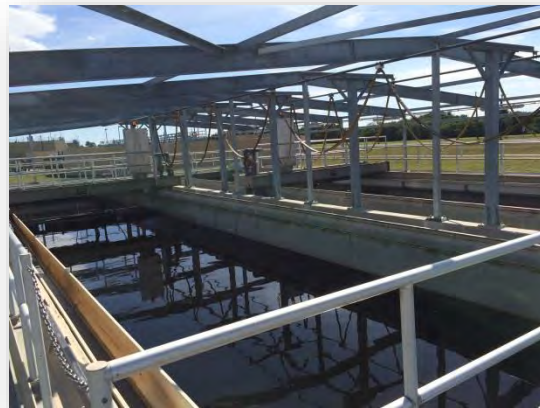
The overall condition of the filtration system is excellent after a complete rehabilitation of both sand filters was completed in October 2013.

There are two (2) traveling bridge sand/anthracite filters which were both in operation at the time of the site visit. Turbidity results indicate that the filters are producing an excellent effluent.

A metal roof was installed over the filters in 2014 to reduce algae growth and reduce the temperature of the components of the travelling screen mechanism. The ferrous metal on the influent sluice gates needs to be painted.

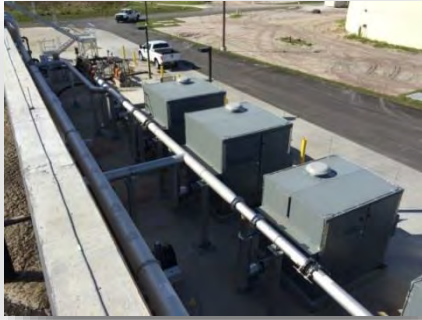
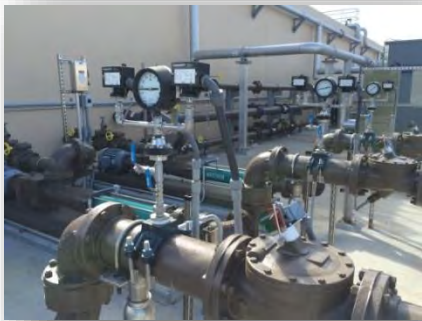
A new concrete sludge storage/digestion tank with three compartments was constructed in 2014. Four (4) new positive displacement blowers in sound attenuating enclosures were installed along the west wall of the new digester. Aeration coverage in the tanks is excellent. Process supporting pumps, floating decant mechanisms, and piping were also installed in 2014 as part of the plant upgrade. A new liquid sludge transfer system with spill containment was constructed in the 2014 plant upgrade.

Progressive cavity pumps withdraw thickened sludge from the digester and pump it to the two (2) belt filter presses. These liquid sludge supply pumps that discharge to the sludge dewatering units are operated by controls at the belt filter presses.

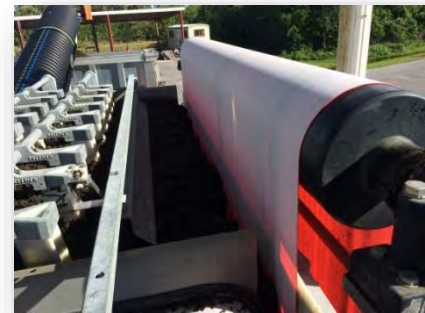
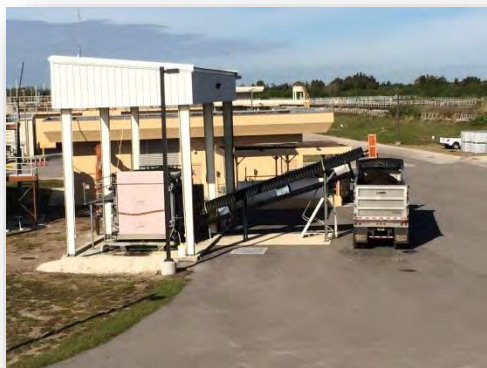
The old sludge digester has been drained for inspection. The center walkway of the old sludge holding tank is showing signs of rust and numerous aerator down-pipes have completely separated from the aerators. Generally, the old concrete tankage looks good, but

should be thoroughly inspected before or during conversion to an equalization tank. Modifications to the old sludge holding tank would have been impossible to make unless the tank was emptied. Since the EPWRF is the central solids handling facility for all of the Charlotte County Utilities Department treatment plants, taking the tank offline would have a detrimental effect on **all facilities' sludge removal process.**

The original belt filter press was repaired in 2013 including a new control panel, new elevated walkway, new screening material, and painting of rusted ferrous metals. A second belt filter press was installed in 2011 and its belt replaced in FY 2015. An additional control panel was installed at both filters to accommodate the new location of the sludge feed pumps that are now located at the sludge digester. Both belt filter presses run five (5) days per week, eight (8) hours per day.

Recommendation: Evaluate the structural integrity of the digester walkways and its ability to serve as an influent equalization tank.

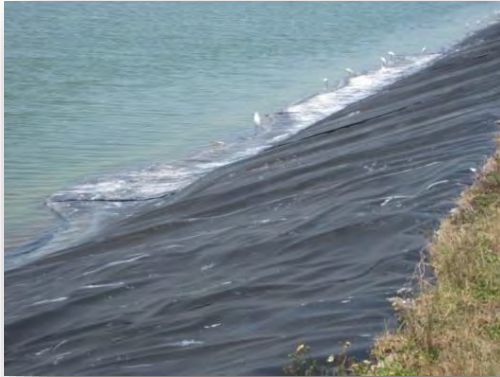
All valves are exercised on a regular basis. All associated meters are calibrated semi-annually and are up to date. Both effluent storage ponds were at safe levels. Both liners are in good/fair condition. The 45 MG

pond is beginning to show signs on the east side of material slippage down slope under the liner near the concrete outlet structure that has a fixed slope of 1 vertical to 3 horizontal. The 95 MG pond is showing signs on the east side that the bank material under the liner is slipping toward the bottom of the pond. If slippage continues, eventually the slopes must be reshaped to 1 vertical to 4 horizontal or a geogrid soil stabilization mat must be installed to prevent slippage of berm material.

Recommendation: Make modifications to the effluent storage ponds to allow one (1) pond to serve as a reclaimed water storage pond and the other pond to serve as storage for on-site spray irrigation flow or effluent to be disposed of **in the plant's deep injection** wells.

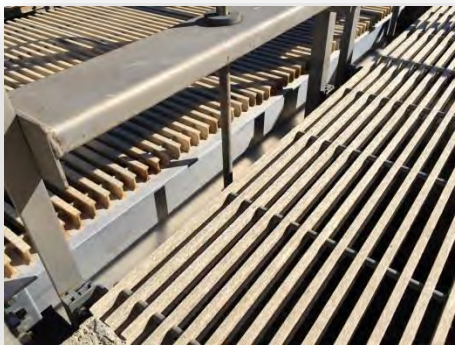
All four (4) mechanical bar screens were in operation at the time of site review. The screens' housing is Type 304 stainless steel, but pin holes had developed in the housing due to the highly corrosive gases released in the headworks. The screen housings on all four (4) screens have been sand blasted and painted with epoxy paint. Most of the screen components are stainless steel. However, the few carbon steel components on the screen mechanics are a constant maintenance item. The 316 stainless steel wedge wire drums are in pristine condition.

There is a fiberglass grating over the influent flow splitter area that had been supported by two (2) carbon steel beams.

were replaced with aluminum beams in FY 2015. The fiberglass grating is showing no signs of deterioration.

Recommendation: Coat the inside and outside of two (2) influent screen housings with material that will resist hydrogen sulfide attack. Plug pin holes in the Type 304 stainless steel housings prior to coating.

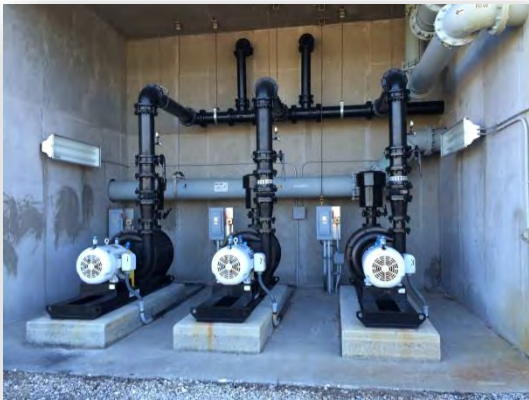
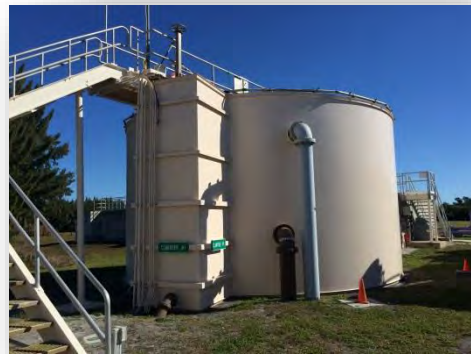
There are four (4) aeration basins. All four (4) basins were in service at the time of the site review. New fine bubble diffusers were installed in all four (4) active aeration tanks in 2013 and 2014. This has had a positive effect on the treatment process by providing a more even air flow distribution. Basin No. 3 was cleaned of grit and aerators were repaired as necessary in FY 2016. The outlet weirs of the aeration tanks require manual cleaning when debris catches on the weirs.

Four (4) Return/Waste Activated Sludge (RAS)/WAS pumps were in good operating condition. The pumps and pipes were painted with marine gloss paint five (5) years ago. The paint is holding up very well. The pumps are housed under a sheet metal roof.

All three (3) blowers were operating properly. A new soft start was added to one blower in FY 2015 to eliminate a surge in power demand.

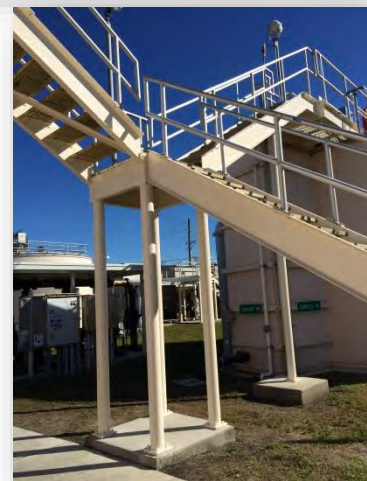
The overall condition of the sedimentation process is fair, but improving.

All four (4) clarifiers were in service at the time of inspection. All four (4) clarifiers have been placed on a schedule of inspection, repair, and painting from

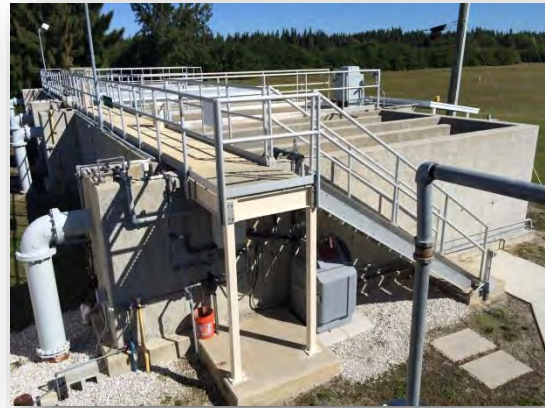
The continuously monitoring pH and chlorine analyzers are in good working order. The pH was 7.23 and the chlorine residual was 9.77 mg/L.

Only one (1) of four (4) CCTs was in use on the day of the site visit. It was calculated that a 15 minute detention time for one CCT can be obtained for peak hourly flows up to 955 gpm. A new chlorine feed system that includes two (2) chemical feed pumps for each of two CCTs has been purchased and is ready for installation in a new chlorine storage and feed area between the two chlorine contact tank structures. This will enable two (2) parallel CCTs to be operated when peak hourly flows exceed 955 gpm.

Recommendation: Install new chlorine chemical feed pumps and put a second chlorine contact tank into service during periods of high flow.

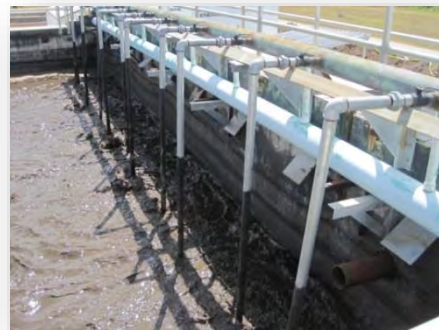
The overall condition of the sludge holding tanks is good.

The four (4) RAS/WAS pumps each serve one (1) clarifier during normal operations, but valves on the inlet pipe manifold allow any pump to be used for alternative clarifier sludge pumping. Liquid sludge is transported to the East Port WRF for dewatering and delivery of dewatered sludge to the Charlotte County Landfill where Class AA compost is made for sale as a soil conditioner. The sludge handling records meet operating permit requirements.

Recommendation: Install pump to transfer sludge from the large sludge holding tank to the smaller sludge tank.

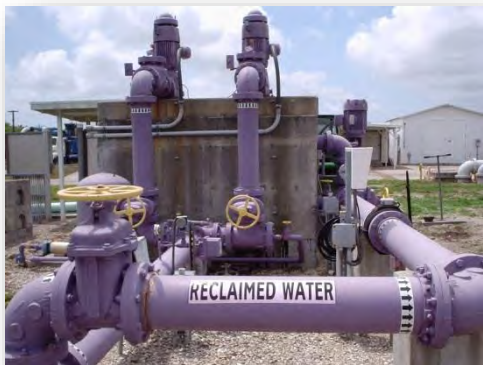
The two (2) high service reclaimed water pumps and one (1) jockey pump are in good condition. A new 16-inch pipe that transports reclaimed water from the East Port WRF to western Charlotte County was completed in FY 2014. The pipe connects directly to the storage ponds and/or the West County distribution system as system valves allow.

There are three (3) new deep well pumps. All pumps were fully functioning at the time of the inspection.

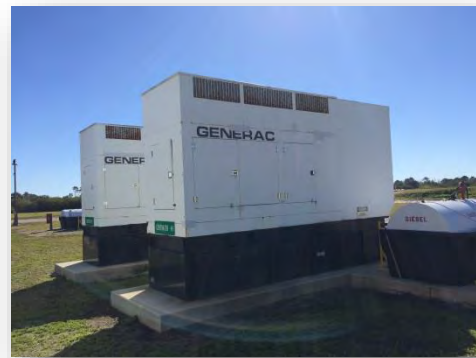
There are two (2) 400 kW generators servicing the facility. The generator can meet the current demand for standby power. The generators are run four (4) hours under load every two (2) weeks. The small diesel and gasoline storage tanks are located next to the generators, placed in spill containment vessels, and tied down. Identification signage is good.

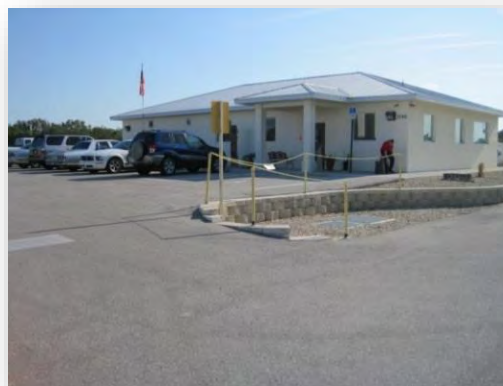
Access to the facility is through a secure gate in a fence that surrounds the wastewater plant and effluent storage ponds. The plant site is well maintained and most of the equipment is less than seven (7) years old. The exterior walls of all of the tanks were painted in 2011. Painted exterior walls and piping is beginning to show signs that repainting should be scheduled in the next two (2) years.

The plant operators continue to exercise all valves on a regular basis. All compliance meters are calibrated every six (6) months and calibration tags were up-to-date at the time of the site visit.

Recommendation: Paint tanks and buildings in the next two (2) years.

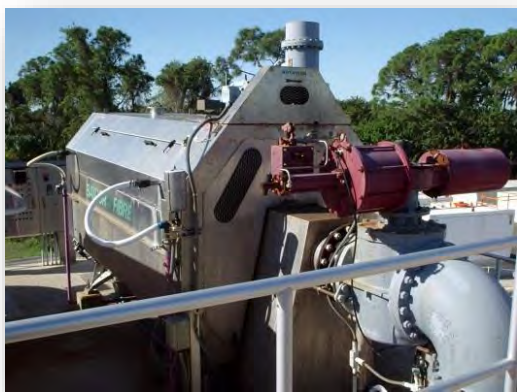
The screenings and grit dumpsters are emptied once per week. The dumpster area is clean and free of odors. The screening screw conveyors/compactors and grit dewatering units are operating as intended. A wash water spray was added to the screening compactors which improved their operation and lengthened the life of the lower bearing units. The drive motor on No. 2 screening conveyor was raised above the bottom bearings to prevent water from entering the motor when the seal bearing leaks. This motor location and with its drive belt has proven to be a better location than the

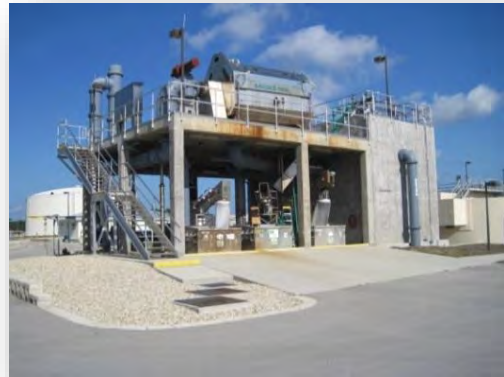
manufacturer's direct drive location. These pieces of equipment are also monitored frequently for wear and operating efficiency.

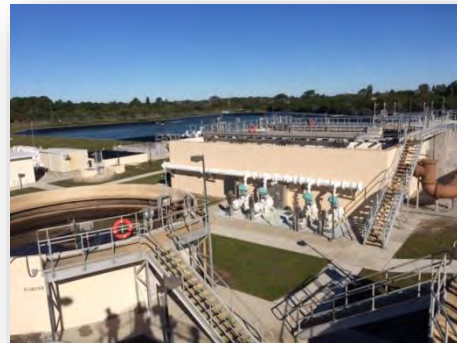
The chief operator noted that Lift Station No. 801 sends 1500 gpm to the Rotonda plant for about 20 minutes and then turns off for 20 to 30 minutes. The equalization tank, which serves as a means to attenuate high hourly flows, is filled through a gravity system initiated by an overflow weir at the headworks structure. The equalization tank contents are returned to the headworks for treatment at a steady flow over 24 hours using variable speed pumps. This has proven to be a valuable asset to the operation of the facility. The operation of the equalization (EQ)

tank has been adjusted to respond to the intermittent discharge from Lift Station No. 801. Dry pit submersible pumps are used to return equalization tank contents to the treatment stream. Pump No. 3 was replaced in FY 2014. The EQ tank positive displacement blowers are run intermittently to save power. Oil sight glasses and fill ports were added by Charlotte County Utilities Department to improve maintenance.

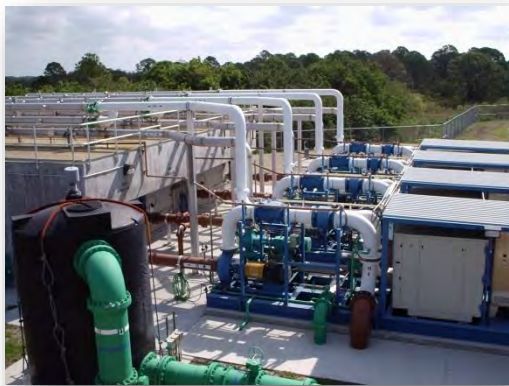
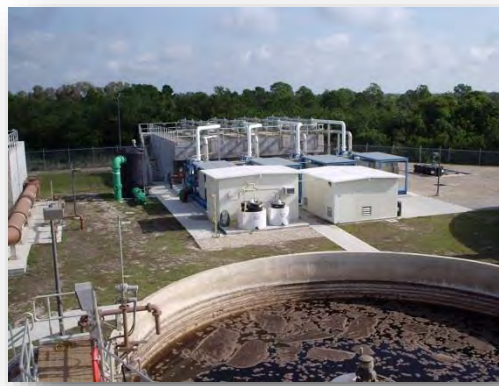
The overall condition of the MBR system is good and well maintained.

There are four (4) trains containing three (3) cassettes each. The cassettes are removed every year for cleaning and receive insitu concentrated chlorine bleach cleaning twice per year.

The MBR system continues to produce a high quality effluent with minimal problems. The MLVSS return/recycle pumps are in good working order.

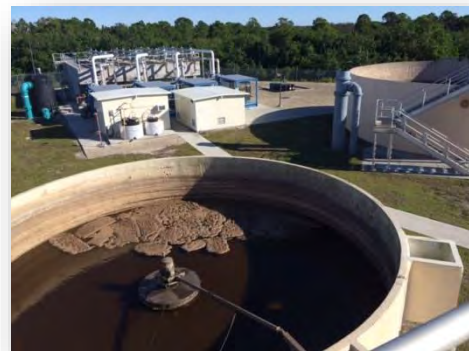
There are two (2) sludge holding tanks in use with a total capacity of nearly 170,000 gallons. Both tanks are converted clarifiers with center surface aerators. Liquid sludge is hauled to the East Port WRF for dewatering and final disposal at a Class AA compost facility located at the Charlotte County Landfill.

The decant mechanism for the sludge holding tanks was designed as telescoping valves, but the telescoping valves can only be lowered to one-half the depth of the tank. The operators have replaced the designed method of decanting

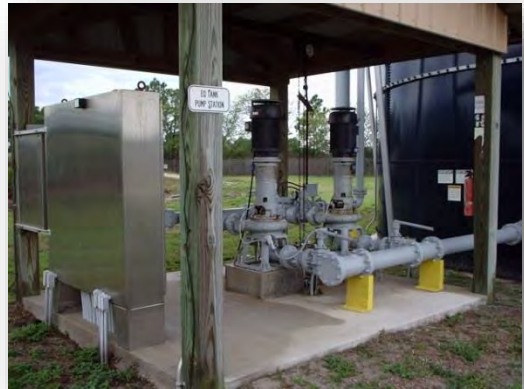
The influent manual screening system cannot prevent moderate-size debris from entering the facility's equalization tank, pumping systems, and process tanks.

In addition, the facility's headworks does not contain a grit removal process. The lack of fine screening creates operational and mechanical problems for the equalization pumps and the RAS/WAS pumps. Staff continues to clear equalization transfer pumps and pipe lines of debris to remove clogs in the system approximately once per month. A permanent pump motor hoist system has been erected over the equalization pumps to allow safe access to the pump volute to remove clogging debris.

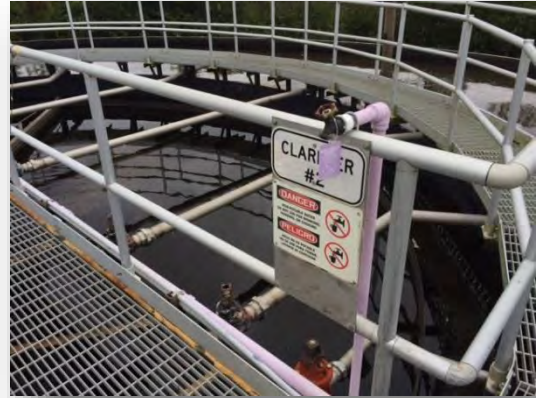
Scum is collected in a scum trough and sent to the plant lift station. The plant's lift station discharges to the equalization tank. Therefore, there is no means to remove scum after it enters the plant flow.

The facility upgrade should include a fine mechanical bar screen at the beginning of the plant to relieve the endless accumulation of scum in the Burnt Store WRF. In the interim, it is recommended that the scum be collected and pumped to the digester where some of the scum will be removed during sludge hauling.
