2016 Annual Report

Prepared for:
Charlotte County Utilities Department
25550 Harborview Road, Suite 1
Port Charlotte, FL 33980

Prepared by:
Stantec Consulting Services Inc.
5172 Station Way
Sarasota, FL 34233
Florida Certificate No. 27013

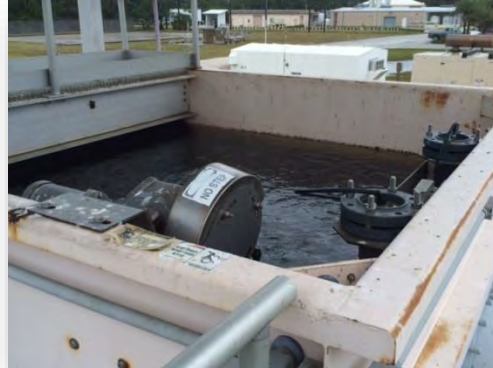
There is one 0.500 mgd disc filter in operation with space for two (2) additional cloth discs. The operator indicated that although the filter is producing a good effluent, it backwashes frequently during periods of high flow. Additional cloth discs to be installed in the two (2) spare slots have been delivered to the plant for installation in 2017.

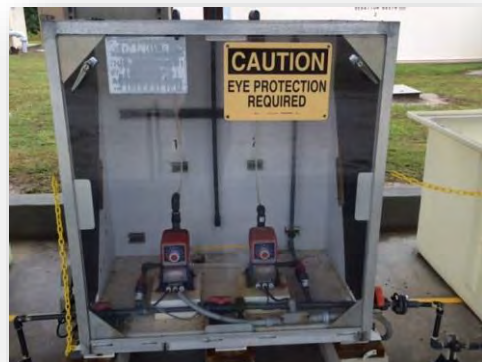
There are two (2) chemical feed pumps that are controlled by a new reagent-less analyzer. The pump chemical feed bases are beginning to show rust and should be painted with chlorine resistant paint.

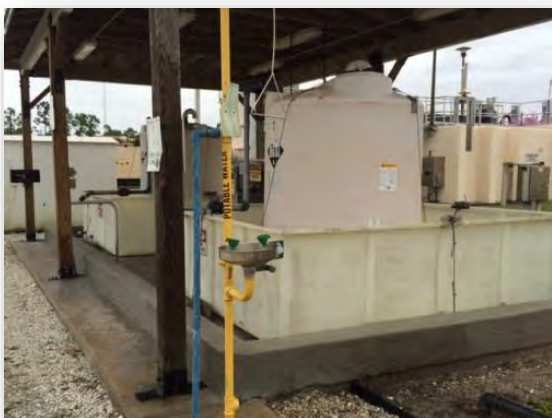
The chlorine analyzer which measures chlorine concentration at the beginning of the chlorine contact

tank (CCT) is used to adjust chlorine feed rates to maintain regulatory residual requirements at the effluent weir. A reagent-less analyzer is the compliance monitoring analyzer that measures the chlorine residual at the discharge of the chlorine contact tank. The concrete chlorine contact basins are in good condition. A UV cover has been installed over the CCT side that is in use to inhibit algae growth. Liquid sodium hypochlorite is used for disinfection. A mixing pump has been added to the area where liquid

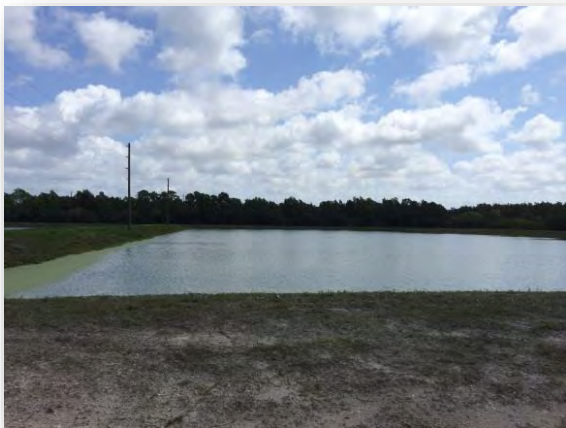
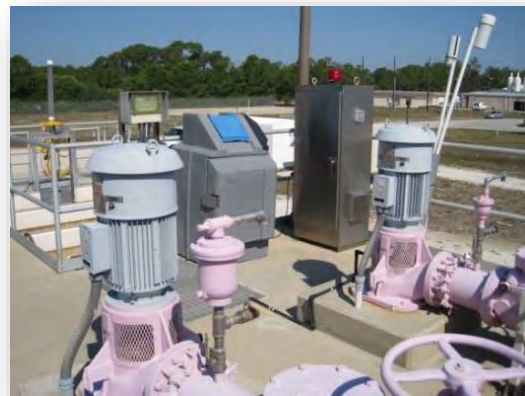
Effluent disposal is accomplished through two (2) deep injection wells, reclaimed water sales, and four (4) rapid infiltration percolation ponds. The

percolation ponds are used to their maximum permitted capacity to encourage shallow groundwater recharge. The percolation ponds are alternately rested and allowed to dry. The pond bottoms are harrowed to enhance percolation. The interior of the ponds above the water line are mowed.

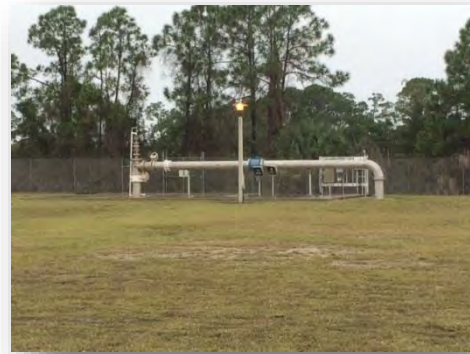
At the time of the site visit, the maximum disposal rate to the deep injection wells was 360 gpm. Effluent is transferred, by gravity flow, from the plant discharge to both the deep well pumping station and percolation ponds. The flow rate to the deep well pumping station wet well is through a 6-inch diameter pipe. The available head between the effluent wetwell at the chlorine contact tanks and the deep well pumping station is insufficient to move peak flows through the small 6-inch transfer pipe. Flow that does not reach the deep well overflows to the percolation ponds.

The limitation on the capability to discharge effluent to the deep well system is counterproductive and may cause overloading of the ponds when future flow increases. The ability to transfer higher flows by gravity or pumping should be investigated as part of the plant upgrade design. The current situation makes it impossible to use the full capacity **of the facilities' deep wells**. A smaller pump was installed to replace an existing pump in the deep well pumping station to match the current flows that flow by gravity to the wetwell. The deep well pumps need to be repainted.

- Recommendation: Paint deep well injection pumps.
Progress: Not Completed.
- Recommendation: Install a pumping system that will pump effluent to the deep injection well pumping station or increase the capacity of the gravity pipe. This will maximize the capacity of the deep injection wells' **system** when necessary.
Progress: Not completed.

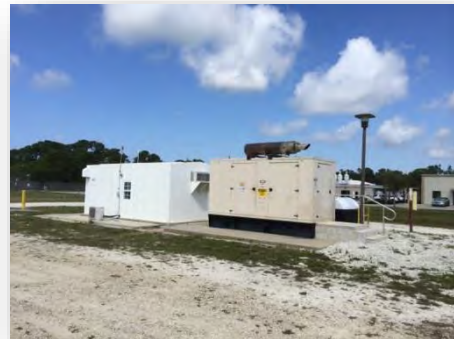
There is a 350 kW generator servicing the facility. The **demand on the generator's capacity is adequate for the** current facility. Service of the generator is provided by an outside contractor. The generator is run every two (2) weeks for four (4) hours under load. Two 500 gallon steel fuel tanks with containment and tie-downs were installed at the facility in 2012.

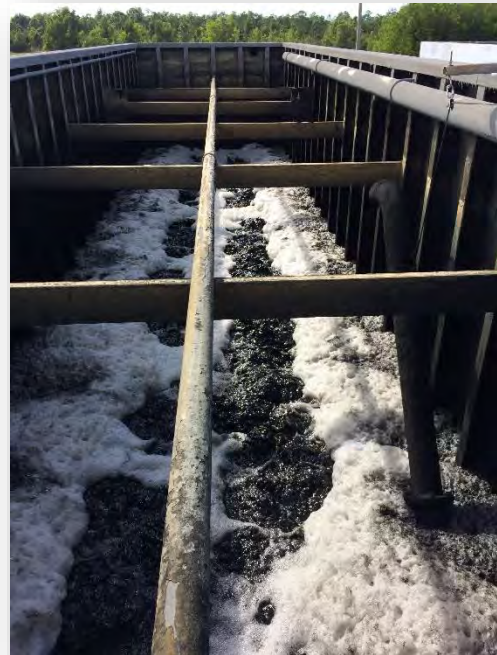
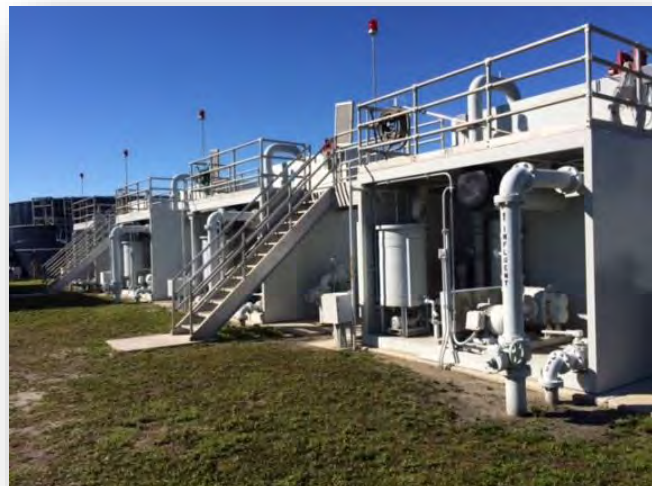
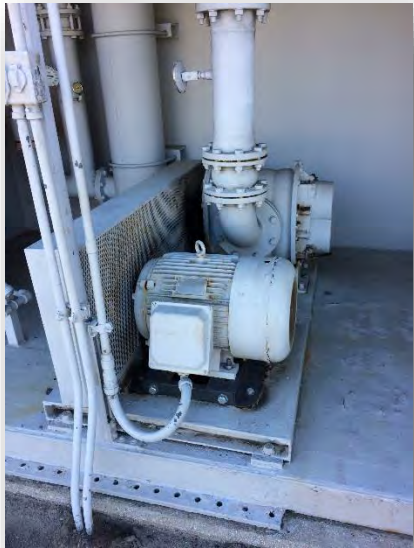
The tanks still have a sufficient coat of exterior paint. The non-slip surface of the tanks’ walkways were painted in 2014. The tank’s exteriors were painted in FY 2015. The elevated walkways are scheduled for repainting in 2017.

In 2005 through 2008, all of the tanks received an interior coating of polyurea. This coating is holding up better than any other previously used interior coating.

Recommendation: Continue to paint the interior and exterior of the PACT tanks on a regular schedule.

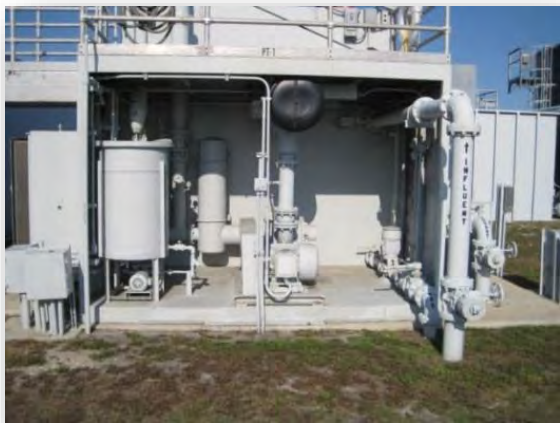
A foaming problem developed when methane wells were installed at the landfill in FY 2014. The operator has managed the foam with anti-foaming agents and water sprays on the top of the PACT tanks and influent pumping station.

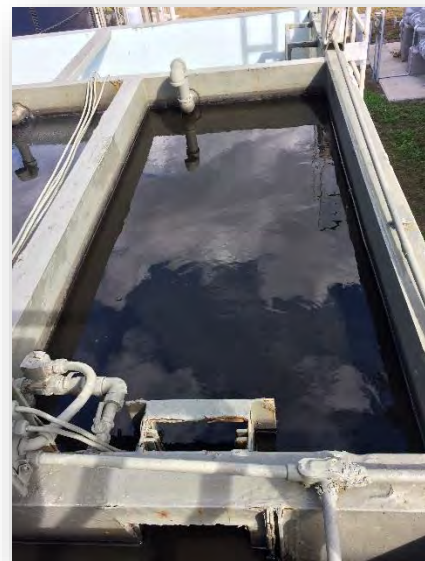
The condition of the sand media filter is good. Rust on this steel tank and equipment supports has been scrapped and painted with epoxy. The interior of this tank should be painted with polyurea in the same manner as the PACT tanks.

There is no back-up for this critical piece of treatment equipment. The installation of a second similar filter in the future should be investigated to enable continuous operation of the plant and provide redundancy for filtration. The sand media and sand support system should be replaced in the

existing filter when necessary, along with removing rust and existing paint to bright metal and painting with a polyurea coating.

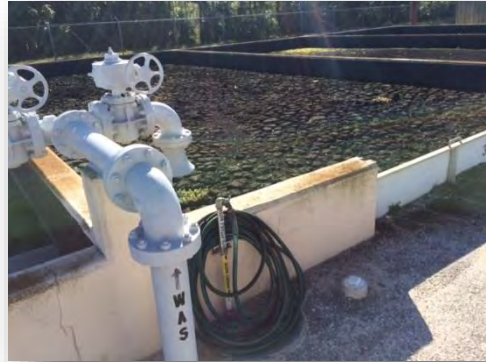
The overall condition of the solids handling facilities is good. The exterior of the sludge digestion/concentrating tank was painted in FY 2015. The use of the tank to concentrate sludge is not necessary. It has the capability of being converted to a fourth PACT treatment unit.

Staff indicated that there are no operational issues with the sludge digestion/concentrating tank. The aeration of the sludge concentrating tank was turned off at the time of the site visit.

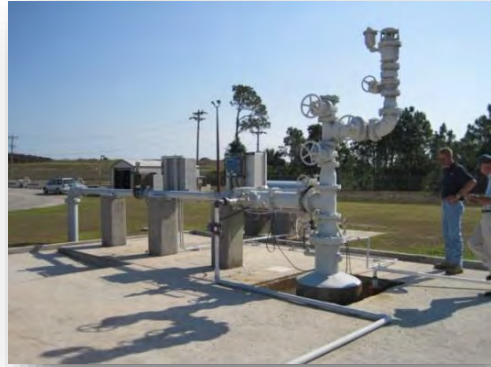
Two (2) dry pit submersible pumps are used to alternately inject effluent into the well. Both pumps were replaced by Charlotte County Utilities Department personnel in 2015. The HP of the pumps was increased from 7.5 HP to 12 HP. The new pumps are operating satisfactorily and not overheating on hot summer days.

The Hydro Tank that is part of the deep well disposal system was replaced with a new tank in 2011. It should have many years of useful life remaining.
