Charlotte County Utilities Department

2017 Annual Report
April 2018

2017 ANNUAL REPORT

Jones Edmunds Project No.: 03405-029-01

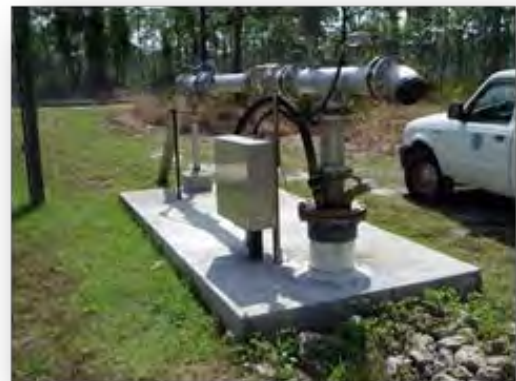
- Well No. 7 is an 8-inch-diameter well, located on site adjacent to the WTP's back-up generator. This is the oldest well in operation at the WTP, but it remains in good condition.

Minor rust was observed on the stainless steel wellhead and butterfly valve operator.

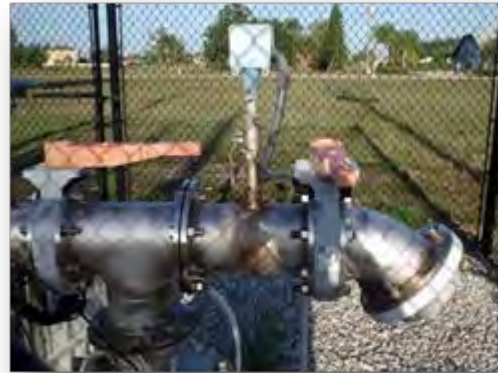
- Well No. 16 is a 12-inch-diameter well located on the east side of the site. The skid-mounted generator has been moved to a mobile trailer for multiple site use. The well pump is in excellent condition.

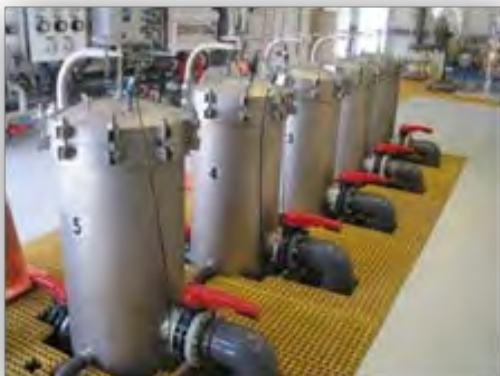
The facility contains five stainless steel cartridge filter housing vessels. Each vessels holds 40 1-micron cartridge filters. The pressure differential of each cartridge filter vessel is monitored to determine when filters need to be replaced.

The vessels are in good condition, and the staff changes the filters within the recommended differential pressure. No irregularities were reported, and the equipment appeared to be in excellent working order at the time of the site visit.

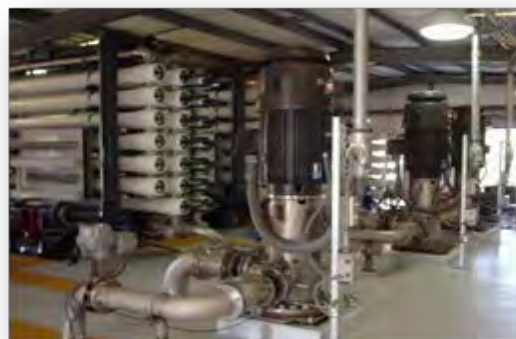
The Burnt Store RO WTP has five 2-stage RO process trains, A through E. Trains A and B were installed in 2007, and Trains C, D, and E were installed in 2009. Trains A and B are served by two horizontal split-case pumps, and Trains C, D, and E are fed by vertical turbine pumps. Each RO feed pump is painted and in good condition.

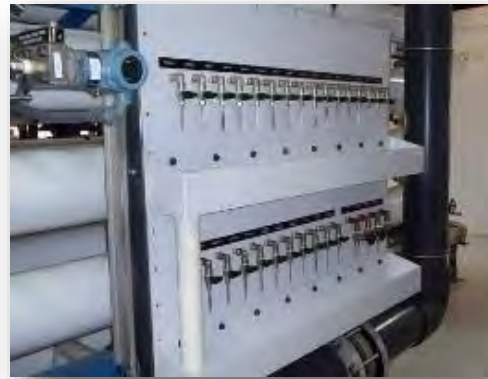
Membrane performance is assessed by monitoring the pressure, recovery, and water quality of the system. Staff have the ability to monitor water quality and pressure throughout the membrane process. Sampling sinks and instrumentation are operating properly and in good condition.

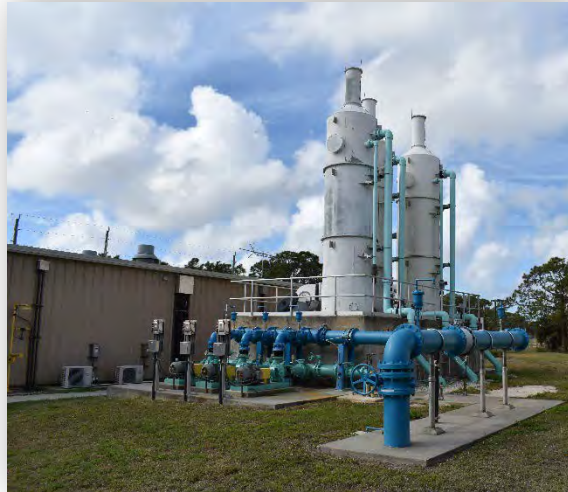
Degasified water is transferred from the clearwells to the GSTs by three horizontal centrifugal pumps. In 2013, two in-line static mixers were installed in the transfer pipe leading to the GSTs to mix sodium hydroxide, corrosion inhibitor, and sodium hypochlorite. In 2015, the redundant and leaking air release valves downstream of the pumps were removed and two additional air-release valves were placed within 25 feet of the removed air-release valves.

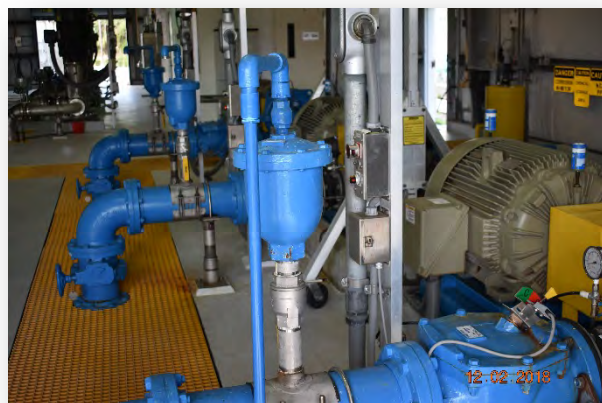
The RO WTP has two medium-flow pumps, one high-flow high-service pump, and two jockey pumps providing flow to the distribution system. The two medium-flow pumps were installed in early 2012 to more accurately match the system flow needs. One of the jockey pumps was installed in August 2017.

The variable-frequency (motor speed) drives on the pumps provide a constant pressure of 65 pounds per square inch (psi) at the beginning of the distribution system at the water plant regardless of the water use. The motor on Jockey Pump A should be painted, but all the high-service pumps are operational and in good condition.

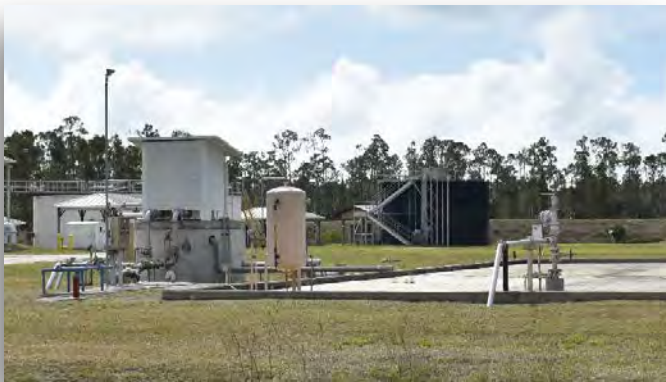
Concentrate from the RO process is disposed of by means of the on-site Deep Injection Wells IW-1 and IW-2. Both wells are permitted to accept concentrate and treated wastewater effluent. Concentrate is transferred to the deep well pumping station clearwell by latent pressure in the RO trains. There it is combined with wastewater effluent and injected into the deep wells. The maximum capacity of IW-1 is 0.564 MGD at a maximum rate of 392 gallons per minute (gpm). The maximum capacity of IW-2 is 2.88 MGD at a maximum rate of 2,000 gpm.

Both injection wells have flow meters and pressure gauges that can be monitored in the control room. Both wells undergo mechanical integrity testing every 5 years. A mechanical integrity test was successfully performed on IW-2 in 2013. A vibration analysis was also conducted for the vertical turbine injection well pumps in 2017. Due to the test results, the pumps were reprogrammed to minimize wear and

appear to be functioning properly at the time of the site visit. The pumps at the station need to be painted.

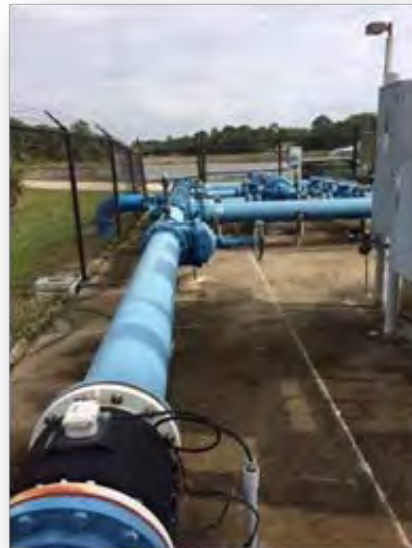
The Englewood Water District (EWD)/CCUD interconnect not only provides redundancy for both water systems in the event of an emergency, but also has the potential for either utility to buy or sell excess water if needed. The EWD interconnect facilities include two 40-horsepower (HP) booster pumps with a diesel generator for backup power supply. Monitoring at the interconnect facility includes total chlorine residual, pressure, and flow. No storage or chemical dosing is provided at this facility. By opening or closing valves, the EWD interconnect pumping station can pump water in either direction, i.e., to or from EWD. However, both entities must get permission from and will be billed by the PRMRWSA to receive excess water as stipulated by the PRMRWSA contract.

Over the past 3 years, one O&M improvement was completed at this interconnect – a faulty human-machine interface (HMI) was replaced in FY 2017.

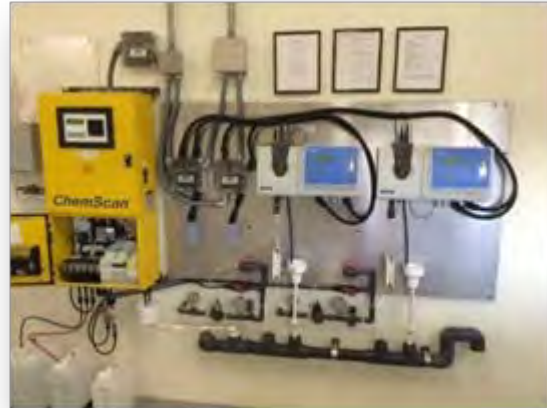
- 2014 – A 70-foot pole/antennae combination was installed at the site to assist with the County’s automatic meter reading initiative.
- 2015 – The chemical feed lines from the bulk chemical storage tanks to pumps to injection points were replaced.
- 2016 – The GST was painted.
- 2017 – The holes penetrating the building walls from the new chemical feed lines were patched.
- 2017 – All site cameras were repaired.
- 2017 – The sodium hypochlorite skid was rebuilt.

The station is in excellent condition with updated equipment and building furnishings. Graveled areas around the station infrastructure are weeded, and landscaping is well maintained. The indoor buildings are kept clean, and tools and equipment are organized and stored properly. The high-service pumps are well maintained and functioning properly.

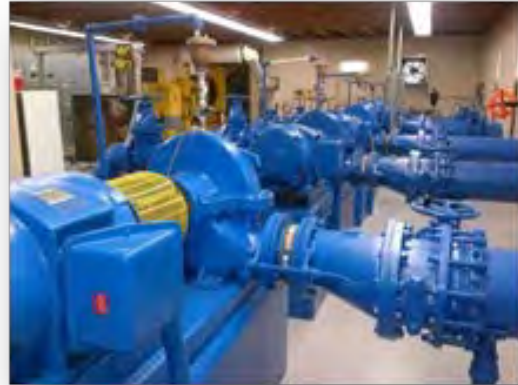
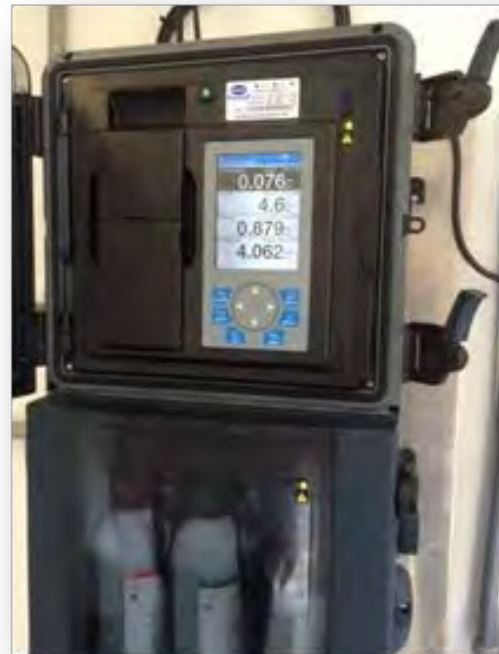
The general condition of the station is good. The access roads outside the facility are aging, but inside the property are in decent condition. Graveled areas around the station infrastructure are weeded, and landscaping is well maintained. The indoor buildings are kept clean, and tools and equipment are organized and stored properly. The high-service pumps are well maintained and functioning properly.

- Exposed concrete was observed on the floor of the chemical skid rooms.
- The outside of the GST has been patched and painted in recent years. Operators are concerned about wall leaks in the interior of the tank.

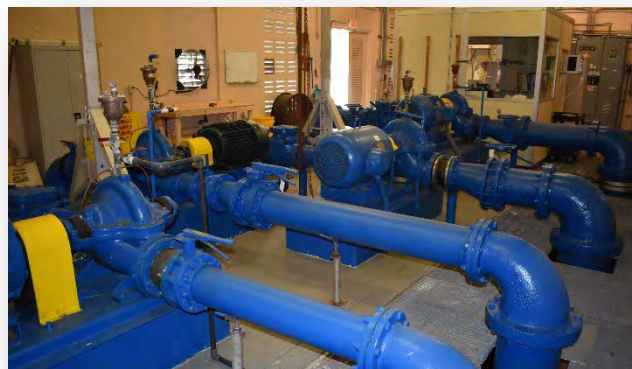
The station is generally in good condition. Roads and landscaping are well maintained. Graveled areas around the facility infrastructure are weeded, the grass is cut, and the perimeter fencing is devoid of plant growth. The indoor buildings are kept clean, and tools and equipment are organized and stored properly. High-service pumps are well maintained and functioning properly. In 2016, the County began planning to install a new water feed pipe across the Myakka River. The project is ongoing.

- The pipe connecting the GST to the pump station is constructed of formed concrete, which is not industry standard.
- The concrete support on the GST influent pipe was corroded.
- Liquid was observed on the floor of the ammonium sulfate chemical injection room.
- The paint on the floor of the sodium hypochlorite injection room was eroded.
- No eye wash station is provided in the new on-site operations room.

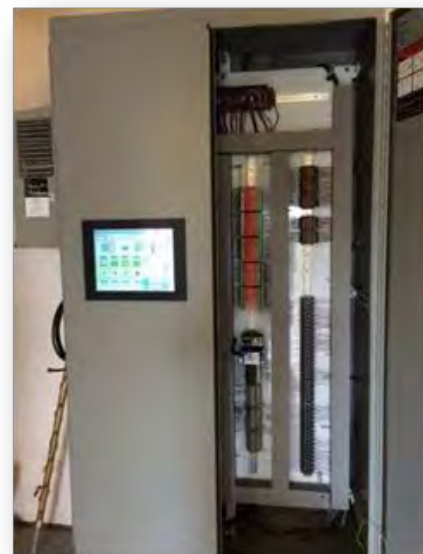
The station is in good condition. Roads and landscaping are in decent condition. Graveled areas around the facility infrastructure are weeded, but minor plant growth on the perimeter fencing was observed. The indoor buildings are kept clean, and tools and equipment are organized and stored properly. The County has plans to install a 24-inch water transmission main from Ingraham Street to the Rotonda GST in 2017.

- Rust on the pump bases was observed on the High-Service Pumps 1 and 3.
- The concrete flooring is exposed in the sodium hypochlorite skid feed room.
- The top of the diesel fuel storage tank for the generator is rusted and collects rainwater.

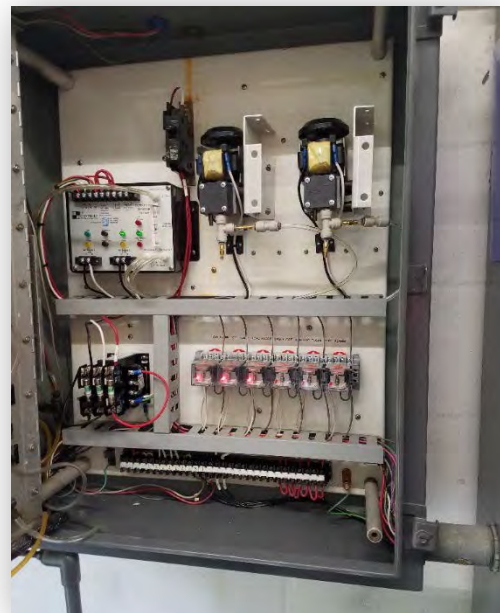
The Quesada Wastewater Lift Station (Lift Station [LS] 37) is a master lift station that receives wastewater from 27 contributing pump stations. It has three submersible, 88-HP pumps that pump directly to the East Port WRF through a long force main. The station is in good/fair condition due to its age and regular preventative maintenance. There is a carbon adsorption, forced air odor-control system at the station, which keeps the hydrogen sulfide level in the wet well low. The station contains a telemetry transmitter that allows monitoring to occur from the CCUD central office and treatment plants.

- The station building is generally in good condition except that the metal doors on the building are rusting and need to be replaced.
- The existing 180-kW stationary generator, which is operated once a week to ensure it is ready for stand-by power, is currently only capable of running two pumps at one time. Given its age, the probability of failure is higher than average; and due to the critical role as the major receptacle of many contributing lift stations, an overhaul or replacement is needed.

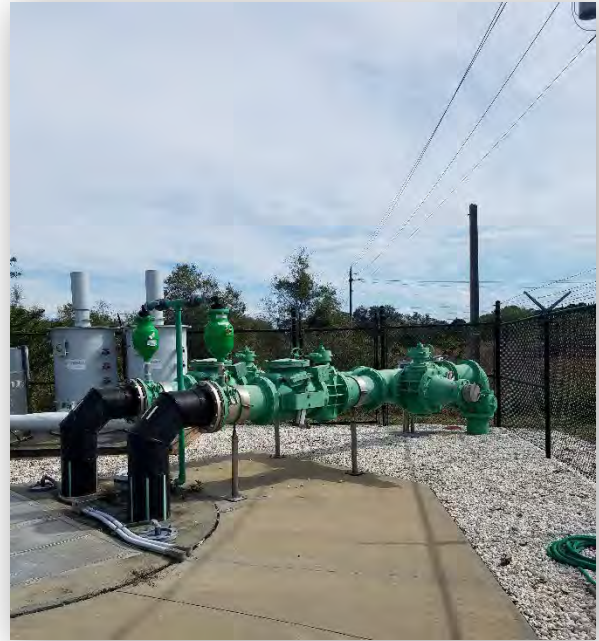
The station is in very good condition. The above ground piping was repainted in 2014. The forced-air odor-control system reduces hydrogen sulfide concentrations in the wet well. The pump discharge at the time of the site visit was 1,500 gpm. The generator is operated once a week to ensure it is ready for stand-by power.

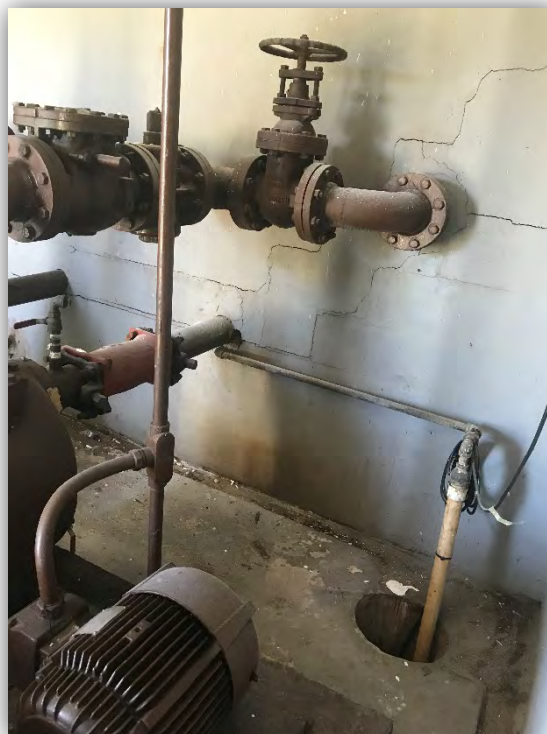
This lift station is located on Dalton Street in one of the oldest Port Charlotte neighborhoods. The station was constructed in 1969, and the overall condition of the station is fair to poor. The building needs a new roof and the concrete block building is deteriorating. The building walls have several cracks and structural integrity may be compromised in the event of a hurricane, thereby presenting a potential safety issue to the CCUD Operations crew during emergency situations.

The station is fenced and is on a vacant lot in a residential neighborhood. It contains two above ground, self-priming 15-HP pumps inside the concrete block building, which is adjacent to a 6-foot diameter wet well. The building also contains discharge valves and a control panel. The concrete wet well is unlined and is showing severe wearing of the surface due to years of high levels of hydrogen

sulfide. The station is scheduled to be replaced by a submersible pumping station. The replacement is included in the FY 2018 Planned Improvements.

- Paint the above ground discharge piping.
- Repair wet well hatch hinges.
- Perform thorough rehabilitation of the lift station including repair of the building or replace the station with a modern submersible configuration with all new equipment.

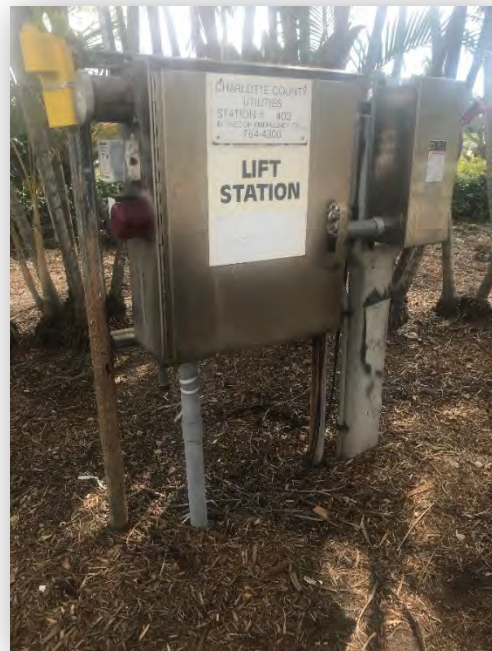
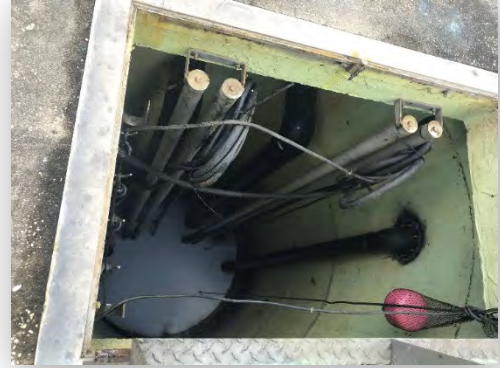
5.2.4.9 Lift Station 412 – Roland

LS 412, at Roland Lane, was constructed in 2011 and receives residential flow from a private development. Sixteen air induction systems that were converted to submersible grinder pumps discharge an estimated average daily flow of 7,700 gpm sewage to the station. The lift station conveys wastewater flow through a dedicated force main to the Burnt Store RO WRF. The lift station is in good condition.

The lift station contains two submersible Hydromatic pumps rated at 5 HP. The wet well interior and discharge piping are painted to prevent rusting, and there is adequate venting to prevent gas build up and corrosion in the wet well. The station has a portable generator quick connection and an emergency bypass pump connection but no permanent generator.

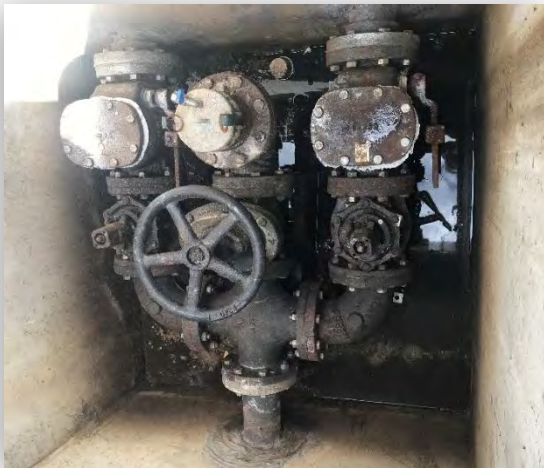
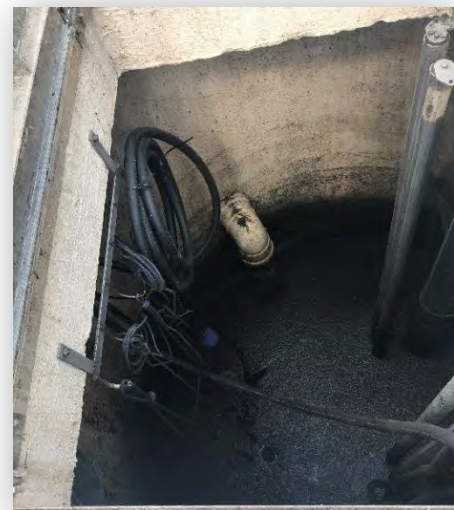
5.2.4.10 Lift Station 415 – Prada

The Prada lift station is on a dirt road south of the intersection of Doredo Drive and Prada Drive. The station exclusively serves residential areas. The overall condition of the station is fair. The station contains two 7.5-HP submersible pumps in the 6-foot wet well. The pumps discharge into a 4-inch force main flowing to the Burnt Store RO WRF. The station is fenced. There is no odor control at the station, and objectionable odor was noted.

The following deficiencies were noted:

- The concrete wet well and valve vault has some corrosion.

Proposed 2018 improvements to the station include:

- Epoxy-coat the inside of the wet well.
- Refurbish or replace the aging control panel.
- Add an odor-control system.

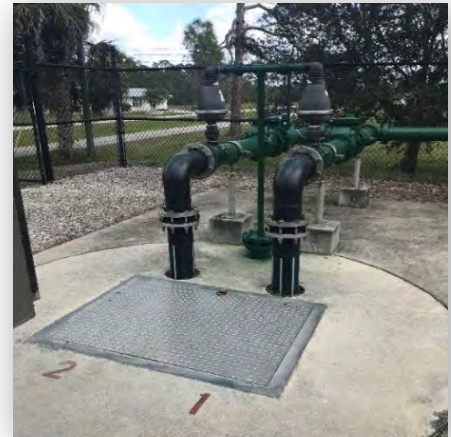
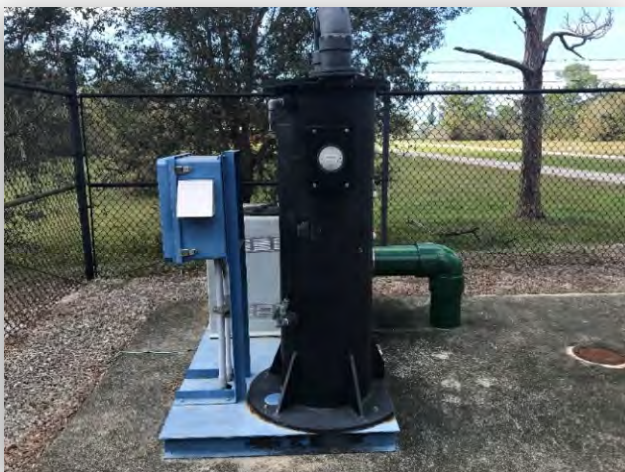
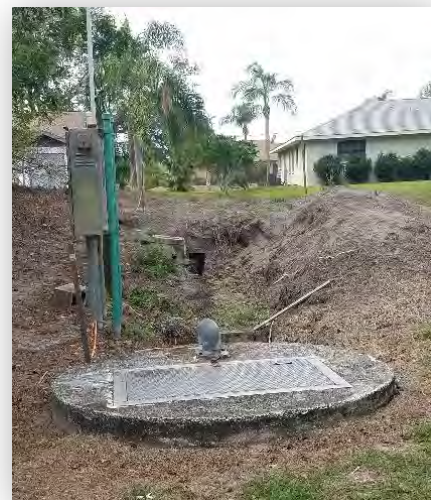
5.2.4.11 Lift Station 420 – Pirate Harbor

This neighborhood lift station receives wastewater flow only from LPS systems in Pirate Harbor. It contains two 23-HP Flygt submersible pumps. The pumps discharge into a 6-inch force main that transmits flow directly to the Burnt Store RO WRF. The lift station is enclosed with chain-link fence topped with barbed wire. It is equipped with a 10-foot-diameter wet well, above ground discharge piping, easy access, a control panel, a telemetry transmitter/receiver, and an odor-control system. The discharge piping have been re-painted and fitted with air-release valves to eliminate air entrapment issues. Wet well top slab, hatch, and interior walls are all in good condition. Although the station does not have a stationary generator, it has generator receptacles and a transfer switch to connect a portable power supply. A flow monitor installed at the station determines pumped flow rates. The overall condition of the station and its components are in very good condition. No deficiencies were noted at this station.

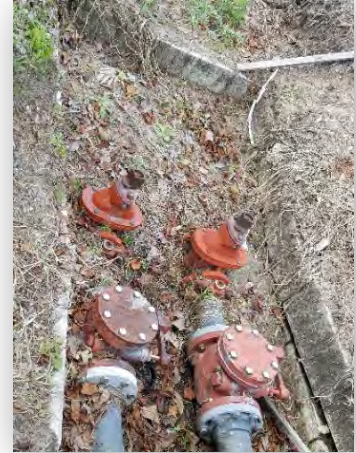
5.2.4.12 Lift Station 817 – Bunker Road

The Bunker Road lift station is in the Rotonda Development, near Hole 5 at The Palms golf course. It contains two 5-HP Flygt submersible pumps. The station is not fenced and is in very poor condition. There is severe soil erosion at the site with dirt filling up the uncovered valve vault. The discharge piping and isolation and check valves are essentially buried in sedimentation. There are cracks in the wet well interior walls with tree roots protruding into the wet well. Previous sealing patches inside the wet well have eroded, creating pathways for inflow and infiltration into the wet well. The piping and valves are rusty and the wet well top slab is severely corroded. Water leaks from the discharge force main inside the valve vault, and no telemetry system is installed at the lift station.

This lift station needs a thorough rehabilitation or replacement. CCUD plans to rehabilitate the station in FY 2018.

Proposed 2018 improvements to the station include:

- Recommend replacing the existing station.

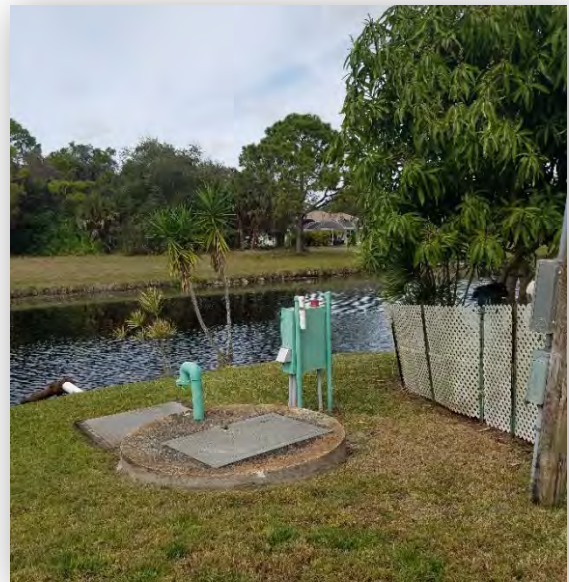
Rotonda Circle 1 lift station is a 47-year-old station northwest of the intersection of Bunker Road and Rotonda Circle near the Rotonda Canal. It serves residents on Bunker Road, Bunker Lane, and Rotonda Circle. The lift station has no vehicular access and has not seen major rehabilitation work since construction. The condition of the lift station is fair to poor. There is no fence around the station, which is typical of lift stations in the Rotonda community.

The station contains two 3-HP Flygt submersible pumps in a 6-foot-diameter wet well that pump flow through a 6-inch force main that crosses the Rotonda canal. The wet well interior has cracks and corrosion.

The following deficiencies were noted:

- Signs of inflow and infiltration into the wet well due to cracks in interior wall.
- Corrosion of piping.
- Outdated control panel.

- Reseal the wet well.
- Replace or repair piping.
- Replace the control panel.
- Add telemetry.
- Perform thorough rehabilitation including the improvements listed above or replace the station with a modern submersible configuration with new equipment.

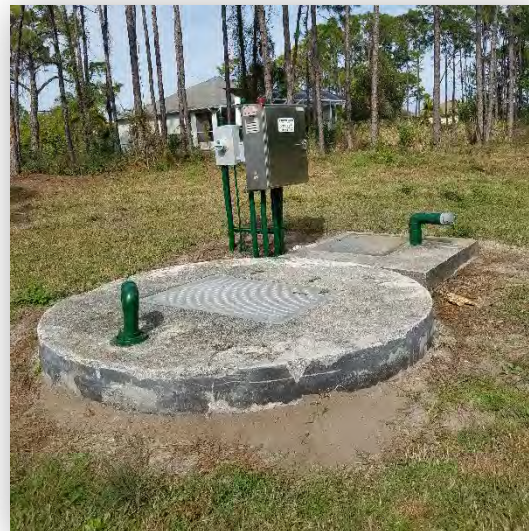
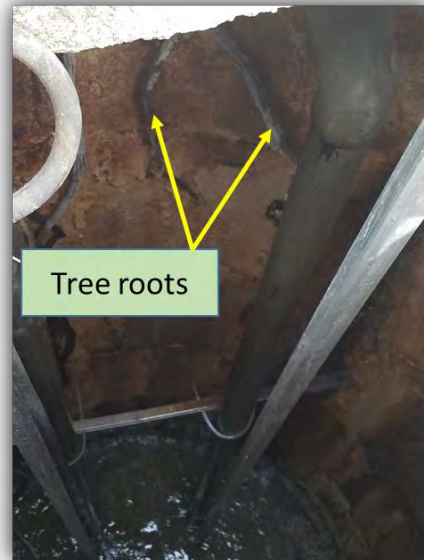
Lift Station 858 is in the southeast portion of Rotonda Circle on south Boundary Boulevard. This community lift station serves residents along Boundary Boulevard and Rotonda Circle from approximately Rotonda Boulevard South to Tournament Road.

The lift station contains two 7.5-HP Sulzer submersible pumps that discharge through a 4-inch force main then into a 12-inch force main, approximately 4,100 linear feet to LS 882. The station is not fenced and is in a common grassy area behind residential

properties. The 6-foot-diameter 21-foot-deep wet well has cracks and shows signs of corrosion around the top of the slab. It appears to have a high concentration of hydrogen sulfide inside the wet well for a prolonged period of time that has caused inner wall spalling and severe corrosion. Many plant roots have protruded into the wet well and may be creating a high-inflow condition. The discharge isolation valves, check valves, and fittings inside the valve vault are also corroded.

The following deficiencies were noted:

- Signs of inflow and infiltration into wet well due to cracks in interior wall.
- Roots protruding into the wet well.
- Corrosion of discharge piping, valves, and fittings
- Stones and debris collected inside valve vault.
- Outdated control panel.

Proposed 2018 improvements to the station include:

- Reseal wet well.
- Replace or repair piping.
- Replace the control panel.
- Add telemetry.

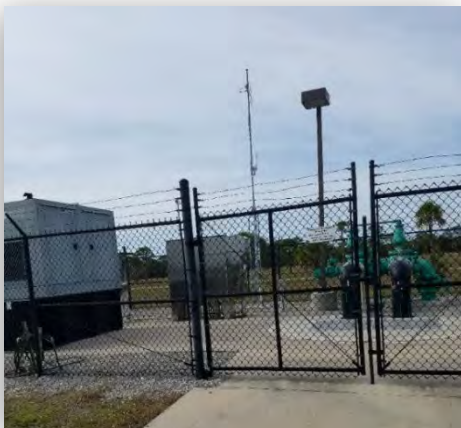
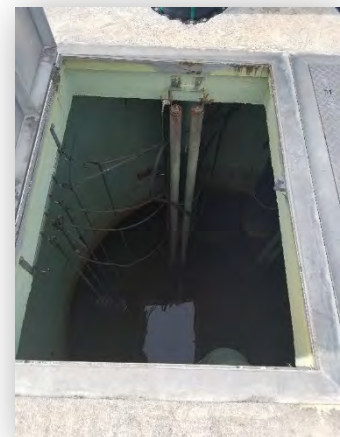
5.2.4.15 Lift Station 861 – Springs

This lift station was constructed in 2010 for future LPS systems within the planned wastewater collection area. It features two 14-HP ABS variable-speed pumps designed to convey flow to West Port WRF through a 12-inch 7,100-foot-long force main. Currently, CCUD routinely runs water through the station to verify that all components function correctly.

The site is fenced with all piping and valves located above ground. The 10-inch circular wet well is approximately 12 feet deep. Flow enters the wet well through a gravity sewer that terminates below the low-water elevation in the wet well. The wet well hatches are in excellent condition and provide adequate access to remove the pumps that are on a rail retrieval system.

The pump discharge pipes in the wet well are constructed of corrosion-resistant HDPE pipe, and the interior of the concrete wet well is coated with a corrosion-resistant polyurethane coating

system. Currently, there is no odor control or metering of flows at the station.

The station is equipped with a stationary emergency generator and a transfer switch. The electrical and control panels are in excellent condition. The station contains a telemetry transmitter. Overall, the station is in excellent condition.

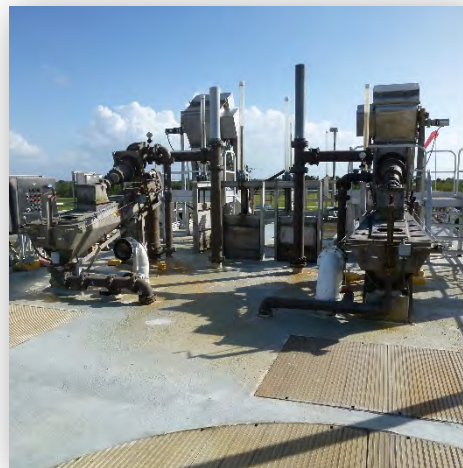
The overall condition of the headworks is good.

The upper concrete deck of the headworks was painted due to years of hydrogen sulfide exposure. A thorough cleaning and epoxy coating of the deck was completed in FY 2016 and appears to be providing adequate coverage of the area. In FY 2017, Screen No. 1 was repaired and grit pumps were rebuilt.

The old grease dewatering building is now used for bulk storage. The screening and grit bagging system that was attached to the chutes that discharge into the dumpsters has significantly reduced the water on the floor, flies, and odors that usually accompany headworks' dumpster areas. The floor is clean and dry.

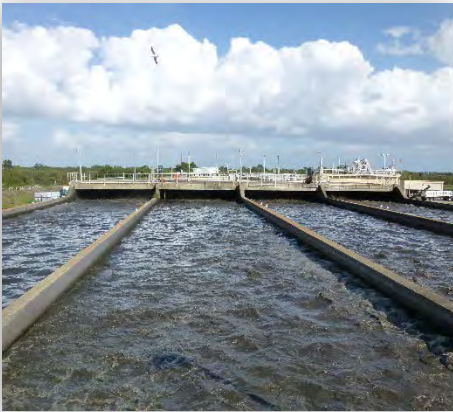
6.4.4.3 Biological Treatment Train – MLE Process

The overall condition of the MLE Process is good following Stage 1 and 2 Improvements in 2015 and 2016, respectively. The concrete is in good shape for its age and showing very little cracking or spalling. The anoxic zones are thoroughly mixed by four submerged mixers, and a baffle was added to both anoxic tanks to prevent aerated mixed liquor into the tank.

Four VFD-controlled surface aerators are in operation in the oxidation ditches. The aerator speed is adjusted based on the dissolved oxygen (DO) probe located at the end of the ditches. The aerators are well maintained and the DO control system is lowering power consumption and allowing a low DO at the end of the oxidation ditches to prevent DO to be pumped into the internal recycle system and back to the anoxic tanks. Six VFD-controlled internal recycle pumps were replaced in the Stage 1 and 2 Improvements and are controlled by the SCADA system based on the operators settings are also well maintained and in good working order.

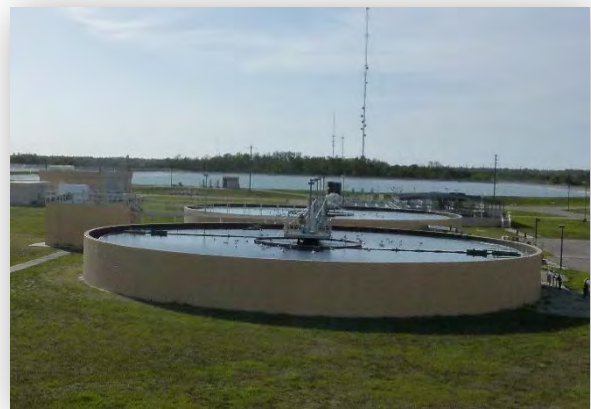
The five RAS pumps are VFD-controlled. The two WAS pumps are controlled by operator settings in the SCADA system. Both pumping systems are well maintained and in good working order.

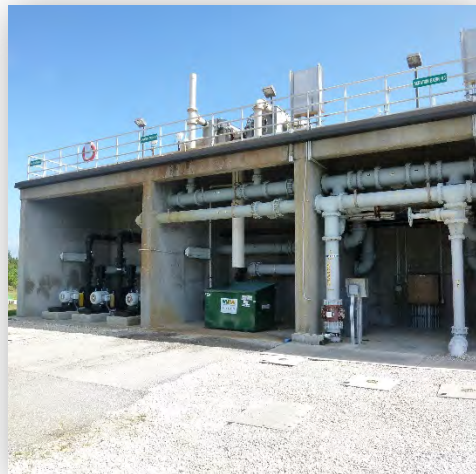
Two of the four mechanical bar screens were in operation at the time of site review. The rotary screens were rebuilt in 2017 but are still having problems. Rotary Screens No. 1 and 2 have been undergoing repair since 2017. The screens' housing is Type 304 stainless steel, but pin holes had developed in the housing due to the highly corrosive gases released in the headworks. Flow equalization storage would greatly reduce or eliminate the highly corrosive gasses at the headworks. To help protect the equipment, the screen housings have been sand blasted and painted with epoxy paint. Most components are stainless steel, but the few carbon components are a constant maintenance challenge. Staff cleans the screens twice daily to help delay rusting from exposure to hydrogen sulfide. The 316 stainless steel wedge wire drums are in very good condition.

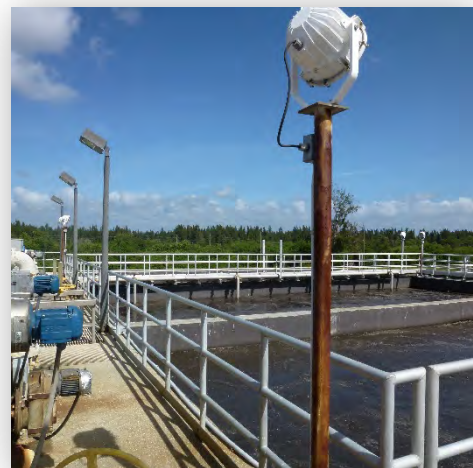
All three blowers were operating properly. A new soft start was added to one blower in FY 2015 to eliminate a surge in power demand. Usually, one blower provides sufficient air, so the operators cycle the blowers weekly. The plant operates between pH 6.7 and 7.0; when the pH exceeds 7.5, a second blower turns on. During summer, a timer is used to turn the blower on and off throughout the day. Using pH for operational control is not the most practical method for treating wastewater; an alternate control method including DO and oxygen reduction potential (ORP) should be evaluated.

The steel supports of the walkway over the aeration tank effluent splitter box were touched up with paint in FY 2017, and the aeration tanks will be repainted in 2018.

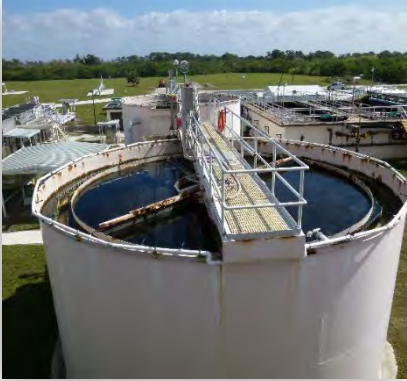
The overall condition of the sedimentation process is fair, but improving.

All four clarifiers were in service at the time of inspection and have been placed on a schedule of inspection, repair, and painting from 2015 to 2018. Clarifier No. 1 was serviced and painted in FY 2015, and Clarifier No. 2 was serviced and painted in FY 2017. Clarifier No. 3 is scheduled to be painted in FY 2018, and Clarifier No. 4 is scheduled in FY 2019.

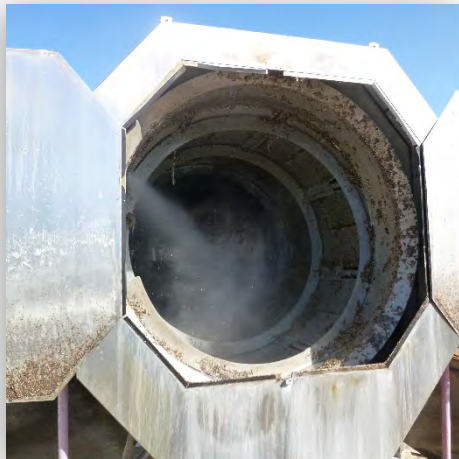
At the time of the site visit, both screens were operating. These screens are critical process units, and one screen must be in service at all times. Each screen rotates on four drum rollers that have been replaced several times on screen No. 1 since installation in 2009. The drum rollers support the stainless steel perforated screen as it rotates. The worn rollers were last replaced in 2016. The rate of rotation has been slowed to extend the life of mechanical components. In 2017, the drums were welded and the roller wheels, chains, and drive gears were replaced.

A wash water spray was added to the screening compactors, which improved operation and lengthened the life of the lower bearing units. The drive motor on Screening Conveyor No. 2 was raised above the bottom bearings to prevent water from entering the motor when the seal bearing leaks. This motor location and with its drive belt has proven to be a better location than the manufacturer's direct drive location. These pieces of equipment are also monitored frequently for wear and operating efficiency.

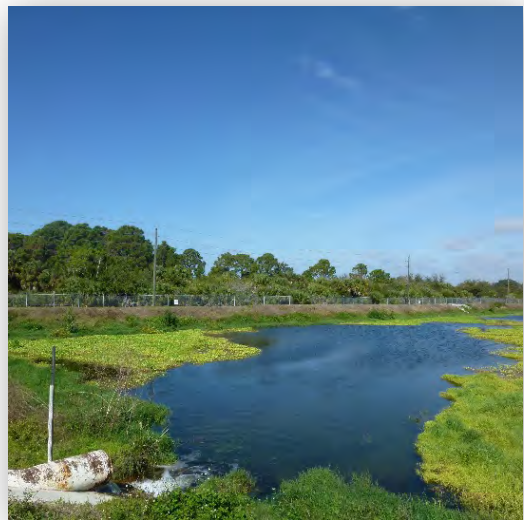
RCW quality effluent can also be stored in the Rotonda WRF on-site RCW storage pond and the 3-MG GST. The GST was drained and cleaned in 2017. The RCW storage pond is overgrown with vegetation, reducing the capacity of the pond. The storage pond is

scheduled to be dug out, cleaned, the berm will be reinforced, and the pond will be lined in 2018.

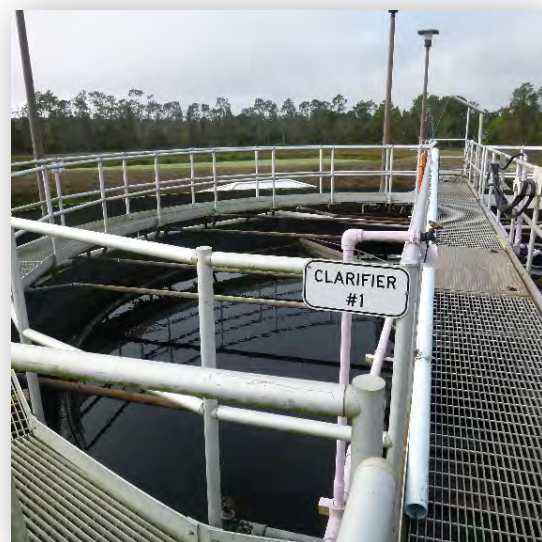
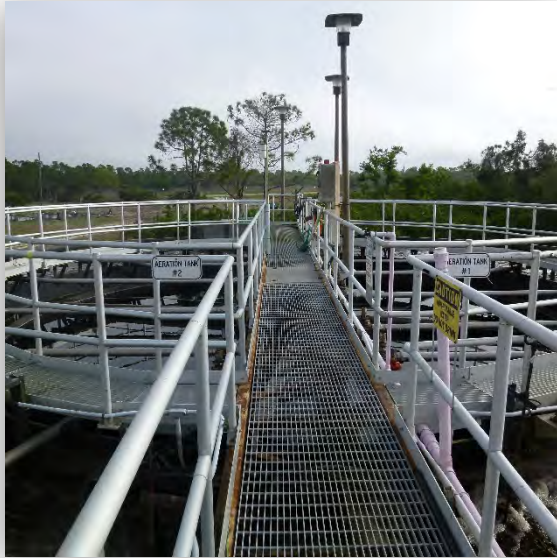
The activated sludge facilities are steel ring package plants and the overall condition is good due to past maintenance and painting.

At the time of the site visit, the aeration basins appeared to have adequate air distribution throughout the tank. The tanks have minimum free-board (<1 foot) creating concerns of on-site sanitary sewer overflow at high-flow conditions or if downstream flow obstruction occurs. The metals tank basins are scheduled for painting in 2018.

All blowers and motors were rebuilt in 2017. The operation of the blowers is based on timers. There are no DO sensors to adjust the blower operation.

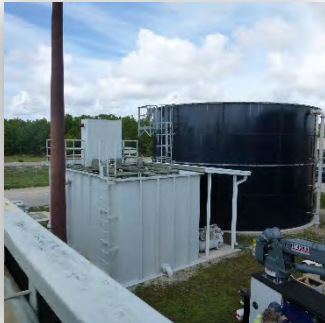
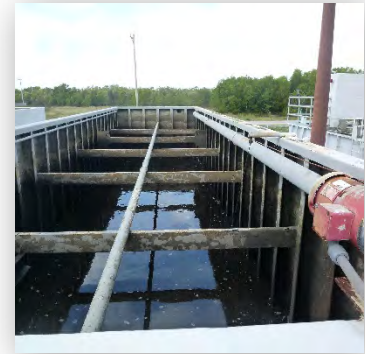
The overall condition of the three PACT treatment units is good, and the facility is operating without any treatment or capacity issues. The tanks' exteriors were partially painted in 2017. The tanks' interiors are scheduled to be painted in 2018; before painting, the surfaces should be pressure washed and rust and lost paint removed, and primed.

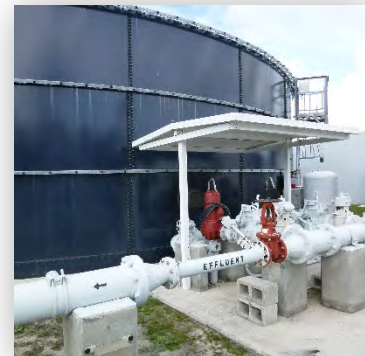
The effluent disposal system is in good condition, well maintained and meets the facility needs.

LTF effluent is injected into the injection well by two dry-pit submersible pumps. The existing 12-hp pumps were installed by CCUD personnel in 2015. The pumps are operating satisfactorily and not overheating on hot summer days.

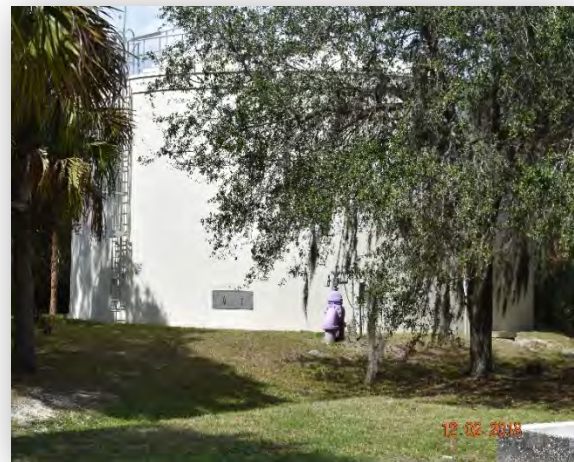
The facility is in good condition. The two concrete block buildings were painted and piping was painted purple and clearly marked. The grounds were well cared for.

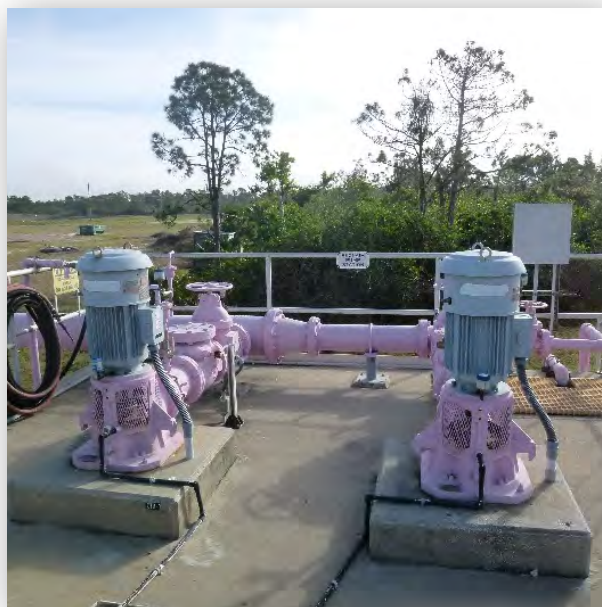
Overall, the system is in good condition.

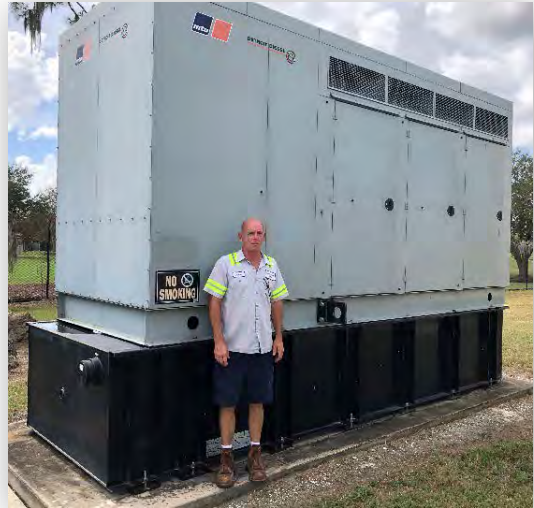
The incoming switchgear and distribution transformer appear in excellent condition with no obvious signs of significant concern. The generator and enclosure are mounted outside on an elevated sub-base fuel tank. They are in excellent condition. However, the height of the elevated tank may pose an issue (see notes below). Overall, the electrical equipment is in excellent functioning condition based on information from the Operations staff. Infrared scanning of the equipment showed no anomalies.

- The generator is mounted on a sub-base tank that is approximately 30 to 36 inches above grade. The height of the sub-base tank makes the generator controls and switchgear much higher than would be normally found and may cause an issue with maintenance personnel, requiring additional temporary platforms or ladders to be able to access the equipment for proper servicing and maintenance (see photograph).
- The switchgear contains no labels identifying parts and components as being energized.

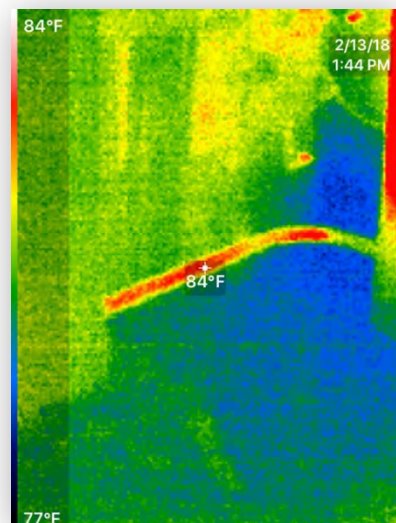
- During the infrared scanning of equipment, the VFD showed elevated temperatures, which is reasonable since it was running. However, the temperature of the conduits supplying and leaving the ATS also showed elevated temperatures (see photograph at the right). This elevated temperature may represent a condition of excessive load on the conductors or excessive heat caused by harmonics generated from the drive.
- The switchgear contains warning labels identifying parts and components as being energized; however, none of the equipment includes the appropriate arc flash labeling as required by NFPA 70E.

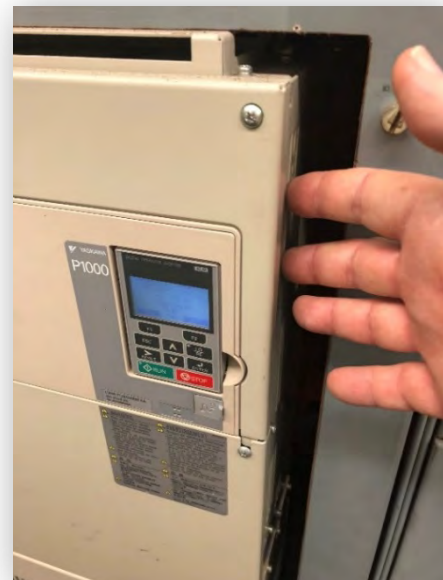
- Much of the switchgear appears to be in only fair condition and is possibly reaching the end of its service life. Many components may no longer be manufactured, making long-term maintenance an issue (see photograph at the right).
- Several of the drives have been updated to Yaskawa VFDs and were retrofitted into the existing cabinets. However, the spaces provided did not match the drives, and there is now a gap between the drive and the enclosure (see photo at right) which may be problematic. Although there appeared to be no exposed life parts, this does raise a maintenance concern and the possibility of exposed parts.
- An exterior-mounted ATS appears to be in fair condition and degraded due to exposure to weather.
- The switchgear contains no warning labels identifying parts and components as being energized.

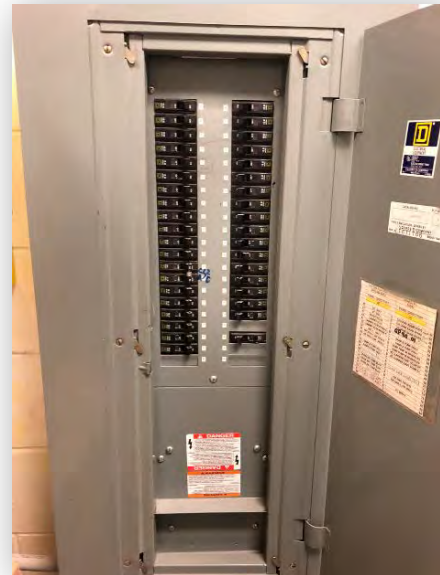
The generator/MCC building is an existing building with older equipment and equipment currently under construction. This review will focus on the existing equipment. The existing switchgear appears to be in good condition. The switchgear includes complete arc flash labeling required by NFPA 70E. The existing 1,250-kW generator is in overall good condition but is reported to require upgrades and an overhaul. The generator set shows minor points of fluids seepage.

- The generator/MCC building – Panel LE SECT 2 showed elevated temperature on one of the breakers possibly indicating an issue that may need further investigation (see photograph at right). The existing generator set showed several indications of wear and is reported by the Operations staff as needing a major overhaul including the fuel system.

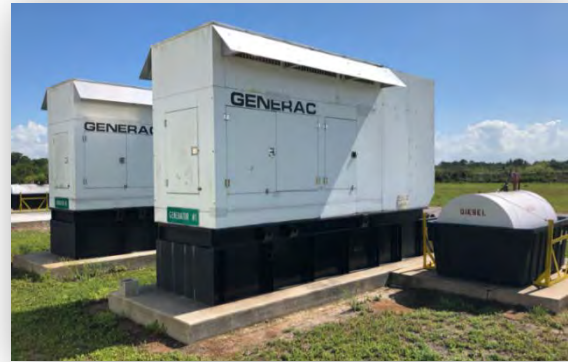
The incoming switchgear and distribution transformer appear in good condition with no obvious signs of significant concern. The incoming power via overhead aerial is new and was installed within the past year. The WRF is served from two 400-kilovolt-ampere (kVA) generators connected in parallel that are fed from a subbase tank and an auxiliary tank adjacent to them (see photograph). Operations staff indicates that a new 6,000-gallon fuel tank and pad for the generators will be installed in 2018. That upgrade may eliminate one of the deficiencies (see below). Overall, the electrical equipment is in good functioning condition based on information from the Operations staff, with the exception of those deficiencies listed below. Thermography scanning of the equipment showed no anomalies.

- CCUD Operations staff reported issues with the generator paralleling equipment and indicated that some equipment drops offline and that one of the generators surges during paralleling operations.
- Operations staff also identified an issue with the power supply for the plant blowers. Reportedly, when they are called to come into service, they overload the system and trip out, bringing the blowers offline. The reason is unknown.
- A power distribution panel located within the plant's MCC is missing a protective cover. Access in the panel to activate a breaker could potentially expose personnel to live conductors (see photograph at right).
- The switchgear contains warning labels identifying parts and components as being energized. However, none of the equipment includes the appropriate arc flash labeling required by NFPA 70E.

Recommendation:	Reviews are needed for the generator control system by the generator manufacturer as well as the paralleling switchgear manufacturer to determine the cause for the generator inconsistencies and surging.
Recommendation:	Secure all electrical switchgear to prevent unauthorized access or inadvertent exposure to live parts.
Recommendation:	Apply appropriate arc flash labeling on all appropriate switchgear in compliance with NFPA 70E to properly notify operations and maintenance personnel of the potential hazard. This may require creating a complete and thorough arc flash model using the existing switchgear to determine the energy levels present. This information would appear on the appropriate arc flash labeling as required.
Recommendation:	Perform a load study to identify any issues related to system power quality, quantity, and capacity. The load study would help identify deficiencies in the system such as the issues related to the faulty blowers and identify reserve capacities and potential anomalies that may affect long-term maintenance and serviceability of the equipment.

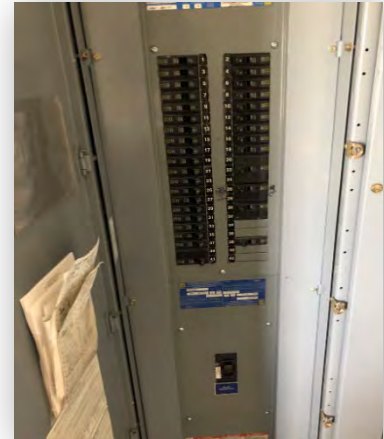
The incoming switchgear and distribution transformer appear in fair-to-good condition. The incoming power

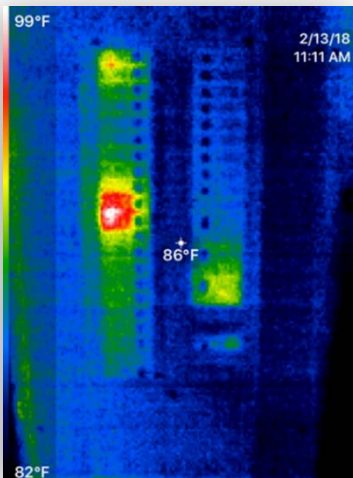
company service transformer exhibits an extensive amount of surface rust, which may soon be impacting the transformer function. The existing primary distribution switchboard outside the MCC room is also exhibiting signs of degradation from the weather. The plant is served from a single generator of an undetermined size. The generator was in good condition but exhibited signs of residual diesel fuel on top of the diesel fuel tank. This may be indicative of additional issues. Overall, the electrical equipment in Building MCC-1 is in good functioning condition based on information from the Operations staff, with the exception of those deficiencies listed below. Thermography scanning of the equipment showed a potential issue with Panel L1.
