# Charlotte County Utilities Department

2018 Annual Report  
March 2019

Jones Edmunds & Associates, Inc.  
824 S. Hyde Park Avenue  
Tampa, Florida 33606

Jones Edmunds Project No.: 03405-029-02

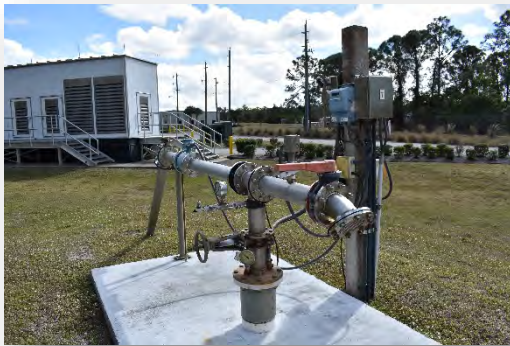
- Well No. 7 is an 8-inch-diameter well, located on site adjacent to the WTP's back-up generator. This is the oldest well in operation at the WTP, but it remains in good condition. Minor rust was observed on the stainless steel wellhead and butterfly valve operator.

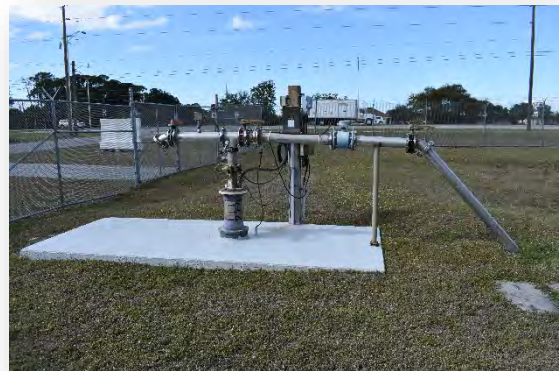
- Well No. 11 is a 12-inch-diameter well located off site on Burnt Store Road. The well meter flow tube and check valve were replaced in February 2016 and are in excellent condition. Minor rust was observed on the wellhead stainless-steel pipe.

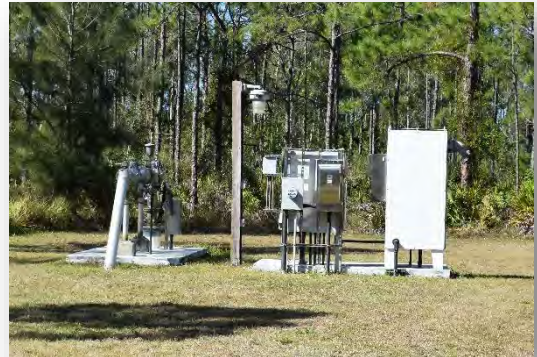
- Well No. 12 is a 12-inch-diameter well located off site on Burnt Store Road. Minor rust was observed on the stainless-steel wellhead pipe, but the pump and motor are in excellent condition.
- Well No. 15 is located at the rear of the site. The well pump and piping are in excellent condition. However, Well No. 15 is currently not in service due to suspected intrusion of lower quality water from this well's terminal strata. The 2013-issued WUP required this well be abandoned and capped. A study was completed in 2017 to evaluate an alternative way to bring this well back into service.
- Well No. 16 is a 12-inch-diameter well located on the east side of the site. The skid-mounted generator has been moved to a mobile trailer for multiple site use. The well pump is in excellent condition.

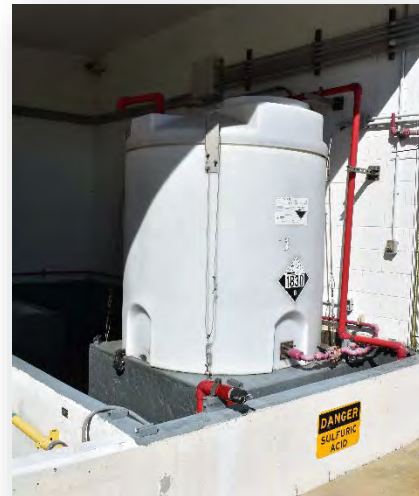
Sulfuric acid is used to decrease the pH of the raw water and prevent calcium carbonate precipitation. The 1,000-gallon bulk sulfuric acid storage tank is outside in the covered bulk storage area. The 100-gallon sulfuric acid storage tank is indoors near the chemical feed skid. The sulfuric acid skid contains two metering pumps. The metering pumps are in good working condition. The concrete in the secondary containment in the bulk chemical storage area was painted in 2018, and the 100-gallon tank inside the process room was replaced.

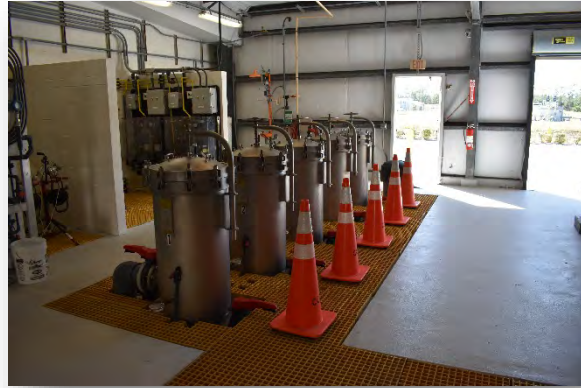
The vessels are in good condition, and the staff changes the filters within the recommended differential pressure. No irregularities were reported, and the equipment appeared to be in excellent working order at the time of the site visit.

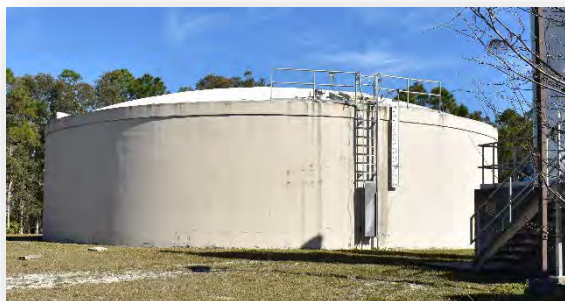
The Burnt Store RO WTP contains three 0.5-MG concrete GSTs housing a total of 1.5 MG of finished water. GSTs A and B were cleaned and inspected in FY 2013, and GST C was inspected in FY 2014. No sedimentation or defects were found in any tank. The outside of the storage tanks should be painted.

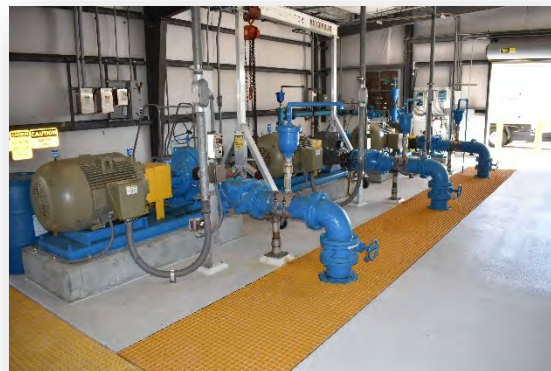
The variable-frequency (motor speed) drives (VFDs) on the pumps provide a constant pressure of 65 pounds per square inch (psi) at the beginning of the distribution system at the water plant regardless of the water use. The motor on Jockey Pump A should be painted due to rust observed on the unit, but the high-service pumps are operational and in good condition.

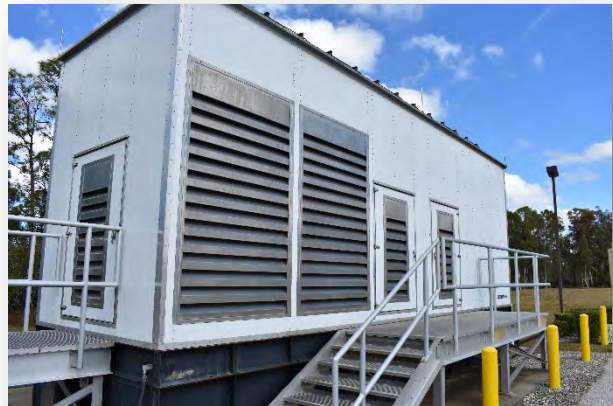
Auxiliary power is adequately sized to run the WTP. The WTP generator and automatic transfer switch were part of the 2009 upgrade of the WTP. The standby generator is operated for 4 hours under load twice per month. An outside contractor performs the maintenance. The generator was cleaned and serviced in 2018. A high-level fuel alarm falsely trips when the fuel tank is filled, which should be corrected. Two generators that were historically attached to Wells No. 15 and 16 were converted to portable trailers. These generators can now be used to power the pumps at Wells No. 11, 12, 15, and 16 through permanently mounted generator connections at each well.

Overall, the electrical equipment is in good functioning condition based on information from the Operations staff.

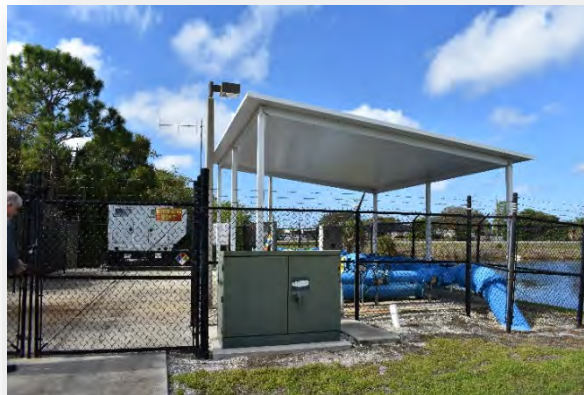
Overall, the interconnect is in good condition, and one deficiency was noted:

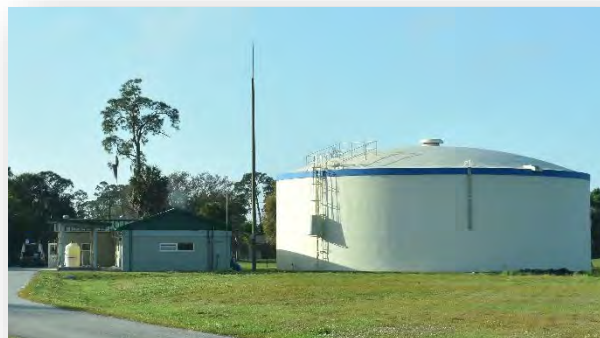
The station is in excellent condition with updated equipment and building furnishings. Graveled areas around the station infrastructure are weeded, and landscaping is well maintained. The indoor buildings are kept clean, and tools and equipment are organized and stored properly. The high-service pumps are well maintained and functioning properly.

The incoming switchgear and distribution transformer appear in good condition with no obvious signs of significant concern. The generator and enclosure are mounted outside on an elevated sub-base fuel tank. They are in good condition. However, the height of the elevated generator may pose an issue (see notes below). Overall, the electrical equipment is in good functioning condition based on information from the Operations staff.

- The generator is mounted on a sub-base tank that is approximately 30 to 36 inches above grade. The height of the sub-base tank makes the generator controls and switchgear much higher than would be normally found and may cause an issue with maintenance personnel, requiring additional temporary platforms or ladders to be able to access the equipment for proper servicing and maintenance (see photograph). The National Electrical Code (NEC)

requires that electrical equipment controls must be mounted no higher than 6 feet 7 inches above finished grade to be accessible. Otherwise, this represents a code violation.

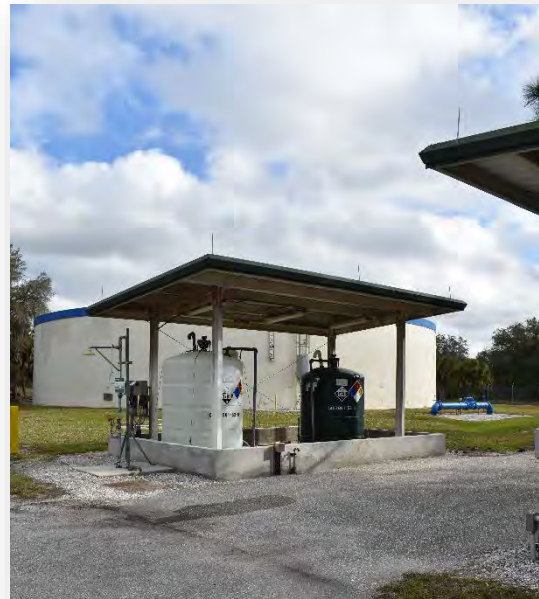
The general condition of the station is good. The access roads outside the facility are aging, but are in fair condition inside the property. Graveled areas around the station infrastructure are weeded, and landscaping is well maintained. The indoor buildings are kept clean, and tools and equipment are organized and stored properly. The high-service pumps are well maintained and functioning properly.

The incoming switchgear and distribution transformer appear in good condition with no obvious signs of significant concern. CCU Operations staff reported that whenever the emergency generator is placed into operation, the power demand is usually greater than its rated capacity of 350 kW. The generator is inside the building that also contains the electrical switchgear. Overall, the electrical equipment is in good functioning condition based on information from the Operations staff.

- The outside of the GST should be re-painted following the new liner.
- CCU Operations staff reported that the generator is unable to accommodate the existing loads of the facility, which is a significant concern and relates to the operational security of the facility. Additionally, since the generator is inside the building that also contains the electrical switchgear, it raises concerns regarding maintenance personnel being properly notified of hazardous conditions that may exist during maintenance operations including fuels present, elevated noise level, and potentially excessive heat. This heat may also prove detrimental to the VFDs in the building since these devices are typically temperature sensitive.

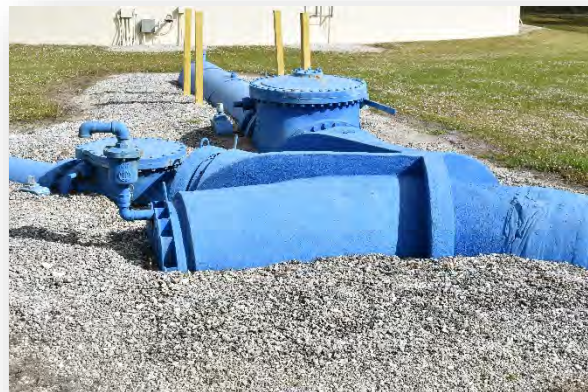
The station is generally in good condition. Roads and landscaping are well maintained. Graveled areas around the facility infrastructure are weeded, the grass is cut, and the perimeter fencing is devoid of plant growth. The indoor buildings are kept clean, and tools and equipment are organized and stored properly. High-service pumps are well maintained and functioning properly. In 2016, the County began planning to install a new water feed pipe across the Myakka River. The project is ongoing.

The incoming switchgear and distribution transformer appear in good condition with no obvious signs of significant concern. The incoming power company transformer did show signs of surficial rust. The standby generator reportedly functions properly and has no issues. The fuel system on the generator is a separate fuel tank, not a sub-base fuel tank as in many other installations throughout the County. The fuel piping and transfer system appears in good condition with no apparent signs of leakage. Overall, the electrical equipment is in good functioning condition based on information from the Operations staff.

- The pipe connecting the GST to the pump station is constructed of formed concrete, which is not industry standard.
- The concrete support on the GST influent pipe was corroded.
- The paint on the floor of the sodium hypochlorite injection room was eroded.
- The switchgear contains warning labels identifying parts and components as being energized; however, none of the equipment includes the appropriate arc flash labeling as required by NFPA 70E.

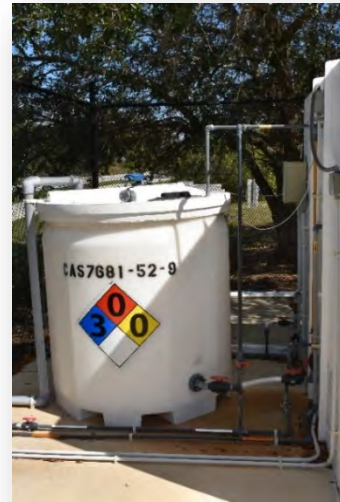
The general condition of the station is fair. The buildings are weathered but in operational condition. The landscaping is maintained.

- The sodium hypochlorite tank is not covered, exposing the tank and pipes to sun, which ages the material more quickly.
- The doorstep to the water quality testing and storage shed needs repair.

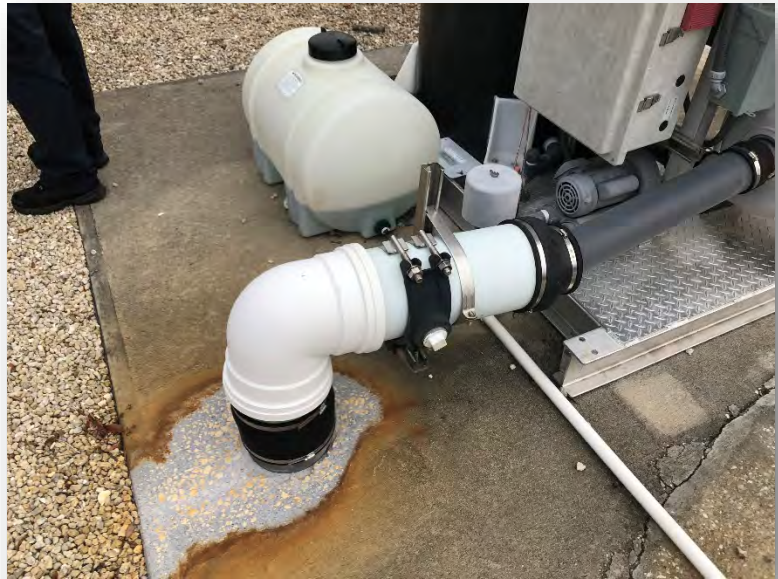
LS 309 currently experiences frequent infiltration during the wet season that requires manual trucking of the excessive flows.

The following deficiencies were noted:

- Signs of corrosion on the wet well interior wall likely due to high hydrogen sulfide concentration.
- Corrosion of piping and valves in the underground vault.
- Seepage under the west discharge pipe in the wet well.
- No dedicated suction bypass piping.
- Substantial concrete wear around the odor-control intake piping.
- Substantial wear of the concrete control panel posts allowing rebar exposure.
- Minor wear of the fence barbed wire due to local vegetation.

- Provide a stationary generator.
- Evaluate pump capacities for potential downsizing once the Deep Creek FM is installed.
- Coat the wet well.
- Replace concrete control panel posts with County aluminum standard.

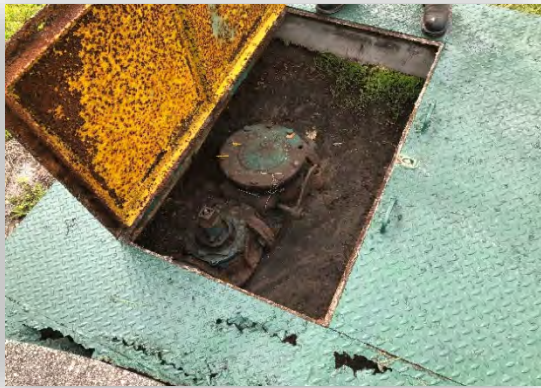
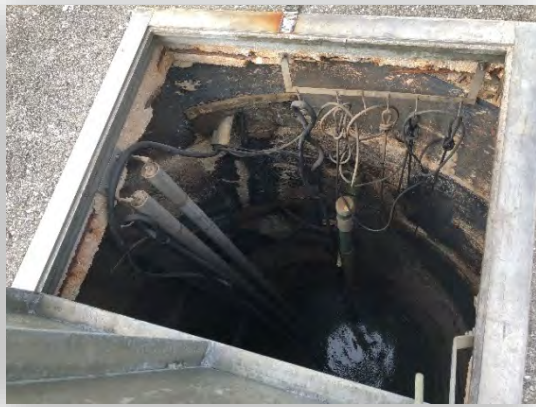
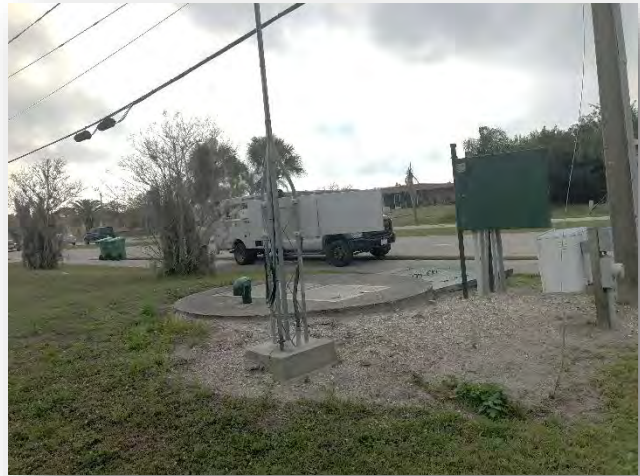
The station wet well exterior and electrical equipment are in relatively good condition, the station wet well interior is in moderate condition, showing signs of corrosion; and the valve vault is in poor condition, having significant corrosion on the steel and significant mud filling. The wet well interior has sufficient storage capacity and does not see significant impacts from I/I, but the coating has worn and the concrete top slab is degraded and exposing structural rebar and wood. There is also significant wear-through of the aluminum vault cover and surrounding concrete wall base. The degradation and exposure of the vault has

resulted in partially buried valves and significant corrosion of the steel vault.

The following deficiencies were noted:

- Signs of corrosion on the wet well interior wall likely due to high hydrogen sulfide concentration.
- Interior concrete slab shows wear, exposing structural rebar and wood.
- Significant wear on the valve vault including partial burial of the valves.
- No dedicated suction or discharge bypass piping.
- Phase monitors appeared to be missing.
- Missing seal-offs from the control panel conduit. This represents a significant code violation as well as a potential explosion hazard.
- Rusted and worn padlocks on the wet well hatches.

Proposed 2019 improvements to the station include:

- Coat the wet well.
- Repair or rehabilitate the concrete top slab.
- Replace the valve vault and bring to current standards or evaluate converting the valves to aboveground.
- Install seal-offs on any electrical equipment within 10 feet of the wet well to return to conformance with code.
- Evaluate the adjacent lot for future lift station conversion.

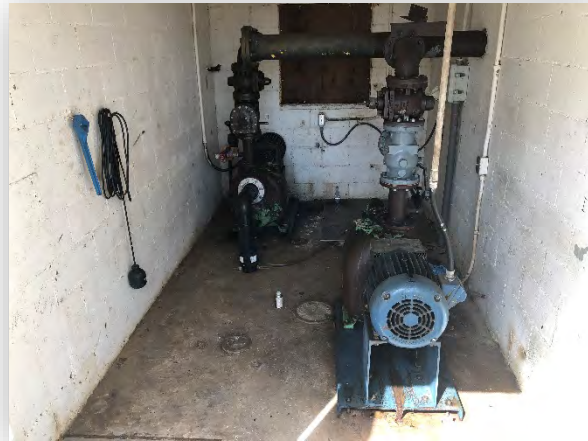
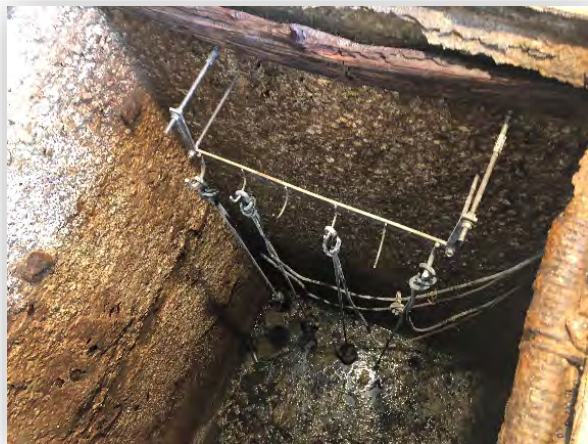
Lift Station 1 is on an open easement with no fencing at the intersection of Orange Street and Easy Street and receives gravity flows from the surrounding community including a seasonal community center. The station pumps are housed in a concrete building. The wall of the structure contains visible cracks. This station, originally built in 1959, contains two aboveground, self-priming, belt-driven 15-HP Gorman-Rupp pumps that were installed in 1980. The pumps receive flow through an 8-inch gravity main and discharge into an 8-inch 2,338-foot-long force main that pumps to LS 65. Each pump has an estimated capacity of 220 gpm at approximately 65 feet of head.

The discharge isolation valves and check valves are above ground for easy access and maintenance. The 7-foot by 6-foot rectangular wet well interior shows signs of corrosion from hydrogen sulfide. The well has no ventilation, so emitted gases are contained within the wet well and the building. Power service to the station is 230-volt, three-phase. The station has no odor-control system and no dedicated well bypass piping, although there is a covered square penetration in the wall directly above the wet well cover for local pump trucks to access the well with trucks for pump out. During storm events, when the water level in wet well is high, CCU uses tanker trucks to collect and transport excess flows to the WRF. The station was recently upgraded to incorporate a portable generator receptacle in the existing electrical control panel. The electrical and control panels are outside the building and are in moderate condition. The station has a SCADA system with a telemetry transmitter/receiver.

The following deficiencies were noted:

- Cracks in the concrete building, including daylight visible through pipe penetrations.
- Corrosion of the wet well.
- Outdated controls and replacement parts and components no longer available.
- Access hatch hinge separated from wall.
- Pipe patch for leaking wye still showed signs to be leaking.
- Paint flaking/peeling.

- Paint the aboveground discharge pump and piping.
- Repair/replace the patched wye connection.
- Repair cracks in the building.
- Seal pipe penetrations.
- Provide an odor-control system.
- Replace the outdated control panel and bring electrical up to current standards.
- Perform thorough rehabilitation of the lift station including repairing the building, or replace the station with a modern submersible configuration and all new equipment.

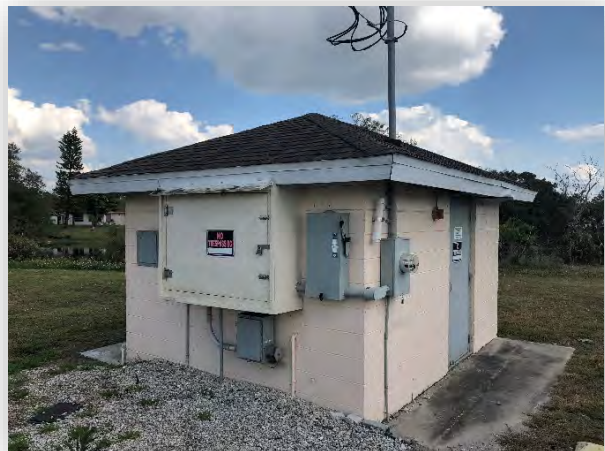
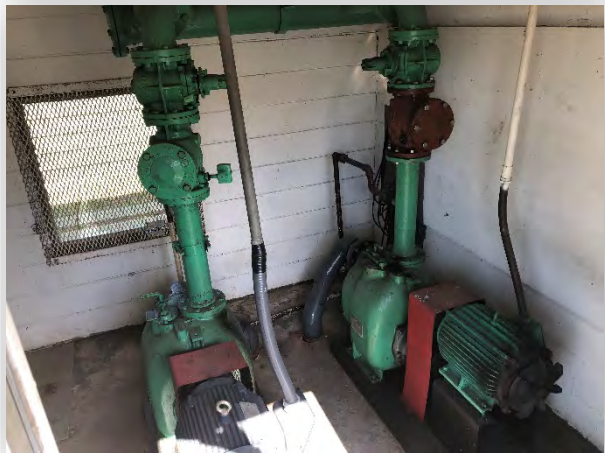
Power service to the station is 230-volt, three-phase. The station is not fenced, and metal reinforcement had to be installed behind the vented window after the plexiglass panels were broken by vandals and vagrants. The building door and all panels are typically locked. The station has no odor-control system and no dedicated well suction bypass piping, although there is a circular penetration in the wall directly above the wet well cover for local pump trucks to access.

The main control panel is a wooden box mounted on the outside of the building. The space inside the building is exposed to sewer gases because access for the wet well entry and float switches are open holes in the floor of the building. A new portable generator receptacle with a manual transfer switch has been recently added. A portable pump connection is in a valve box outside of the building. The station has a SCADA system with a telemetry transmitter/receiver.

The following deficiencies were noted:

- Deteriorated roof overhang.
- Missing glass windowpanes.
- Presence of odor.
- Missing seal-offs from the control panel conduit.
- Obstructed access for crane truck.

Proposed 2019 improvements to the station include:

- Repair the roof overhang.
- Replace the glass windowpanes.
- Paint the building.
- Install odor controls.
- Install seal-offs on any electrical equipment within 10 feet of the wet well to return to conformance with code.
- Perform thorough rehabilitation including the improvements listed above or replace the station with a modern submersible configuration and all new equipment.
- Evaluate providing a dedicated access to the station.

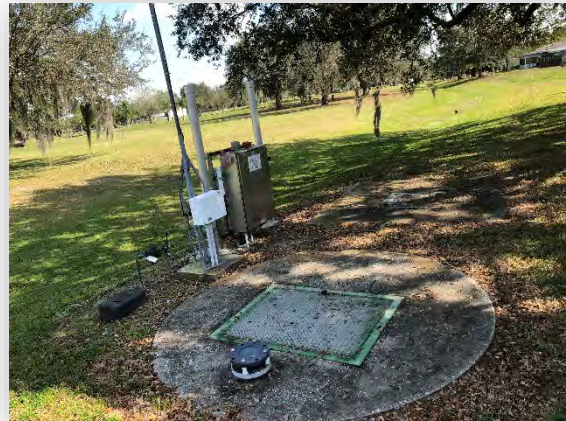
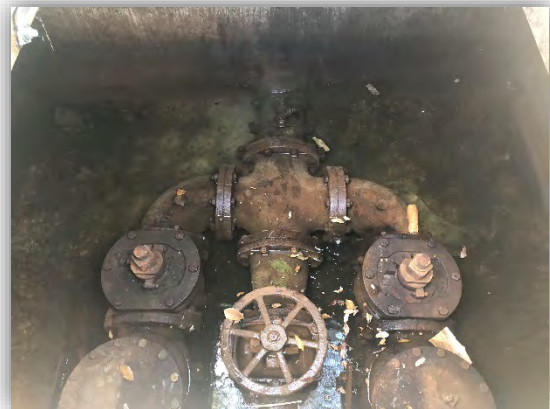
The lift station was last updated in 1981. The overall condition of the station is well maintained with all equipment and structures in good condition. The station contains two 20-HP Flygt submersible pumps in an 8-foot-diameter concrete wet well. Each pump has an estimated capacity of 420 gpm at approximately 65 feet of head. The wet well hatches are in good condition and include a vent with bug screens. The wet well concrete is currently unlined and shows signs of wear along the walls and especially underneath the wet well slab. The discharge isolation valves and emergency pump connection are below ground in an adjacent valve vault and are consistently partially submerged under water due to the surrounding groundwater elevation. Power service to the station is 240-volt, three-phase. The main control panel is in good condition although it appears to be missing both seal-offs from the control panel conduit as well as an interlock between the generator breaker and the main breaker. The station has a SCADA system with a telemetry transmitter/receiver.

The high-level float at the Sistina lift station triggers a control that shuts down the nearby LS 16. The pumps discharge into an 8-inch force main that flows to the East Port WRF. The station is not fenced and is not equipped with odor control.

The following deficiencies were noted:

- No interlock between the generator breaker and the main breaker.
- Missing seal-offs from the control panel conduit.
- The open-floor design keeps the valve vault continually flooded due to the high water table in this area.
- Station location causes difficulty of access.

Proposed 2019 improvements to the station include:

- Coat the wet well or repair some of the degraded concrete.
- Install seal-offs and interlocks on electrical equipment and perform a detailed electrical code review to return to conformance with code.
- Replace the valve vault and bring to current standards or evaluate converting the valves to aboveground.
- Evaluate the adjacent lot for future lift station conversion.

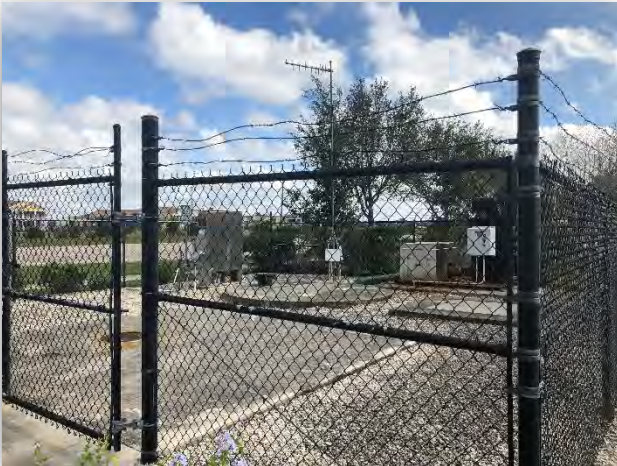
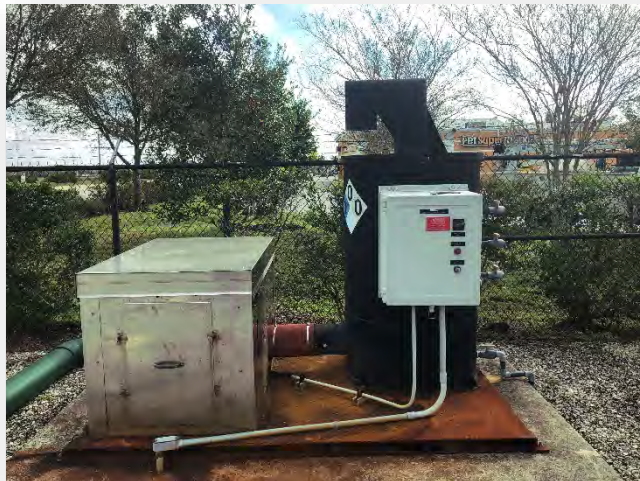
well. Each pump has an estimated capacity of 1,000 gpm at approximately 70 feet of head. The wet well hatches are in good condition and provide adequate access to remove the pumps that are on a rail retrieval system. The wet well lining is largely showing protection from sulfide; however, the seam areas including those in the liner and the pipe penetrations all have signs of significant seepage and wear. The discharge isolation valves and emergency pump connection are below ground in an adjacent valve vault. The pipe penetrations appear to have been sealed after the HDPE discharge piping was

installed. Additionally, staff noted minor standing water in the vault despite an open drain port during a period of no rain for multiple days.

The station is fenced and has a standard carbon odor-control system. The power service to the station is 480-volt, three-phase. The station has a SCADA system with a telemetry transmitter/receiver. Minor concrete wear and structural metal rusting was observed on the control panel posts. The metal platform that the odor control unit is resting on is severely rusted and discolored, with layers of metal flaking and peeling off.

The following deficiencies were noted:

- Minor wear of the concrete control panel posts and rusting of the structural metal supporting the posts.
- Seepage and lining wear around seams and pipe penetrations within the wet well.
- Significantly rusted odor-control base.
- Missing pressure gauge and miscellaneous piping removed from the odor-control unit.
- Valve vault drain is not functioning properly.

Proposed 2019 improvements to the station include:

- Replace concrete control panel posts with County aluminum standard.
- Re-line the wet well or specifically address the exposed penetrations and seams.
- Replace the odor-control unit base.
- Grout the valve vault at the appropriate slope.
- Evaluate and prepare for the rearrangement of the site as described above.

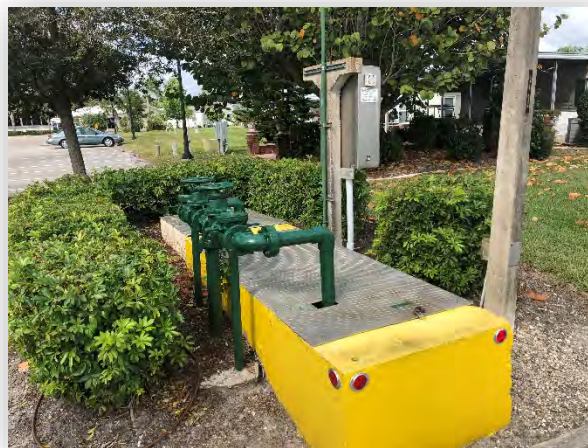
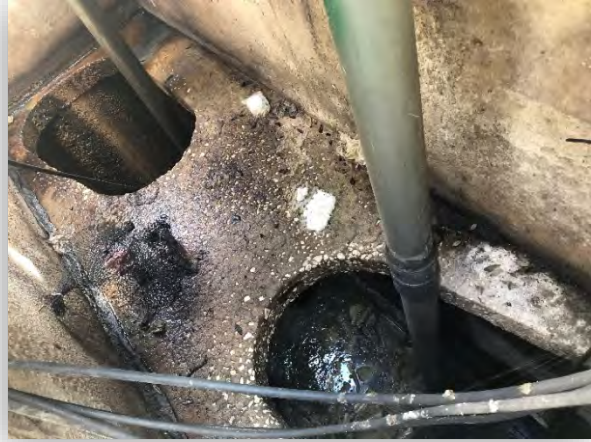
The lift station was constructed in 1993 and last rehabilitated in 2005. The overall condition of the station is good with newly installed pumps and maintained structures. The

station contains two 2-HP Zoller submersible pumps that were replaced in 2018. The concrete wet well is dual layered and rectangular (9 feet by 3 feet). The wet well cover is plated aluminum that is in good condition. There are 12-inch square hatches to observe the wet well, but the cover is bolted on. The pumps are not on a rail retrieval system, so the piping would need to be disconnected to pull the pump from the wet well. The discharge isolation valves

appear to be in good condition. No emergency pump connections were noted. The station is not fenced and there is no odor-control system.

The following deficiencies were noted:

- Signs of corrosion on the wet well interior wall likely due to high hydrogen sulfide concentrations.
- Wear of the interior concrete slab, including structural concern near the supporting bolts.
- Rodent nesting observed.
- No dedicated suction or discharge bypass piping.
- Missing seal-offs from the control panel conduit.

Proposed 2019 improvements to the station include:

- Coat the wet well or repair some of the degraded concrete.
- Install seal-offs on any electrical equipment to return to conformance with code.

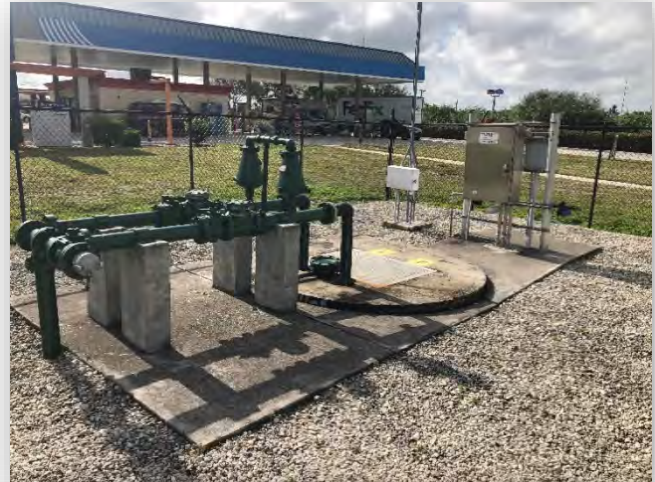
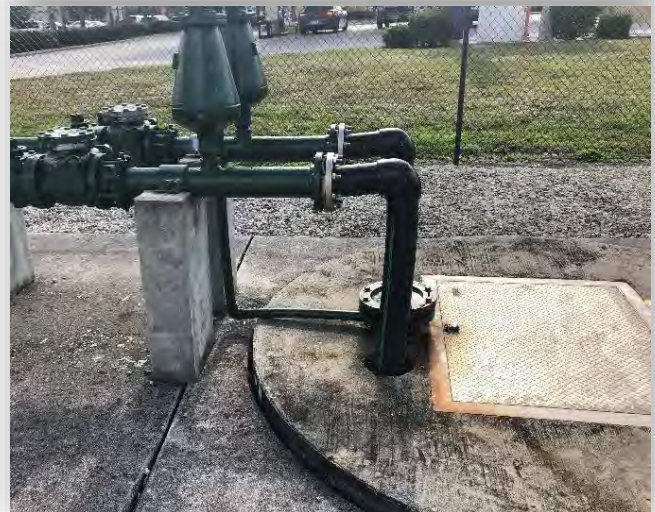
There are two major concerns with the condition of this station. First, there appears to be severe settling between the wet well and the surrounding equipment and substantial evidence of elevation changes between the wet well and the surrounding piping, valves, and control panel. This evidence is largely substantiated by significant cracking of the concrete pad, bending of the piping between the wet well and valves, disconnect of some electrical conduit exposing the wire inside, cracking of the PVC vent cap, and bending of the metal supporting the control panel. The second is the velocity in the 4-inch discharge main, which is beyond the County's level of service norms. At 472 gpm, the velocity in the 4-inch force main exceeds 10 feet per second regularly.

The following deficiencies were noted:

- Settlement impacts including, but not limited to, concrete cracking, pipe bending, PVC cracking, metal bending, and conduit separation.
- Force main velocity exceeding the County's level of service.

Proposed 2019 improvements to the station include:

- Evaluate the lift station site to determine the source of the settling and either repair with flowable fill or relocate the station to an adjacent site.
- Install a 6-inch force main to connect to the manifold 8-inch force main at King's Highway.

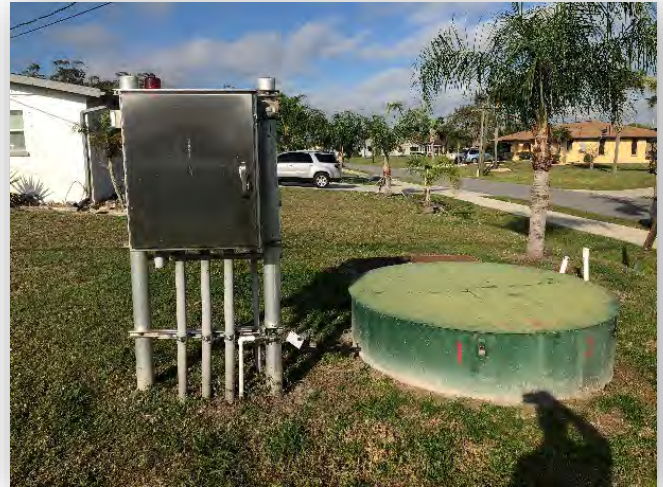
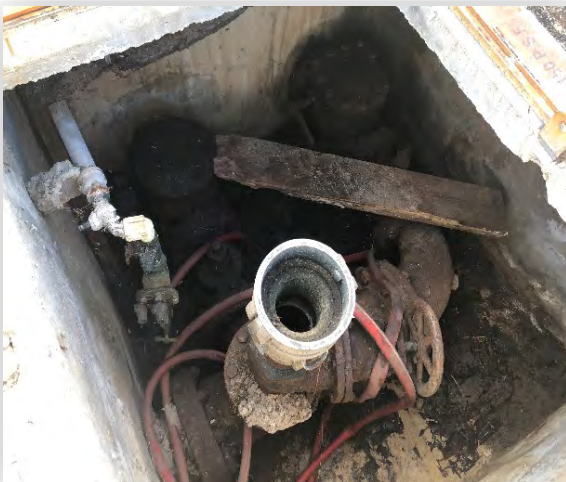
The station contains two 10-HP Davis EMU submersible pumps in a 6-foot wet well. Each pump has an estimated capacity of 228 gpm at 92 feet of head. The concrete wet well shows substantial signs of wear including aggregate exposure, although no structural rebar appeared to be exposed. The discharge isolation

valves and emergency pump connection are below ground in an adjacent valve vault. The vault appears to be poorly maintained, with wood, hosing, piping pieces, and debris filling the vault and obstructing access to the isolation valves. The station is not fenced, but the panel, wet well, and valve vault are padlocked. The station does not have any odor control other than bagged deodorizing blocks.

Power service to the station is 230-volt, three-phase. The control panel was upgraded in 2014. The station has a battery backup for the high well alarm horn if power is lost, but does not have any SCADA, telemetry transmitter, or telemetry receivers. A generator receptacle with a manual transfer switch is available on the control panel. The wet well is immediately adjacent to a utility pole with low-hanging electrical lines. The nearby overhead power lines result in potential danger to County staff when station pumps need to be pulled with a crane truck.

The following deficiencies were noted:

- Signs of corrosion on the wet well interior wall likely due to high hydrogen sulfide concentration.
- Wear of the interior concrete slab, including structural concerns near the supporting bolts.
- Significant FOG and rag build-up in the wet well.
- Valve vault debris.
- Low-hanging overhead power lines.
- Missing seal-offs from the control panel conduit.

- Coat the wet well or repair some of the degraded concrete.
- Clear out the valve vault and perform required repairs to maintain integrity.
- Install seal-offs on any electrical equipment within 10 feet of the wet well to return to conformance with code.

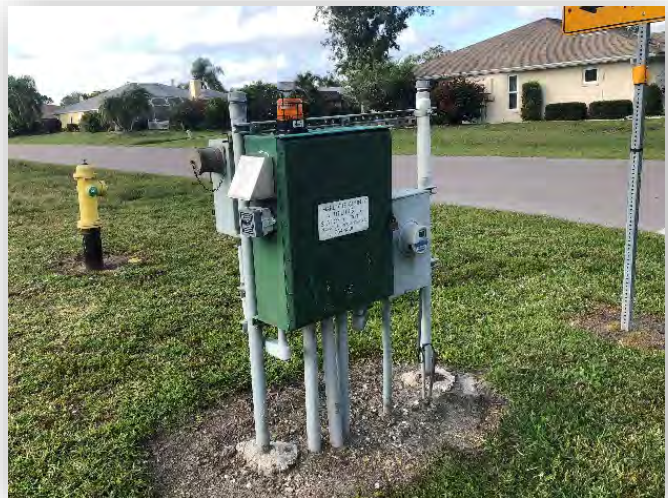
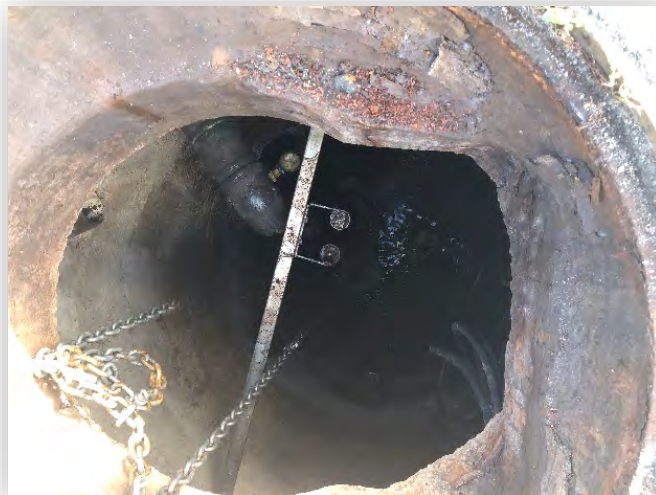
The wet well is in the center of the road intersection, which requires Operations staff to manage traffic during routine maintenance and any pump pulling. The wet well has some signs of corrosion and seepage under pipe penetrations in addition to having an older conical lid design, obstructing access during the maintenance events. The County owns the adjacent lot southeast of the intersection. The design to move the lift station into the lot and the existing wet well converted to a master manhole has been completed. This would also allow for appropriate installation and access to isolation valves and bypass piping, which currently do not exist at this simplex station.

- Signs of corrosion on the wet well interior wall likely due to hydrogen sulfide concentration.
- No interlock between the generator breaker and the main breaker.
- Missing seal-offs from the control panel conduit.
- Difficult to access wet well.
- No isolation valves.

- Coat the wet well or repair some of the degraded concrete.
- Install seal-offs and interlocks on electrical equipment and perform a detailed electrical code review to return to conformance with code.
- Evaluate the adjacent lot for future lift station conversion.
- Evaluate the installation of a secondary standby pump.

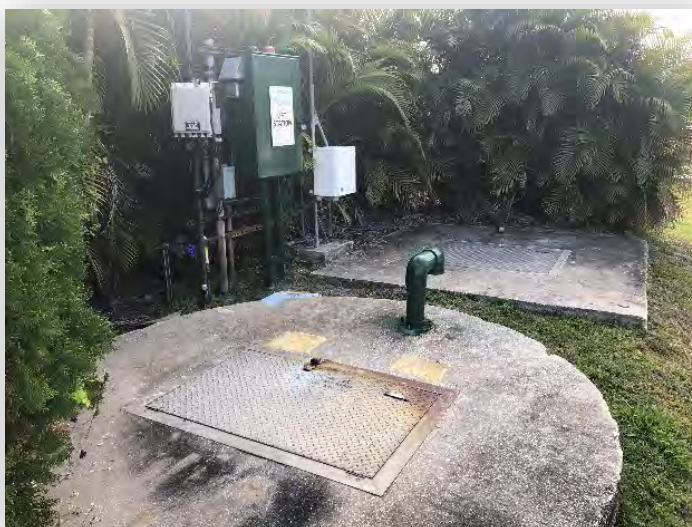
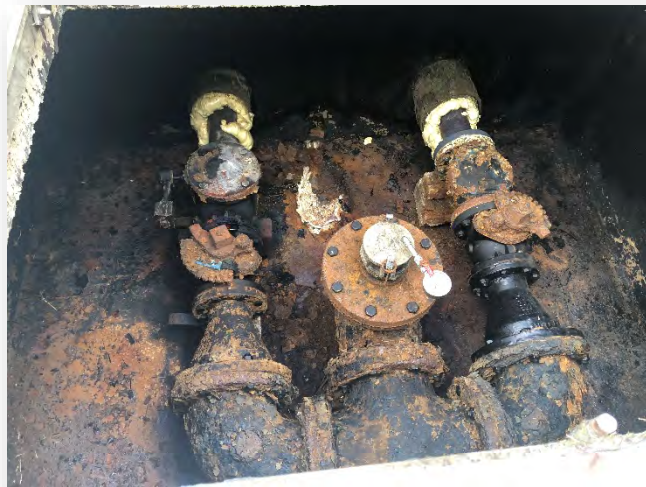
The wet well is showing signs of corrosion, with what appears to be the former lining material peeling from the walls. Discharge isolation valves and the emergency pump connection are below ground in an adjacent valve vault. The pump discharge piping appears to be travelling through the former larger pipe, with the latter acting as a casing. This pipe was filled with foam insulation, but the vault still appears to be receiving significant rust and corrosion, likely from hydrogen sulfide. This has resulted in concrete wear, including exposed structural rebar. The station is not fenced, but the panel, wet well, and valve vault are padlocked. The station does not have any odor control.

- Signs of corrosion on the wet well and valve vault interior likely due to hydrogen sulfide concentrations.
- No interlock between the generator breaker and the main breaker.
- Missing seal-offs from the control panel conduit.
- Nearby vegetation.

- Coat the wet well and seal and repair the contents of the valve vault.
- Install seal-offs and interlocks on electrical equipment and perform a detailed electrical code review to return to conformance with code.
- Proceed with lift station conversion.

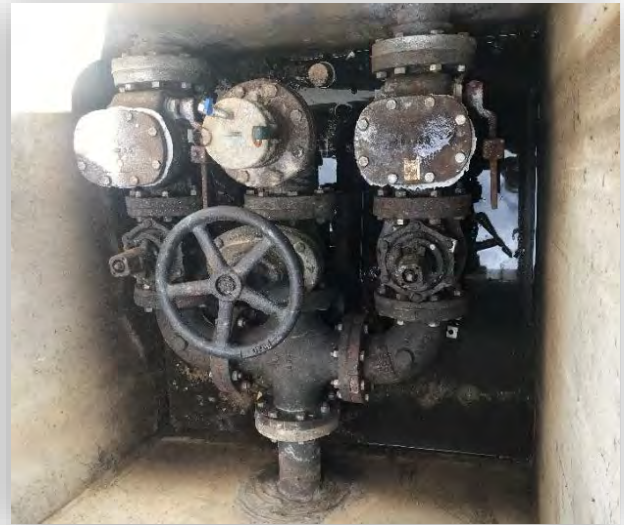
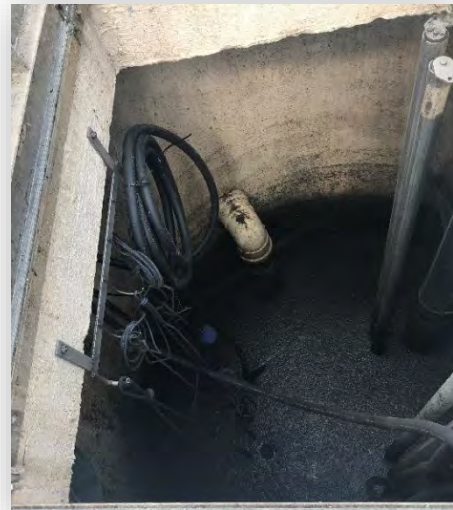
The station contains two 7.5-HP Davis EMU submersible pumps in the 8-foot wet well. Each pump has an estimated capacity of 109 gpm at 80 feet of head. The pumps are installed on an older t-rail system. The station is fenced, but there is no odor control at the station.

- Signs of corrosion on the wet well and valve vault interior due to hydrogen sulfide concentrations.
- Missing seal-offs from the control panel conduit.
- The conduit was partially installed within the concrete of the wet well, possibly undermining the integrity of the concrete and resulting in difficulty performing electrical maintenance.

- Coat the wet well and seal and repair the contents of the valve vault.
- Install seal-offs on any electrical equipment within 10 feet of the wet well to return to conformance with code.
- Evaluate upgrade to the electrical including replacing the aging control panel, updating the conduit location, and generally bringing the system up to current standards.

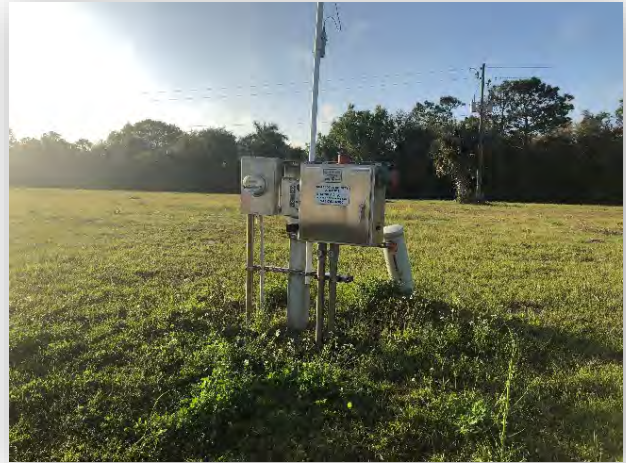
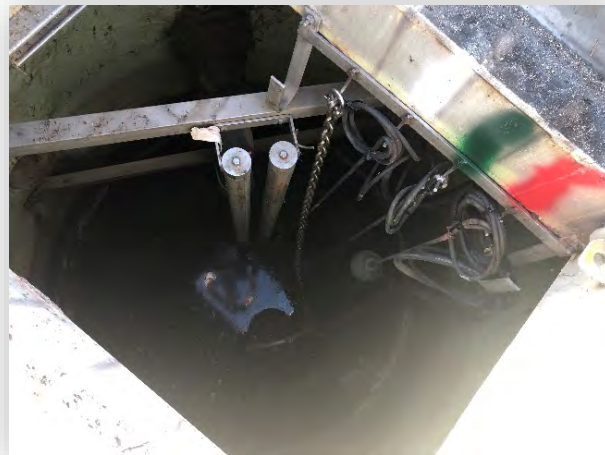
The wet well is in the center of the road intersection, which requires Operations staff to manage traffic during routine maintenance and any pump pulling or to schedule the operations to be performed at night. The wet well has almost no signs of corrosion. The wet well access hatch is a bolt-down design. The adjacent lots to the south of the intersection are already procured by a separate entity, but the County would prefer to move the wet well out of the road and convert the existing wet well to a master manhole. The move would also allow for the installation of a stand-by pump, isolation valves, and bypass piping.

- Location of wet well and method to access hatch promote possible danger to staff.
- No isolation valves.
- No stand-by pump.
- No bypass piping.

- Evaluate an adjacent lot for future lift station conversion.
- Evaluate the installation of a secondary stand-by pump.

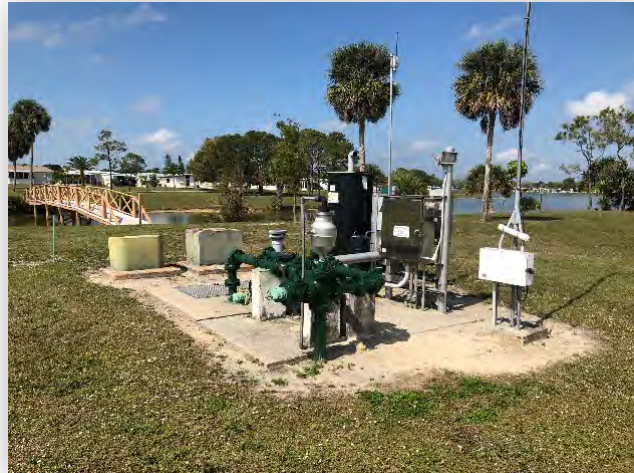
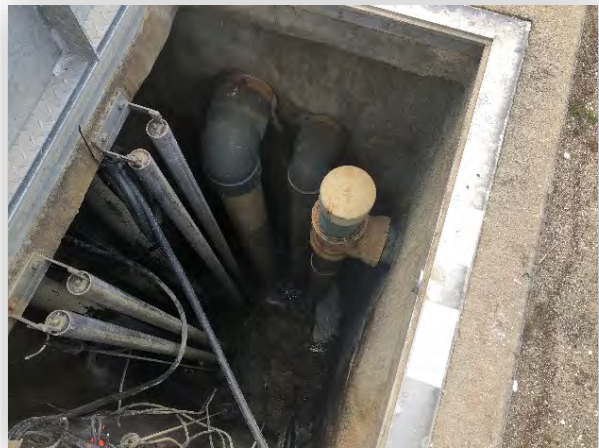
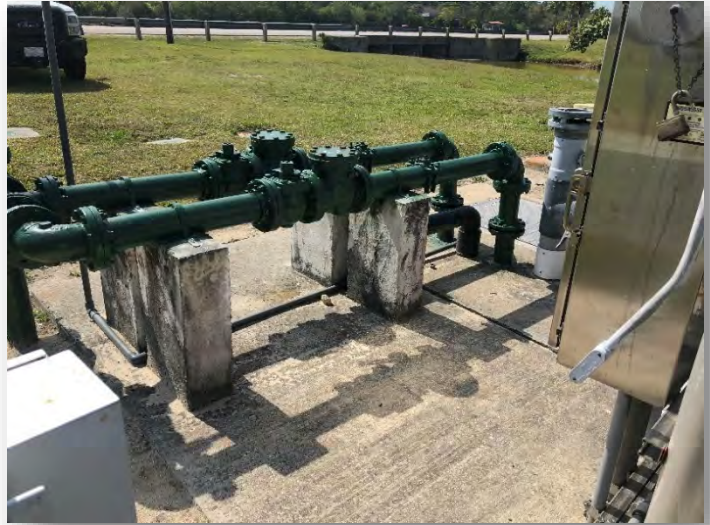
The wet well is showing signs of corrosion around the pipe penetrations, but the existing coating appears to be in good condition. Discharge isolation valves and emergency pump connections are above ground and adjacent to the wet well. The station is not fenced, but the panel and wet well are padlocked. A biological odor-control unit with a fan draws air from the wet well and reduces the hydrogen sulfide odor generated. The air movement also reduces the concentration of hydrogen sulfide in the wet well, which will lengthen the life of this structure; however, there are concerns with the level of algae growth within the odor-control unit.

The lift station has required a lot of upkeep with frequent starter and pump issues. Increased flow to this lift station is expected with growth in the area, which may impact the existing storage; however, it could present more dire circumstances if the pump and starter issues persist.

- Signs of corrosion around pipe penetrations due to hydrogen sulfide concentration.
- One of the three conduits entering the control panel does not have a seal-off.
- Algae growth is interfering with the odor-control unit.

- Coat or repair the pipe penetrations within the wet well.
- Install seal-offs on any electrical equipment within 10 feet of the wet well to return to conformance with code.
- Evaluate the odor-control unit to prevent algae growth.
- Evaluate the possibility of an on-site generator in preparation for the projected future buildout.

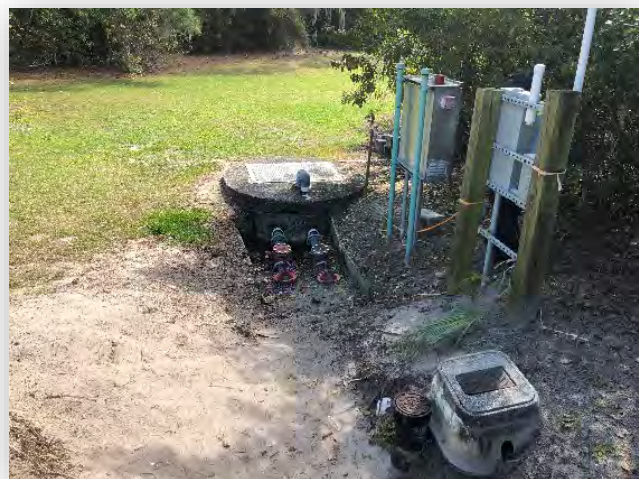
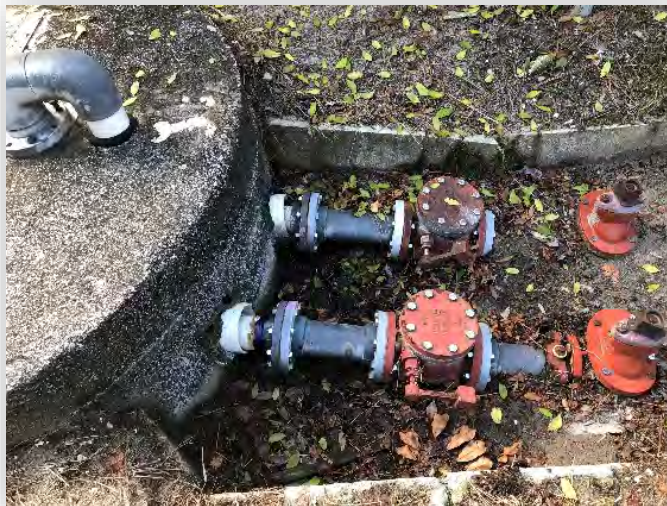
The station is not fenced and has no odor control. The wet well has cracking and root intrusion. Previous sealing patches inside the wet well appear to have experienced erosion, allowing for additional I/I into this wet well. The valve vault cover is nonexistent, and the surrounding soil erosion has filled the remaining cracked concrete walls, partially burying the isolation and check valves. The pipes appear to have been sealed to prevent the water from leaking from the discharge force main into the valve vault, but there are signs of damp soil in this area.

- Signs of corrosion and intrusion in the wet well.
- Missing seal-offs from the control panel conduit.
- Worn and partially buried valve vault.

- Coat the wet well and seal and repair the contents of the valve vault.
- Install interconnect and seal-offs on any electrical equipment within 10 feet of the wet well to return to conformance with code.
- Evaluate the two proposed adjacent lots for future lift station conversion.

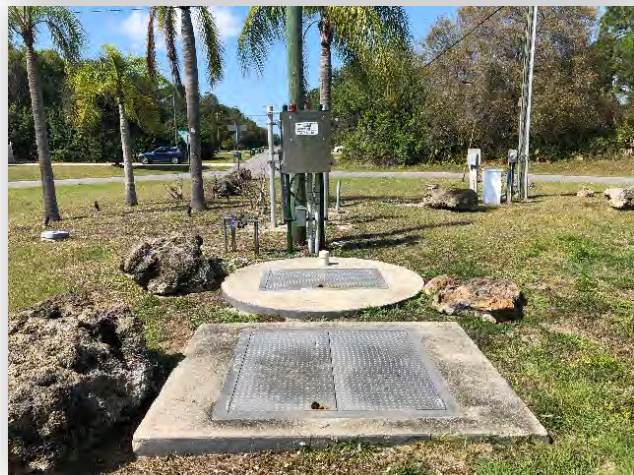
Signs of hydrogen sulfide corrosion or wear exist on the influent manhole and in areas where the wet well coatings are separated or where pipes penetrate the walls. The station is not fenced and does not have odor control. The valve vault had standing water despite an open drain port and no recent rainfall.

Additionally, signs of corrosion were observed in the valve vault, likely due to hydrogen sulfide gas. The bypass pumping connection in the valve vault was directly tied into one of the discharge pipes instead of the combined discharge header. The valves also had significant rust and wear.

- Control panel still installed in old location.
- Wet well and valve vault corrosion.

- Coat the wet well and seal and repair the contents of the valve vault.
- Evaluate fencing and odor control at this site
- Move the control panel and meter to the updated posts.

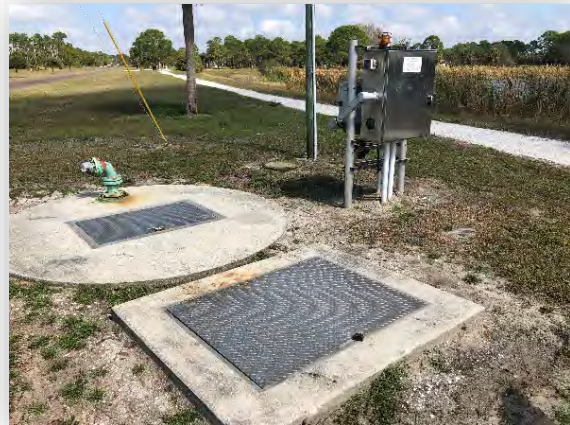
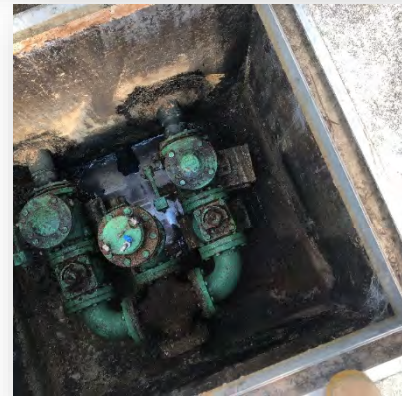
The valve vault shows signs of rust and wear from hydrogen sulfide gas. Portions of the valve vault lid's interior were rusted through and flaking off. The wet well appeared to be in good condition with the coating showing minimal signs of wear.

- Corrosion of discharge piping, valves, and fittings.

- Replace or repair the valve vault and piping.

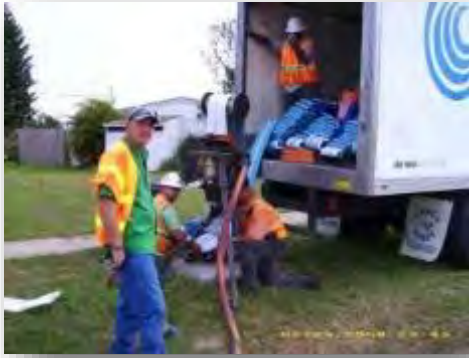
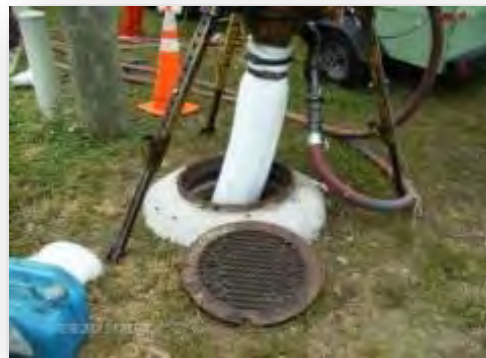
The older gravity sewer pipes are vitrified clay with frequent joints that are sources of infiltration. Vitrified clay pipe is resistant to corrosion but is more brittle than PVC and HDPE pipe. After many years of service, cracks develop, and pieces of the clay pipe protrude into the flow stream. Although CCU has relatively few plugged sewers, the broken clay pipe will cause blockage and must be repaired.

CCU Wastewater Collections staff performs in-place pipe repairs to fix most of the broken pipes in the system. Most of these repairs involve a cast-in-place lining, fold-and-form lining, or PVC lining. These repair methods restore the integrity of the sewer system without requiring excavation.
