# Charlotte County Utilities Department

2018 Annual Report  
March 2019

Jones Edmunds & Associates, Inc.  
824 S. Hyde Park Avenue  
Tampa, Florida 33606

Jones Edmunds Project No.: 03405-029-02

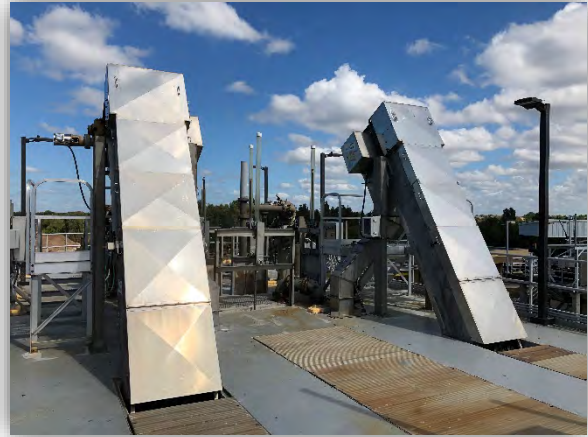
The overall condition of the headworks is good.

The upper concrete deck of the headworks was painted due to years of hydrogen sulfide exposure. A thorough cleaning and epoxy coating of the deck was completed in FY 2016 and appears to be providing adequate coverage of the area. In FY 2017, Screen No. 1 was repaired, and grit pumps were rebuilt.

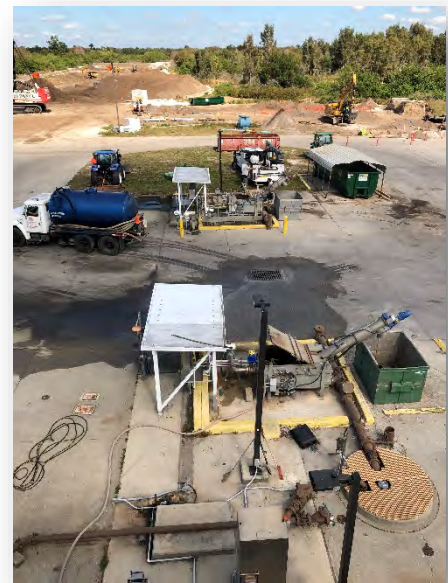
The two septage receiving stations require constant maintenance due to the high number of septage haulers that use the facilities and the nature of the waste. The septage receiving units are aging and need to be included in future capital replacement plans. Replacement of moving parts on Septage Receiving Unit No. 1 was completed in FY 2016.

The septage receiving units and the adjacent driveway area collect grit and spillage of septic waste. A hose is used by the haulers to clean the area. The wash water is collected in the plant sewer system and pumped to the headworks for treatment. A steam cleaner is used by CCU WRF staff for cleaning this area periodically.

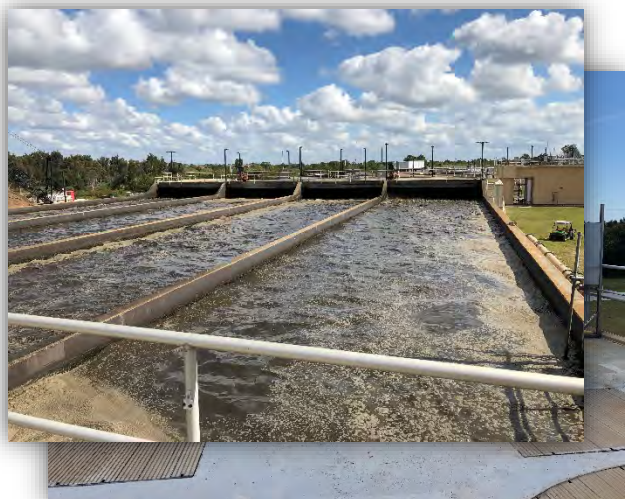
The overall condition of the MLE process is good following Stage 1 and 2 Improvements in 2015 and 2016, respectively. The concrete is in good shape for its age and showing very little cracking or

spalling. The anoxic zones are thoroughly mixed by four submerged mixers. A baffle wall was installed in both anoxic tanks to minimize short-circuiting and improve performance.

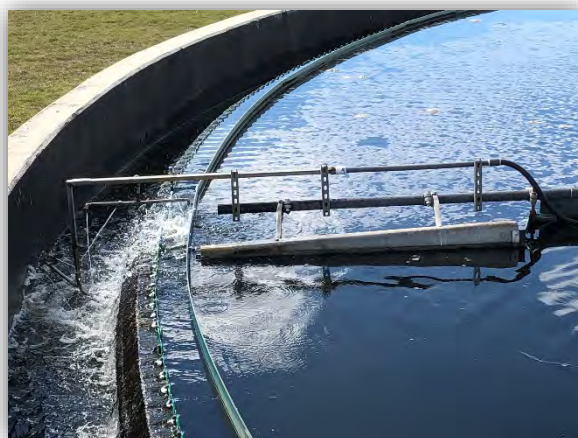
The two clarifiers were rehabilitated as part of the Stage 1 and 2 upgrades in 2016, which included replacement of the clarifier scraper mechanisms. The overall condition of the sedimentation process is well maintained and clean, and the clarifiers are producing a high-quality effluent.

A "weir washer" system was installed on Clarifier No. 1 and Clarifier No. 2 in 2017 and 2018, respectively. The weir washers eliminate the need to have O&M staff enter the clarifier effluent launders to remove algae, eliminating associated safety concerns. The weir washers do an excellent job keeping the clarifier effluent weirs and troughs clean. An excellent-quality effluent is being produced by both clarifiers.

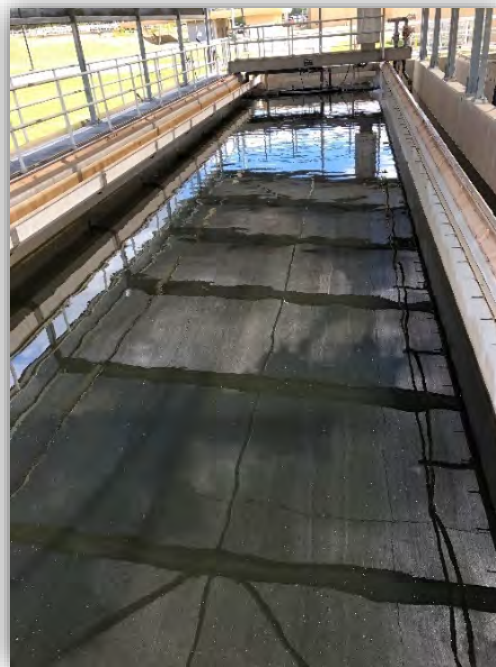
The CCCs are in good condition, well maintained, and operated to produce reclaimed water for unrestricted public-access reuse. A UV shade cloth was recently installed over the CCCs to reduce the loss of chlorine residual in the tanks. The previous UV shade cloth was removed by strong winds during Hurricane Irma in September 2017. Liquid sodium hypochlorite (12.5 percent) is used for disinfection to maintain a residual of  $\geq 1.0$  mg/L to meet unrestricted public-access reuse standards. In 2018, the old liquid reagent chlorine residual analyzer was replaced with a non-reagent analyzer to control chlorine feed rates. Another non-reagent analyzer is used for chlorine residual compliance measurement. The new skid-mounted chlorine feed system is encased in a clear plastic enclosure to control the spray of liquid chlorine for safety purposes. The two sodium hypochlorite storage tanks are well kept and meet regulatory requirements. The overall chemical feed systems and instrumentation are well operated and maintained to meet regulatory permit requirements.

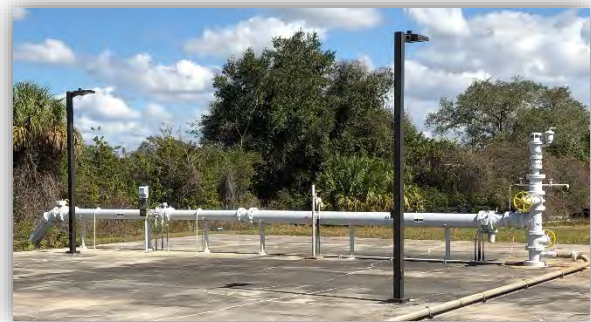
Excess RCW or effluent not meeting RCW standards (reject water) is disposed of through two deep injection wells and a restricted-access, on-site slow-rate irrigation system (on-site spray field). The 45-MG effluent storage pond is used to store effluent before injection well and/or spray field disposal. The 45-MG pond liner is in good condition.

Effluent transfer pumps are well maintained but are showing signs that they need to be repainted. The irrigation pump station is on the east bank of the 45-MG pond and pumps water from the pond to the deep injection wells or the spray field.

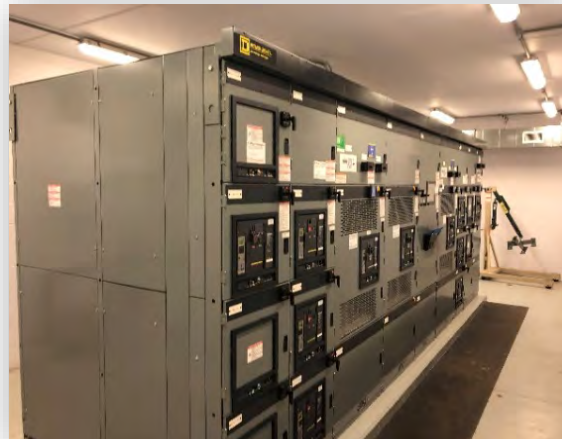
The East Port WRF contains one 1,250-kW generator serving the primary WRF as standby power. One 1,500-kW generator, which was installed as part of the Stage 5 Reclaimed Water Improvements. One standby generator serving the administration building was relocated from another facility in used condition. The facility has five primary electrical switchgear locations – the administration building, the generator/MCC building, the new primary incoming switchgear building, new electrical building #2, and the blower building. The administration building has a separate

The incoming service and distribution transformers at the administration building are relatively new and in excellent condition with no obvious signs of significant concern. The standby generator functions properly and is in good condition. Since it was relocated from another location, it does show signs of wear and deterioration but with no major issues to interfere with its function. The distribution switchgear of the administration building was in excellent condition with minor issues (see below). Overall, the electrical equipment is in good functioning condition based on information from Operations staff.

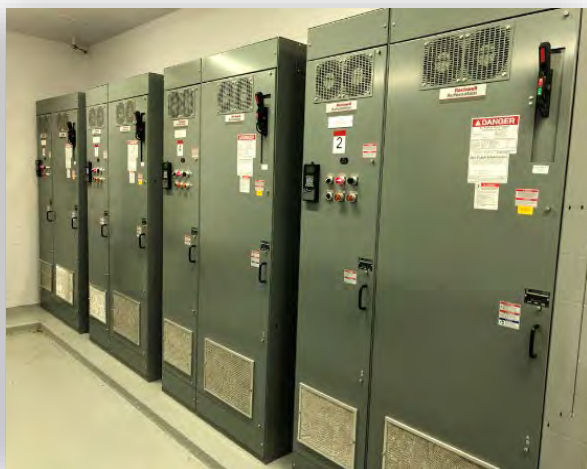
The incoming switchgear building is relatively new, constructed only a few years ago. As such, all equipment is in excellent condition (see photograph at left). The facility is fed from two

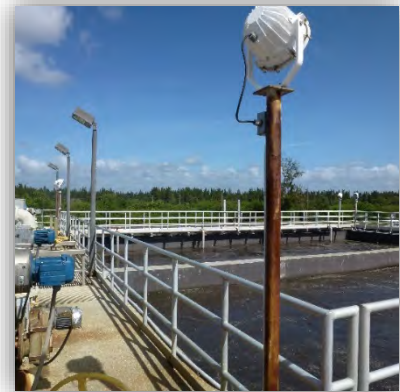
The WRF has no grit removal system. Grit usually accumulate in aeration basins and at the on-site lift station. Grit is removed from the system periodically by vacuum trucks. Although the lack of a grit removal system is an issue, grit content of the wastewater entering the WRF is probably lower than most plants because nearly all flow is received from septic tank effluent pumps.

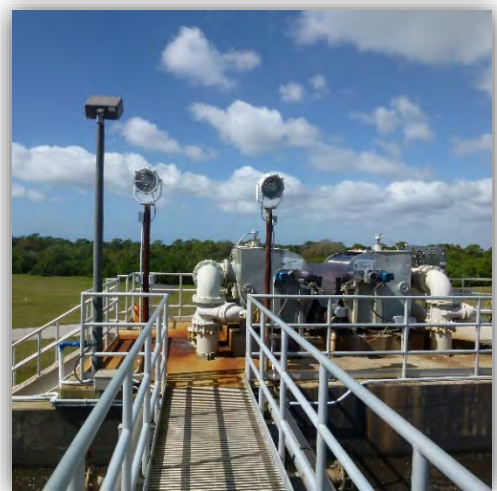
The WRF has four aeration basins that were in service at the time of the site review. New fine-bubble diffusers were installed in all basins in 2013 and 2014. This has had a positive effect on the treatment process by providing a more even air flow distribution. However, the lack of grit removal continues to present a maintenance challenge since

deposited grit levels rise to block the diffusers. Basin No. 3 was cleaned of grit and damaged aerators were repaired in FY 2016.

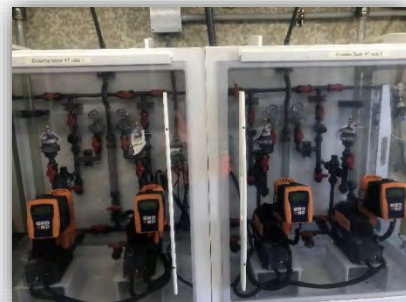
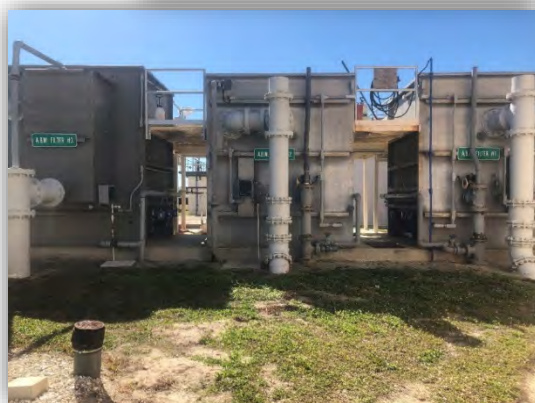
In June 2017, a new chlorine feed system with two chemical feed pumps for each CCC and new storage tanks was installed in a new chlorine storage and feed area between the two CCC structures. This will enable two parallel CCCs to operate when peak hourly flows exceed 955 pm.

The new dosing pumps have double-containment protection.

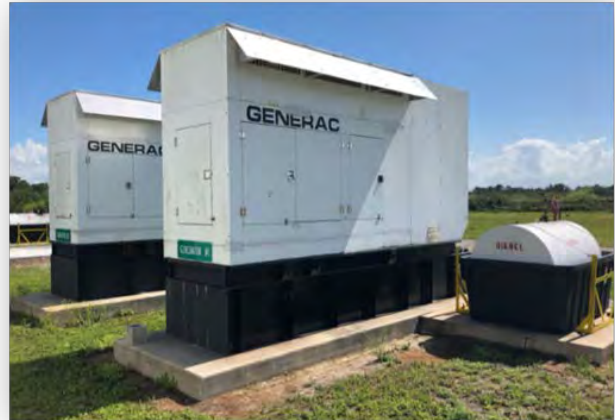
The incoming switchgear and distribution transformer appear in good condition with no obvious signs of significant concern. The incoming power via overhead aerial is new and was installed within the past couple of years. The WRF is served from two 400-kilovolt-ampere (kVA) generators connected in parallel that are fed from a subbase tank and an auxiliary tank adjacent to them (see photograph above). Operations staff indicates that a new 6,000-gallon fuel tank and pad for the generators will be installed in the near future. Overall, the electrical equipment is in good functioning condition based on information from the Operations staff, except for the deficiencies listed below. Thermography scanning of the equipment showed no anomalies.

- A power distribution panel located within the plant's MCC is missing a protective cover. Access in the panel to activate a breaker could potentially expose personnel to live conductors (see photograph above).
- The switchgear contains warning labels identifying parts and components as being energized. However, none of the equipment includes the appropriate arc flash labeling required by NFPA 70E.

Recommendation:	Secure all electrical switchgear to prevent unauthorized access or inadvertent exposure to live parts.
Recommendation:	Apply appropriate arc flash labeling on all appropriate switchgear in compliance with NFPA 70E to properly notify operations and maintenance personnel of the potential hazard. This may require creating a complete and thorough arc flash model using the existing switchgear to determine the energy levels present. This information would appear on the appropriate arc flash labeling as required.
Recommendation:	Perform a load study to identify any issues related to the system power quality, quantity, and capacity. The load study would help identify deficiencies in the system such as the issues related to the faulty blowers and identify reserve capacities and potential anomalies that may affect long-term maintenance and serviceability of the equipment.

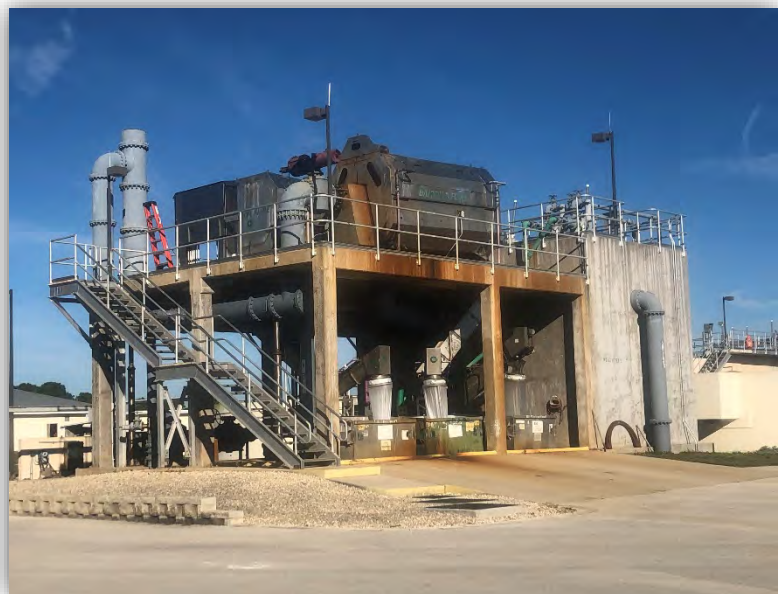
The grit removal process operates as intended. The organic wastewater component of the pumped mixture is returned to the wet wells. The separated grit passes to a grit "snail" washer before being deposited into a dumpster bag. The grit "snail" washer includes a conveyor belt that allows the grit to shed water as it proceeds to the dumpster. The grit "snail" washer produces a dry grit that is deposited into a plastic grit bag. In 2017, Grit Pump No. 2 was replaced, and the cyclones are scheduled for replacement in 2019.

clean and free of odors. The screening screw conveyors/compactors and grit dewatering units are operating as intended.

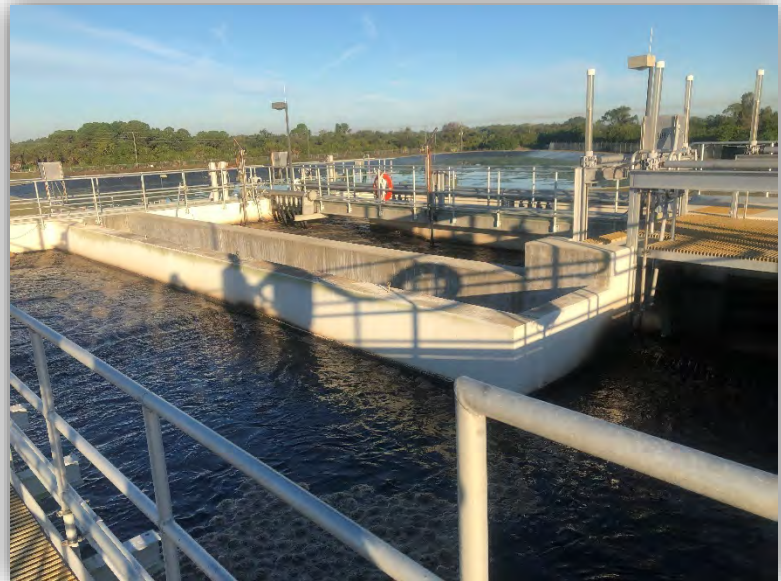
The overall condition of the 0.3-MG EQ tank is good.

The EQ tank, which attenuates high hourly flows, is filled through a gravity system initiated by an overflow weir at the headworks structure. The EQ tank contents are returned to the headworks for treatment at a steady flow over 24 hours using variable-speed pumps. This has proven to be a valuable asset to the operation of the facility. The Chief Operator noted that Lift Station

No. 801 sends 1,500 gpm to the Rotonda WRF for about 20 minutes and then turns off for 20 to 30 minutes. The operation of the EQ tank has been adjusted to respond to the intermittent discharge from Lift Station No. 801. Dry pit submersible pumps are used to return EQ tank contents to the treatment stream. The EQ tank positive displacement blowers are run intermittently to save power. Oil sight glasses and fill ports were added by CCU to improve maintenance.

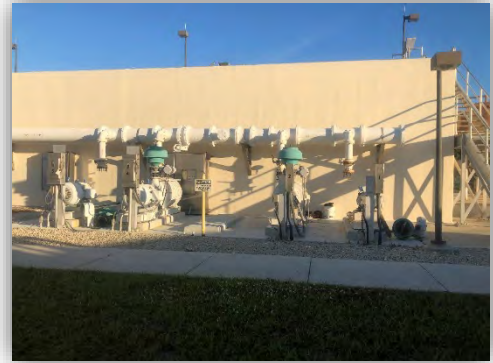
The aeration system continues to supply adequate air to the aeration tanks. Four blowers serve the aeration trains. Generally, one blower meets air requirements. Additional units are brought online during higher demands. Blower No. 2 has been repaired multiple times including a new motor in 2014 and new bearings in 2016; however, the blower motor was again repaired in 2017. During the site visit, only Blower No. 2 and Blower No. 4 were in

service. Blower No. 1 has been taken offline for service since 2017 and is expected to be put back online in FY 2019. Blower No. 5 will be replaced after Blower No. 1 is put back in service. The blowers are well painted, and piping is marked.

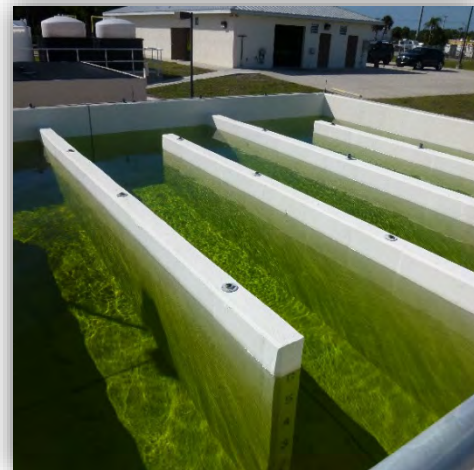
The two concrete CCCs are in good condition. Both CCCs are used alternately, but only one is required to meet the required contact time under current flows.

Wind from Hurricane Irma in September 2017 caused the UV filter cloth to be disconnected from the CCC. A new UV filter cloth of 90-percent UV block cover was installed in 2018 over the CCCs to conserve bleach and inhibit algae growth.

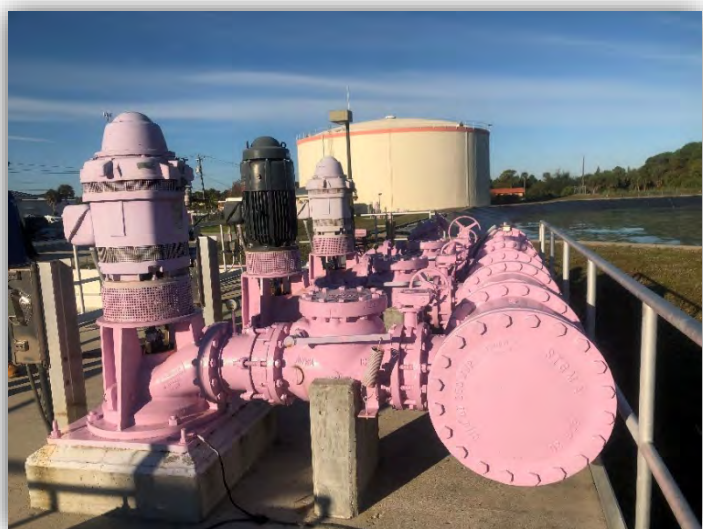
The high-pressure pumps were last painted in 2018.

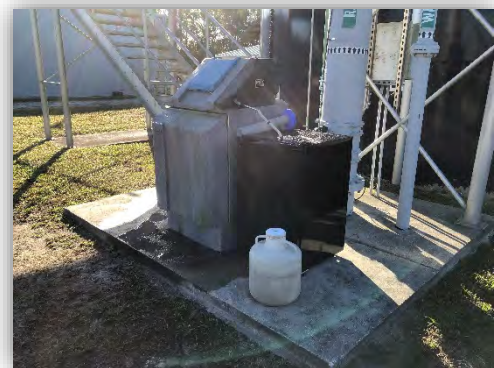
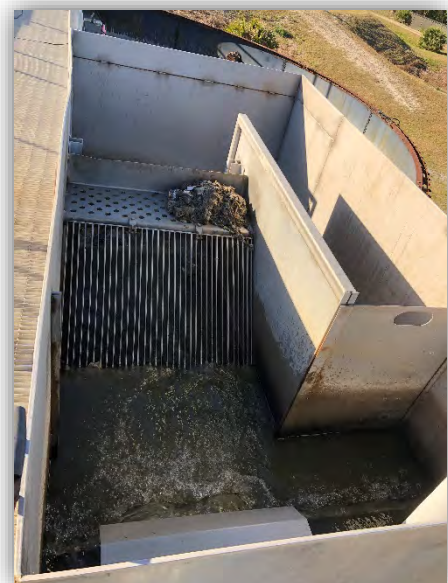
The headworks overall condition is fair. It consists of one manually cleaned bar rack. Issues with the headworks include insufficient treatment, lack of floatables removal, and no grit removal facilities.

Currently, the only way to remove floatables that pass through the manual bar screen is by using a bucket to remove them from the EQ tank.

A mechanical fine screen and scum/floatables removal and grit removal systems are highly recommended. This issue is expected to be resolved as part of a future facility upgrade.

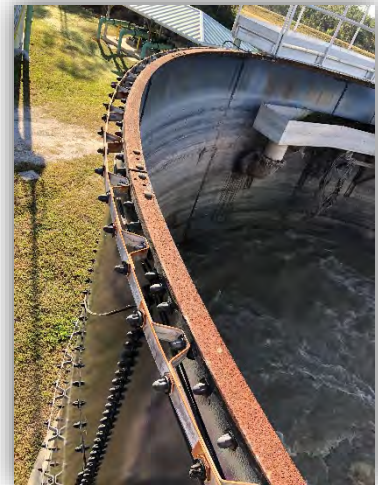
The EQ tank has signs of rust around the upper steel rim. Removing rust and painting rusted areas was not done in 2018 as scheduled and is rescheduled for 2019. Internal piping is in poor condition with leaks at flanged fittings. The leaks do not pose an environmental hazard because they are inside the tank. The piping should be replaced as part of a plant upgrade.

A leak in the aeration header of the EQ tank blower was repaired in 2017. One of the drop diffusers inside the EQ tank is damaged.

The lack of fine screening and grit removal creates operational and mechanical problems for the EQ tank and pumps. Staff clears the EQ transfer pumps and pipe lines of debris monthly to remove clogs in the system. To help make this cleaning process safer, a permanent pump motor hoist system is installed over the EQ pumps to allow access to the pump volute.

Future plant upgrades should simplify the operation of the EQ tank to allow modes for flow and/or plant load equalization and to provide proper headworks treatment to reduce grit and screenings accumulation and wear in EQ tank and pumps.

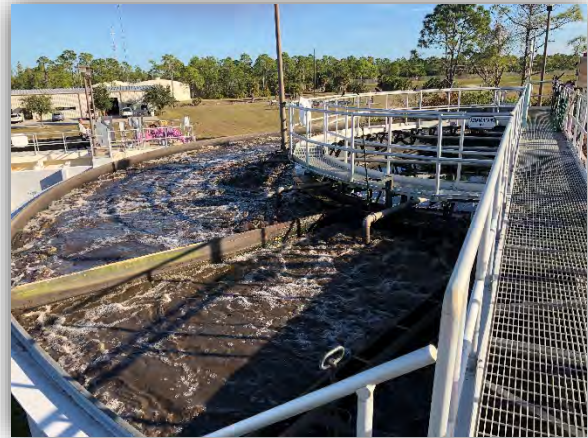
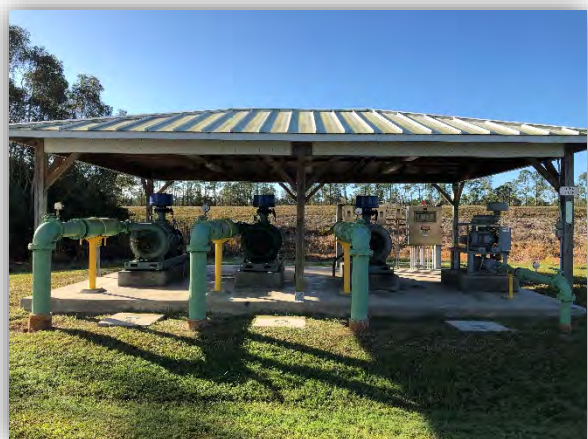
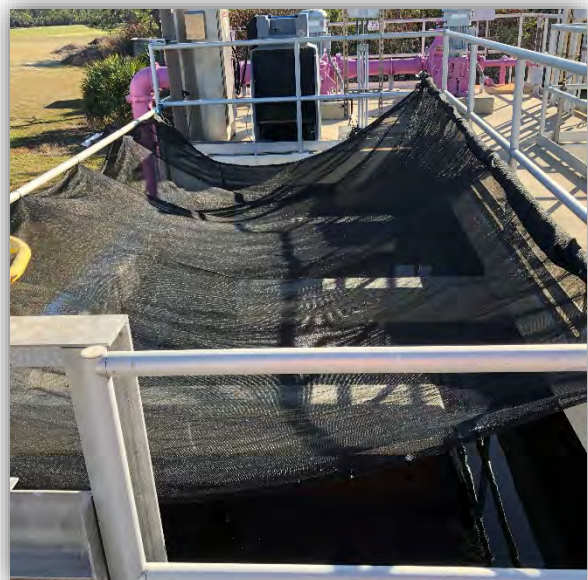
The overall condition of the chlorination system is good. CCC No. 2 is not in service since it does not provide sufficient contact time due to the chlorine injection location.

The chemical-dosing pump bases are beginning to show rust and should be painted with chlorine-resistant paint.

The concrete CCCs are in good condition. A UV cover has been installed over the CCC No. 1. Where liquid chlorine is added to the flow stream, a mixing pump is used to provide a more consistent chlorine reading for dosing

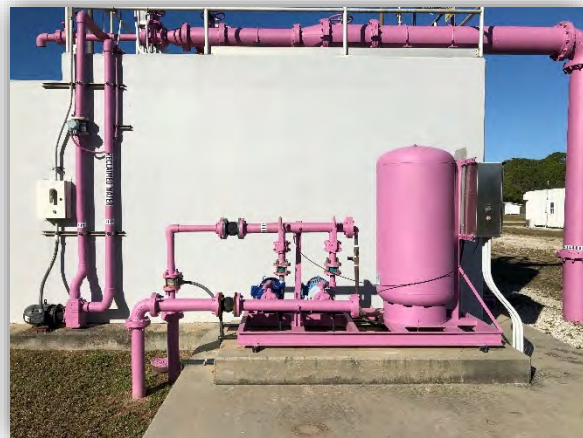
A smaller pump was installed to replace an existing pump in the deep well pumping station to match the current flows that flow by gravity to the wet well. The deep well pumps were repainted in 2017. One of the injection well pumps was replaced in 2018.

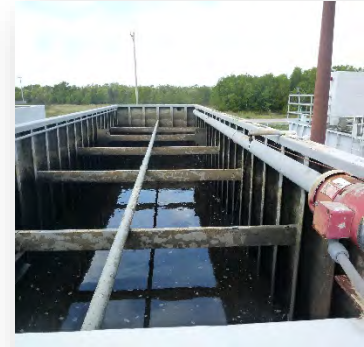
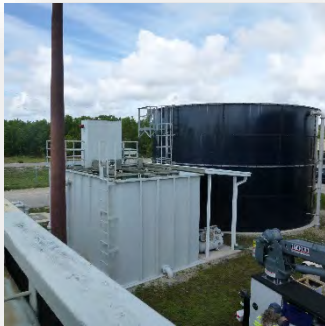
The overall condition of the three PACT treatment units is good, and the facility is operating without any treatment or capacity issues. The tanks' exteriors were partially painted in 2017. The tanks' interiors are scheduled to be painted in 2018; before painting, the surfaces should be pressure washed and rust and lost paint removed and primed.

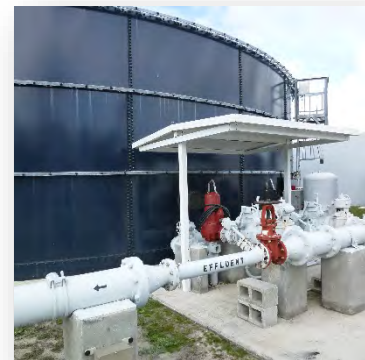
The effluent disposal system is in good condition, well maintained, and meets the facility needs.

LTF effluent is injected into the injection well by two dry-pit submersible pumps. The existing 12-HP pumps were installed by CCU personnel in 2015. The pumps are operating satisfactorily and not overheating on hot summer days.

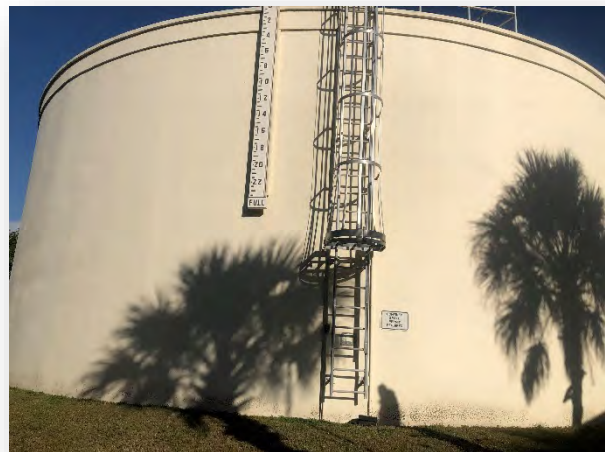
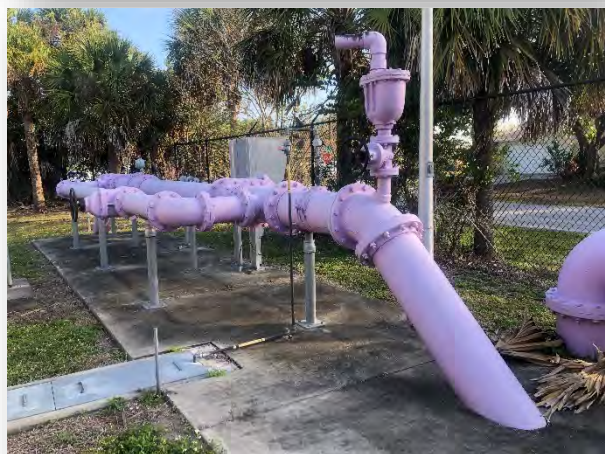
The electrical room equipment, pump room equipment, and tank were found in good condition. The piping was painted purple and clearly marked. The outside paint on some brick surfaces of the electrical building was deteriorated. Decommissioning of the on-site chlorine injection system should be evaluated. The grounds require constant maintenance, which is provided by a private contract.

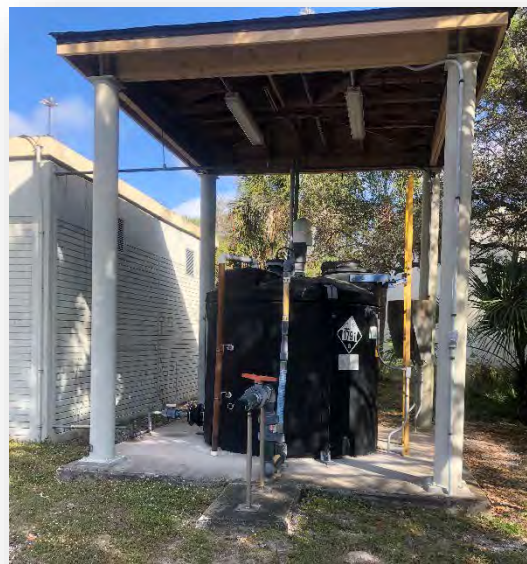
The electrical room equipment, pump room equipment, and tank are in good condition. The two concrete block buildings were painted, and piping was painted purple and clearly marked. Decommissioning of the on-site chlorine injection system should be evaluated. The grounds are well maintained.

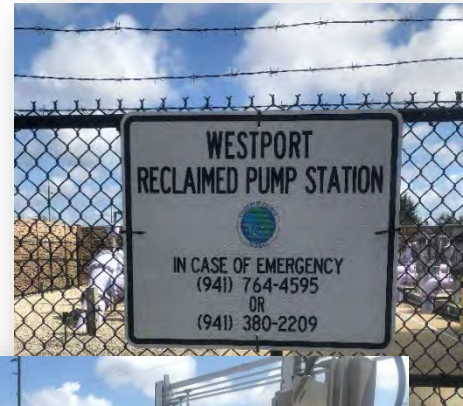
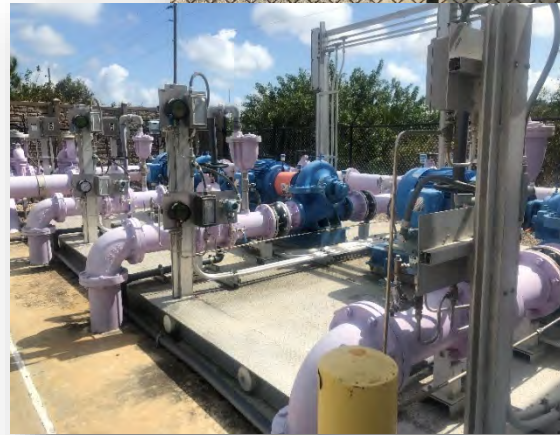
The condition of the West County RCW Booster Station is excellent.

- The station's PLC is being evaluated as part of the RCW modeling effort to reduce the energy needed to serve RCW customers in West County, which would result in operational cost savings.
- The station's hydraulics must be evaluated to update the operating protocol and improve the usefulness of the station to operators. Adding a storage tank and SCADA improvements may be considered.

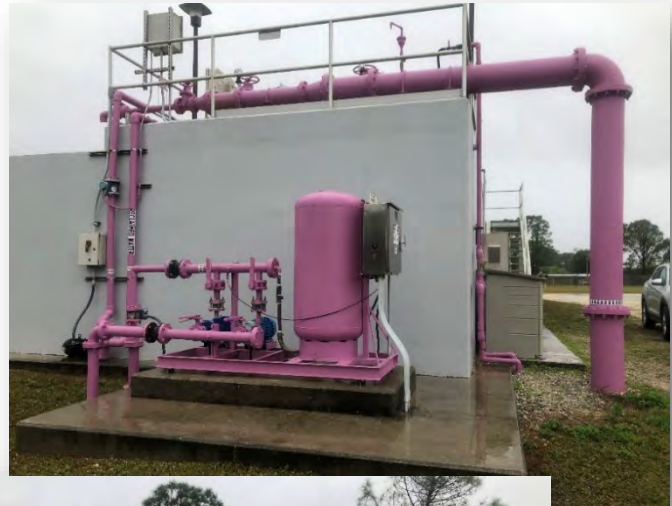
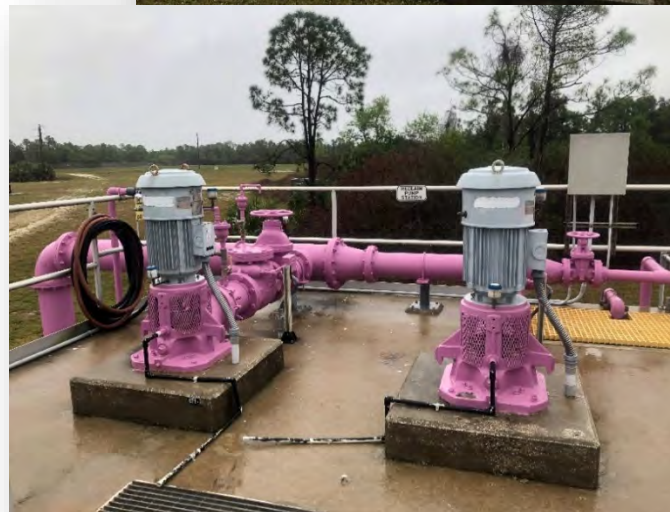
Overall, the system is in good condition.

- A new flow meter on the RCW discharge line is required to measure flow leaving the site. CCU intends to address this requirement as part of the plant upgrade.

- The Burnt Store RO WRF has no RCW storage, and the pumps are not capable of matching demand with flow. New customer development would require customer storage in the same manner as that proposed by the original golf course customer.
