Charlotte County Utilities Department

2021 Annual Report
March 2022

2021 ANNUAL REPORT

Jones Edmunds Project No.: 03405-029-05

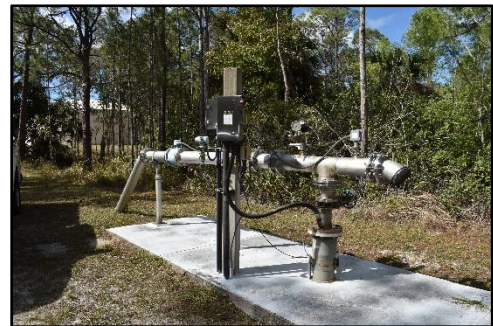
- Well No. 16 is a 12-inch-diameter well on the east side of the site. The well pump is in excellent condition.

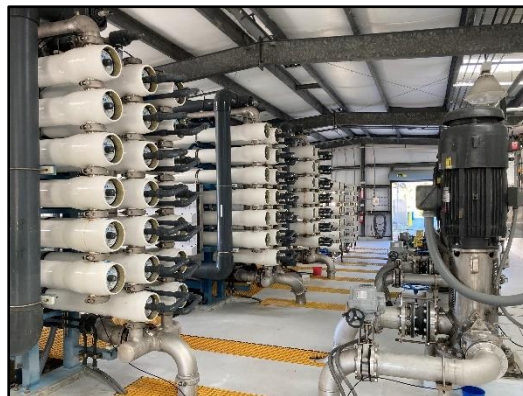
Trains A and B are arranged in an 8:4 array – eight pressure vessels in the first stage and four pressure vessels in the second stage. Trains C, D, and E are arranged in a 14:6 array. Each pressure vessel contains seven RO membrane elements resulting in a total of 84 for Trains A and B and 120 for Trains C, D, and E. The total number of membrane elements at the Burnt Store RO WTP is 528. The membrane elements in Trains A and B are approximately 14 years old and have shown signs of minor membrane fouling. The membrane elements in Trains C, D, and E are 12 years old.

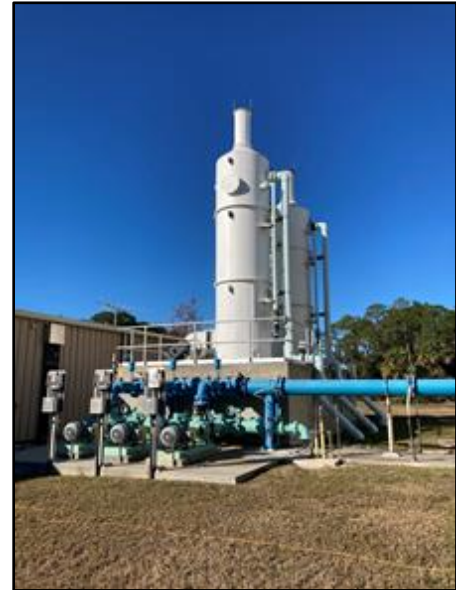
Hydrogen sulfide is removed from the RO permeate via packed-tower degasification. Three packed-tower degasification units are on top of the concrete clearwell and can be operated automatically or manually. One of the degasifier blowers was repaired in February 2017. The degasifier media is expected to be in good condition but should be inspected and potentially cleaned or replaced pending the inspection. In 2014, the clearwell was temporarily taken out of service for inspection. The clearwell inspection report noted for staff to paint the clearwell and exercise the isolation valve between the two tanks. The clearwell valve was exercised by staff and found to be operational in 2019. The outside of the clearwell should be painted. We recommend that the degasification tower and media be scheduled for cleaning and inspection.

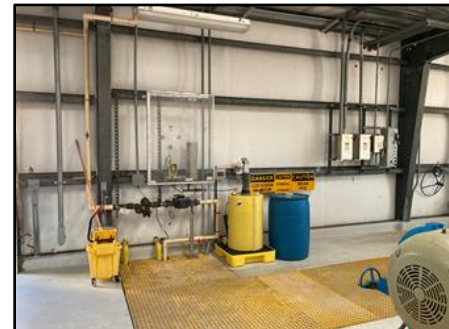
Sodium hydroxide is used to adjust the pH of the finished water before pumping it into the distribution system. The sodium hydroxide system consists of a 1,100-gallon bulk storage tank, a chemical feed skid with two metering pumps, and a 90-gallon chemical feed tank. The skid and smaller storage tank are in the RO process room and are in good condition. The bulk storage tank is outside near the other bulk chemical storage tanks, which poses operational issues during cold weather. When temperatures are less than 45 degrees Fahrenheit ($^{\circ}\text{F}$), operators install heat lamps to prevent the sodium hydroxide viscosity from increasing. The glass sight gauge on the bottom of the 1,100-gallon bulk storage tank and the ball valve on the transfer line from the bulk tank were replaced in 2018 and are functioning properly.

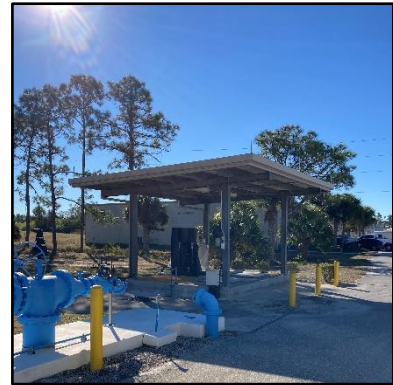
Redundant analyzers that monitor post-treatment conditions of the water are on the wall of the clearwell. The instruments are well organized with SCADA connections to the Wonderware program, which can be monitored from the Operations Building. Instruments and chemical feed rates can be adjusted to obtain the proper water quality. Instrumentation is calibrated and up to date. Operations staff reported that the conductivity meter requires periodic replacement. We recommend the cover of the analyzer panel be extended to prevent water from contacting the equipment during rain events.

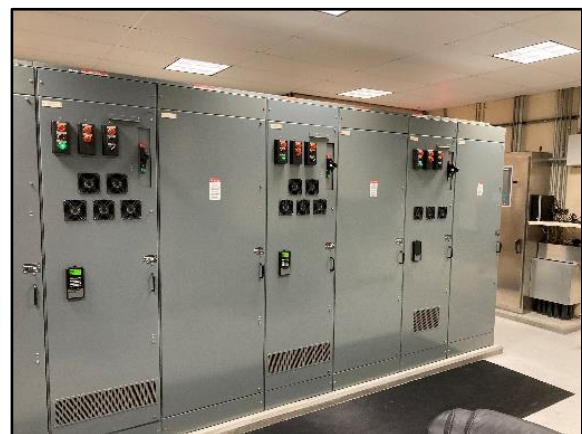
The incoming switchgear is in good condition with minor issues. The switchgear contains warning labels identifying parts and components behind blank cabinets as being energized. The floor near the electrical equipment is marked with hazard tape, but none of the equipment includes the appropriate arc flash labeling as required by National Fire Protection Association (NFPA) 70E. In FY 2021, the building exterior was pressure washed.

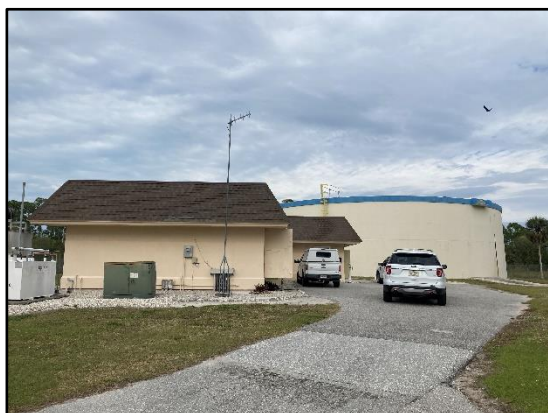
Additionally, an electrical equipment site visit assessment was conducted by a Jones Edmunds electrical engineer on February 17, 2022. The Operations staff reported no issues. The review of the plant showed systems in good condition and well maintained.

No deficiencies were noted.

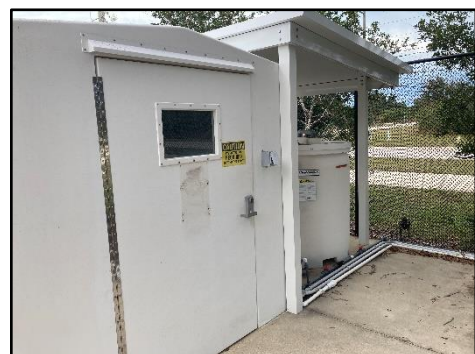
4.1.2.5 Ingraham – WBS #7

The general condition of the station is fair. The buildings are weathered but in operational condition. The landscaping is maintained. The electrical components at the Ingraham Disinfection Station are in good condition. Interviews with County staff reported no unresolved issues.

No deficiencies were noted at the time of the site visit.

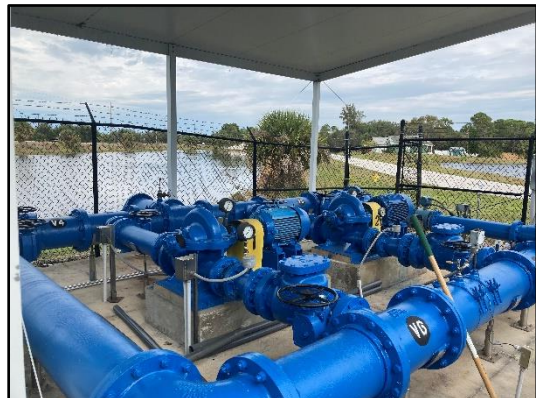
4.1.2.1 Englewood – WBS #8

Overall, the interconnect is in good condition, but the lighting fixtures should be turned or lowered so that the cover does not block the illumination of the pumps and equipment.

<u>Interconnects</u>							
Recommendation:	Reinstall (turn or lower) the lighting fixture to illuminate the pumps and equipment at the EWD interconnect.						
Progress:	Incomplete.						
<u>WBS General</u>							
Recommendations:	<ol style="list-style-type: none"> 1. Perform a load study to identify any issues related to power quality, quantity, and capacity and to help identify deficiencies in the system, reserve capacities, and potential anomalies that may affect long-term maintenance and serviceability of the equipment. 2. Apply appropriate arc-flash labeling on appropriate switchgear in compliance with NFPA 70E to properly notify O&M personnel of a potential hazard. This may require creating a complete and thorough arc-flash model using the existing switchgear to determine energy levels present. This information would appear on the appropriate arc-flash labeling as required. 						
Progress:	<ol style="list-style-type: none"> 1. Completed. 2. CCU has completed labeling for the Port Charlotte Golf Course WBS and has scheduled it for Gulf and Rotonda WBSs in 2021. 						
<u>Port Charlotte Golf Course WBS</u>							
Recommendations:	<ol style="list-style-type: none"> 1. Perform yard maintenance around the perimeter fencing. 2. Label the switchgear to identify parts and components that could be energized. 						
Progress:	<ol style="list-style-type: none"> 1. Ongoing. 2. Completed. 						
<u>Walenda WBS</u>							
Recommendations:	<ol style="list-style-type: none"> 1. Perform yard maintenance around the perimeter fencing. 2. Replace the generator at the WBS with a properly sized generator to accommodate the loads and maintain reliable operation of the station. 3. Fix the leak on the seal of Pump No. 3. 4. Repair the bonding and re-paint the GST. 5. Replace the missing cover on the junction box. 6. Fix unsupported and damaged conduits throughout the facility. 						
Progress:

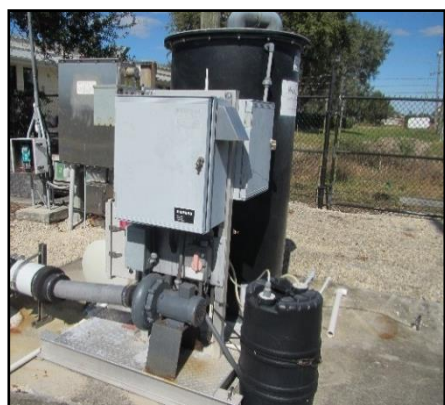
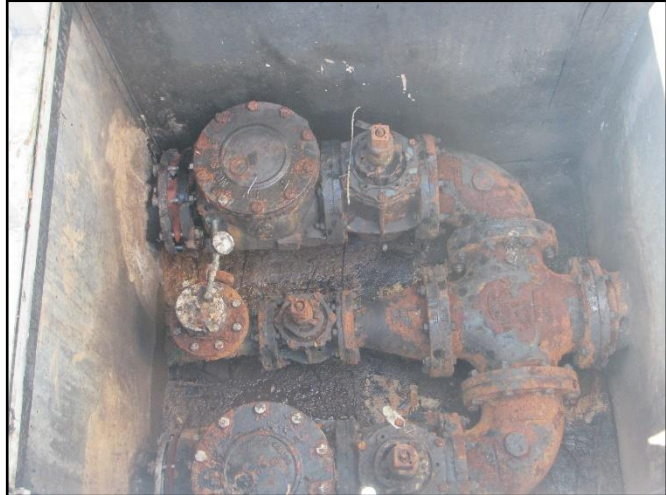
5.2.1 MASTER LIFT STATION 309 – BRIDGEWATER (DEEP CREEK)

The wetwell hatches are in good condition and provide adequate access to remove the pumps on the rail-retrieval system. The wetwell was last coated in the 1980s. The discharge 8-inch Dezurik plug valves, 8-inch Kennedy check valves, and dedicated discharge are in an underground concrete vault north of the wetwell. The pump discharge check valves are in fair condition but have wear and sticking and require repair and replacement.

The station is fenced and generally well kept, although gaps between the gravel and the bottom of the fence in some areas create easy access for small animals. Power is provided by a 480-volt, three-phase power service. The station contains a telemetry transmitter that allows monitoring to occur from the CCU central office and treatment plants.

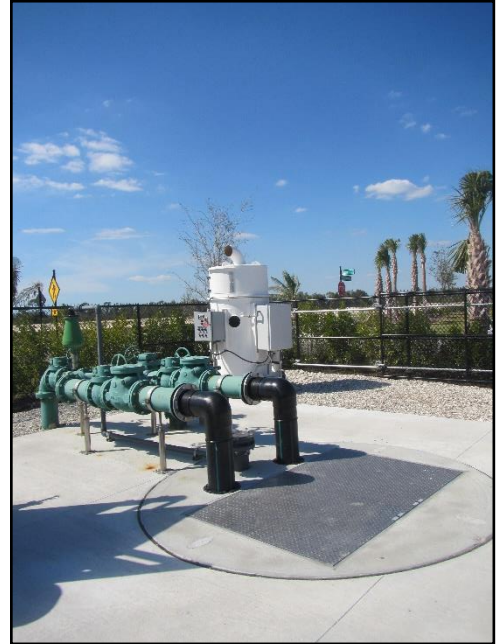
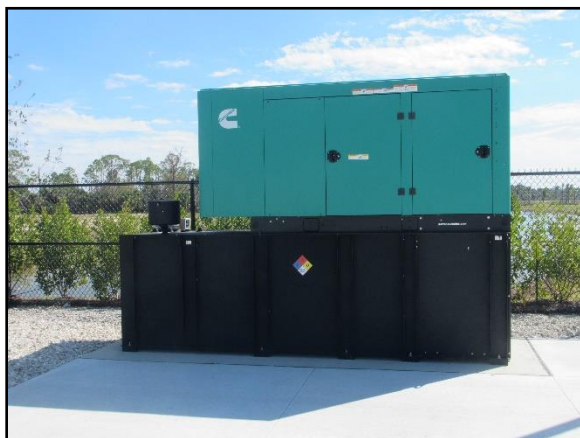
The site is fenced and has proper lighting within the fenced area. No deficiencies were noted at this station.

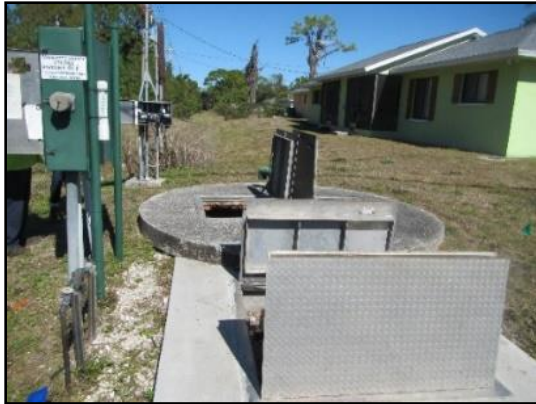
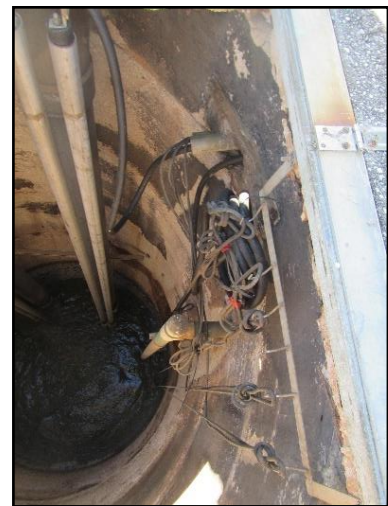
5.2.3 MASTER LIFT STATION 816 – ROTONDA BOULEVARD WEST

The station wetwell exterior and electrical equipment are in relatively good condition, and the station wetwell interior is showing signs of corrosion. The valve vault cover was recently replaced with a concrete slab and updated hatches; however, significant mud is filling the valve vault and partially covers the valves. The new concrete slab appears to be partially covering some of the valve bolts, which may cause future maintenance issues. The wetwell interior has sufficient storage capacity and does not incur significant impacts from I/I; however, the coating is worn and the concrete top slab is degraded, exposing structural rebar and wood. The valve vault's surrounding concrete wall base exhibits significant wear-through. The degradation and exposure of the vault has resulted in partially buried valves.

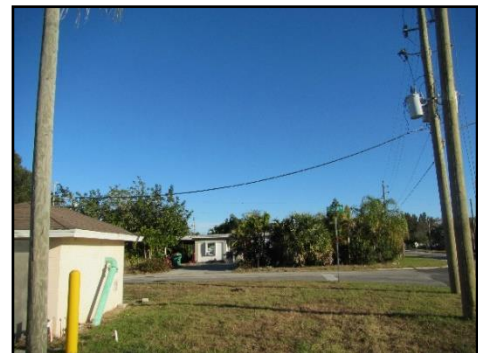
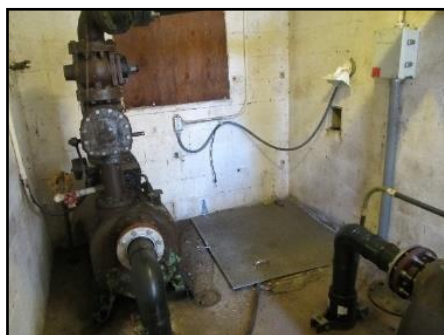
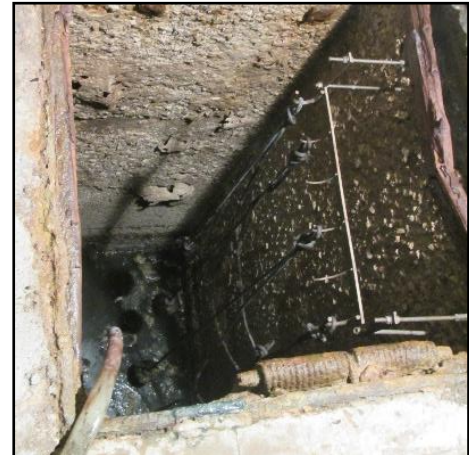
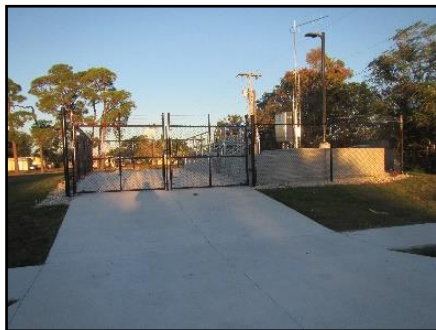
5.2.4.1 Lift Station 1 – Community Center

The station is housed in a concrete building on an open easement with no fencing. The wall of the structure contains visible cracks. This station, originally built in 1959, contains two

aboveground, self-priming, belt-driven 15-HP Gorman-Rupp pumps that were installed in 1980. Each pump has an estimated capacity of 220 gpm at approximately 65 feet of head. The 13-foot 9-inch depth, 7-foot by 6-foot rectangular wetwell interior shows signs of corrosion from hydrogen sulfide. The wetwell has no ventilation, so emitted gases are contained within the wetwell and the building. The 4-inch Dezurik plug valves and 4-inch Kennedy check valves are above the pumps.

- Paint the aboveground discharge pump and piping.
- Repair/replace the patched wye connection.
- Repair cracks in the building.
- Seal pipe penetrations.
- Provide an odor-control system.
- Replace the outdated control panel and bring electrical up to current standards.
- Perform thorough rehabilitation of the lift station including repairing the building or replace the station with a modern submersible configuration and all new equipment.

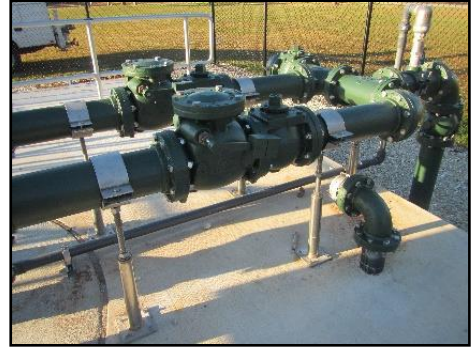
5.2.4.2 Lift Station 2 – Dalton

The lined concrete wetwell is in excellent condition and is vented. The wetwell hatches are in good condition and provide adequate access to remove the pumps on the 2-inch cylindrical-rail retrieval system. The 6-inch APCO plug valves, 6-inch Kennedy check valves, and dedicated suction and discharge connections are above grade, west of the wetwell.

The station has barbed wire fencing and is on an unimproved parking lot in a residential neighborhood. No deficiencies were noted at this station.

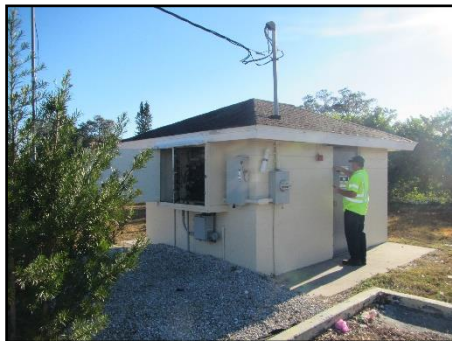
5.2.4.3 Lift Station 7 – Pure Oil

The station is housed in a concrete building and contains two aboveground, self-priming, belt-driven 20-HP Gorman-Rupp model T4A3B pumps providing a 48-amp draw. Each pump has an estimated capacity of 440 gpm at approximately 50 feet of head. The 13-foot-deep, 6-foot-by-13-foot-diameter concrete wet well is corroded by years of hydrogen sulfide exposure, and metal reinforcement is exposed near the access hatch. The wetwell has an older trough design and is not vented. The station has no odor control and no dedicated well suction bypass piping, although a circular penetration in the wall directly above the wetwell cover is available for local pump trucks to access. The space inside the building is exposed to sewer gases because access for the wetwell entry and float switches are open holes in the floor of the building.

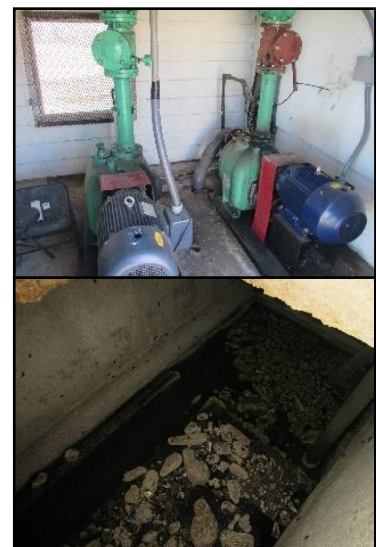
- Odor noted on site.
- Missing seal-offs from the control panel conduit.
- Obstructed access for a crane truck.
- Existing aerial power supply should be replaced with an underground supply.

- Evaluate odor-control opportunities.
- Install seal-offs on any electrical equipment within 10 feet of the wetwell to conform with current codes.
- Evaluate possibilities for a dedicated access to the station.
- Perform thorough rehabilitation including the improvements listed above or replace the station with a modern submersible configuration and all new equipment.

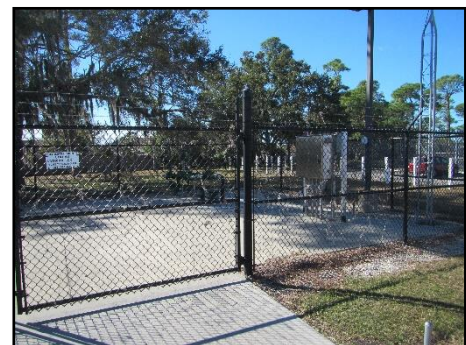
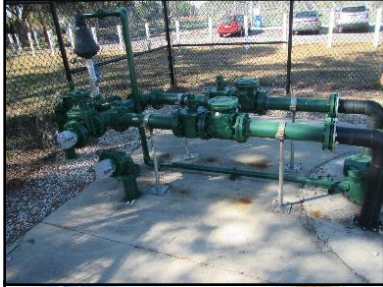
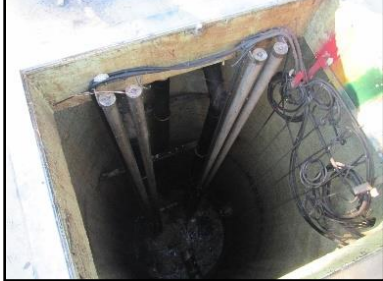
5.2.4.4 Lift Station 18 – Jr. High

The wetwell hatches are in good condition and provide adequate access to remove the pumps along the 2-inch cylindrical-rail retrieval system. The wetwell lining is in good condition. The 6-inch Dezurik plug valves, 6-inch Kennedy check valves, and dedicated pump suction and discharge connections are all above grade to the south of the wetwell.

- Rust was observed at the site under valves and flanges, indicating rain is entering through pitting between the bolts and flanges.

- Perform routine maintenance including tightening bolts and touch-up painting.

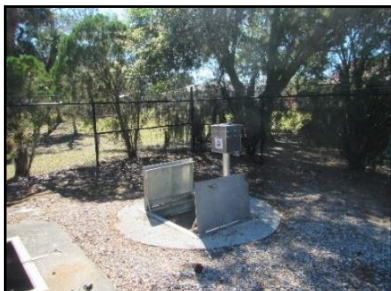
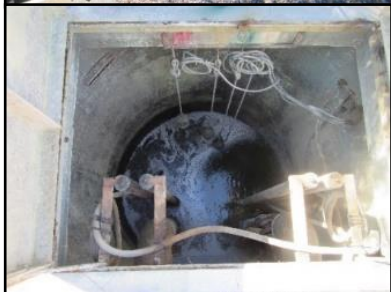
5.2.4.5 Lift Station 20 – Lake Worth

The wetwell exterior is in relatively good condition, and the interior is not showing any signs of corrosion. The station has

a valve vault east of the wetwell housing 6-inch plug Dezurik valves, dedicated discharge, and 6-inch Kennedy check valves. The interior valve vault wall is in poor condition with cracks; the bottom is filled with stones indicating leakage.

- Missing seal-offs from the control panel conduit. This represents a significant code violation as well as a potential explosion hazard.

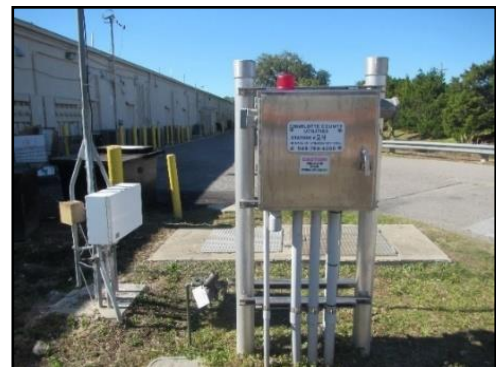
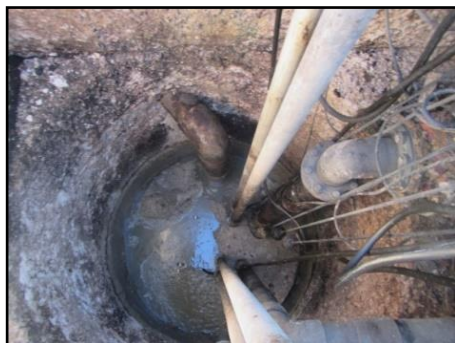
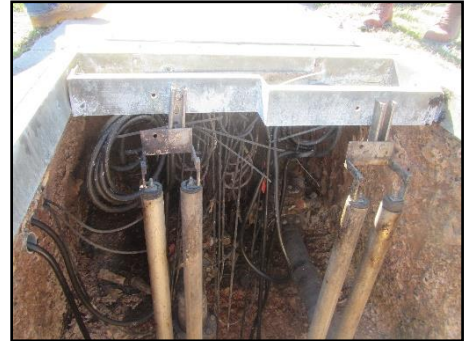
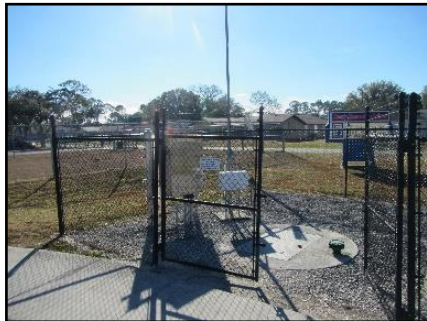
5.2.4.6 Lift Station 24 – Charlotte Square

The wetwell is very corroded, and the lining is separated from the wall in some places. Additionally, the surface of the liquid in the well shows some signs of grease. The wetwell is an older design in which the valve vault is not separated by a wall and is instead a shelf built into the side of the wetwell (shown in bottom left photo). This design can be dangerous to operators who need access during high-water levels in addition to confined space issues and sulfide exposure. The 4-inch Dezurik plug valves and 4-inch Kennedy check valves are on this shelf.

- Heavy corrosion of the lined concrete.
- The station experiences flooding during storm events and the valves are on the shelf of the wetwell without dedicated discharge.
- Missing seal-offs from the control panel conduit. This represents a significant code violation as well as a potential explosion hazard.

- Evaluate the wetwell for lining replacement and potential structural repair.
- Evaluate construction of a separate, isolated valve vault for operator safety, including standard dedicated discharge.
- Install seal-offs on any electrical equipment within 10 feet of the wetwell to conform with current codes.

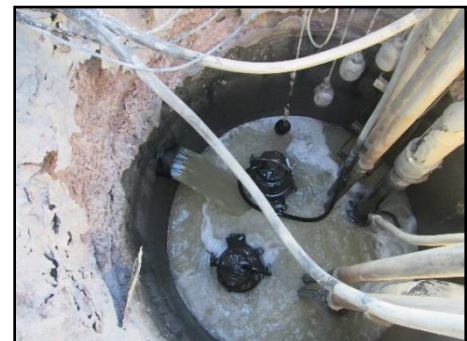
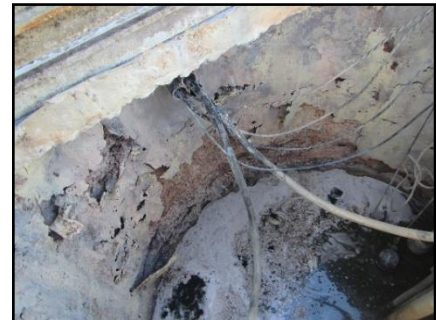
5.2.4.7 Lift Station 44 – Liberty Elementary

The wetwell is extremely corroded and has cracks along the lining of the wall, including a portion that appears to be half-collapsed. The wetwell hatch is in good condition and provides adequate access to remove the pumps along the 2-inch cylindrical-rail retrieval system. An odor was present at the time of the site visit but the wetwell is vented. The 4-inch discharge Dezurik plug valves and 4-inch Mueller check valves are in an adjacent lined valve vault with a dedicated discharge. Corrosion is slightly evident within the vault surrounding the check valves. The hatch of the valve vault is in good condition.

- The wetwell is partially collapsed and needs repair in addition to the wetwell lining needs to be repaired.
- Check valves are rusted.
- Being located next to the school makes access difficult during peak school traffic.

- Perform thorough rehabilitation including some form of structural improvement and lining repair.
- Evaluate the replacement of the check valves.
- Evaluate possibilities for a dedicated access to the station.

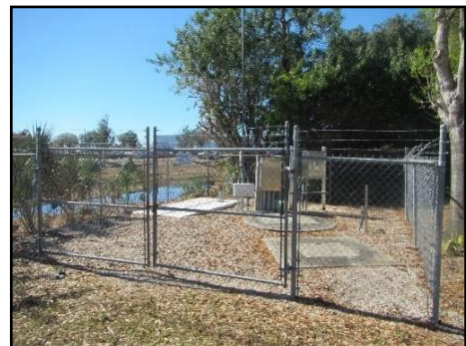
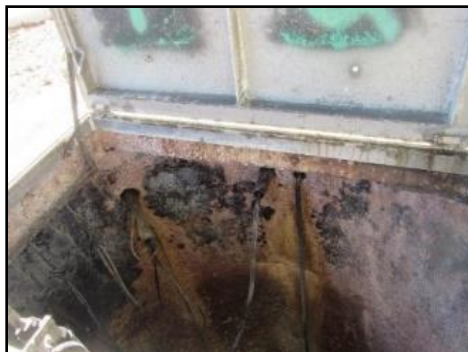
5.2.4.8 Lift Station 45 – Woodbury

The wetwell exterior and electrical equipment are in relatively good condition but the wetwell interior is showing signs of corrosion and odor. The station has a dedicated discharge in the valve vault that also houses a 6-inch AFC plug valve and 6-inch Mueller check valve. The interior valve vault is in good condition and is made of concrete with dry dirt at the bottom.

- Missing seal-offs from the control panel conduit. This represents a significant code violation as well as a potential explosion hazard.
- Odor problem.
- Broken invert coming to station.

- Install seal-offs on any electrical equipment within 10 feet of the wetwell to return to conformance with current electrical codes.
- Evaluate incorporating a simplistic HIVENT odor-control unit, if appropriate.
- Rehabilitate the invert coming to the station.

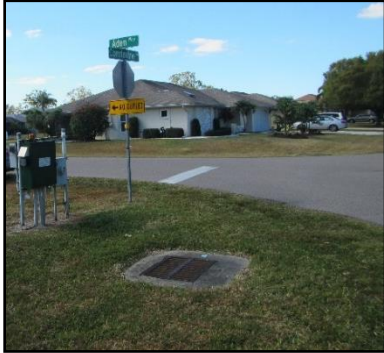
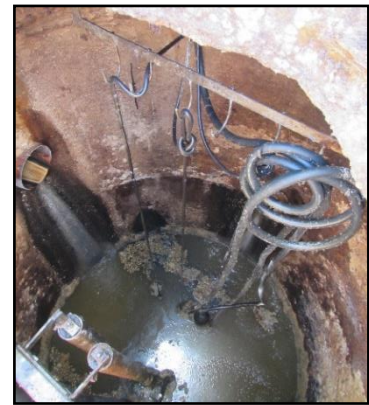
5.2.4.10 Lift Station 303 – Constantine

The wetwell lining is largely unaffected by hydrogen sulfide but does show some signs of corrosion. The wetwell has an older conical-lid design that can obstruct access during maintenance events. The wetwell manhole opening is in good condition. Although guiderails appear to have been included in this station, they end some distance below the manhole conical lid, which may present some difficulty when removing and resetting the pumps. The station has no discharge isolation valves, emergency dedicated pump suction connection, or emergency discharge connection.

- No interlock between the generator breaker and the main breaker.
- Missing seal-offs from the control panel conduit.
- Difficult-to-access wetwell.
- No isolation valves.

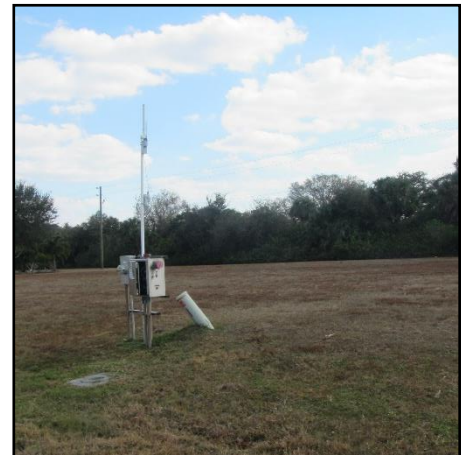
Power service to the station is 230-volt, 3-phase. A portable generator receptacle with a mechanical interlock is available. The station does not have a SCADA system but does have a local annunciator with a 12-volt battery backup. The station experiences high flows and can often have ponding during high-rain events. The system is not fenced and does not have an odor-control system. The wetwell top slab, hatch, and interior walls are in good condition.

The wetwell is in the center of the road intersection, which requires Operations staff to manage traffic during routine maintenance and any pump pulling or to schedule the operations to be performed at night. The wetwell has almost no signs of corrosion. The wetwell access hatch is a bolt-down design. The adjacent lots to the south of the intersection are already procured by a separate entity, but the County would like to move the wetwell out of the road and convert the existing wetwell to a master manhole. The move would also allow installation of a stand-by pump, isolation valves, and bypass piping.

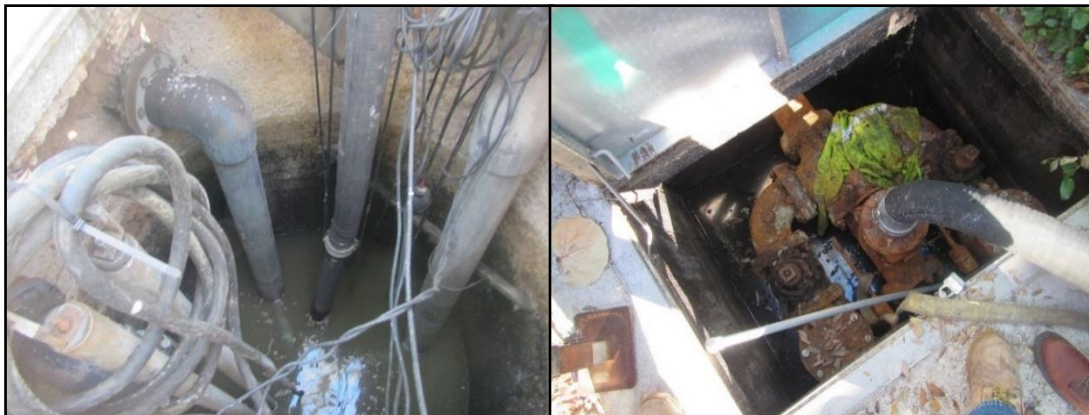
The station wetwell exterior and electrical equipment are in poor condition, and the station wetwell interior is showing signs of corrosion. The 6-inch Dezurik plug valves and 6-inch Kennedy check valves are in the adjacent valve vault.

- Missing seal-offs from the control panel conduit. This represents a significant code violation as well as a potential explosion hazard.
- The lift station was operating on a bypass pump at the time of the site visit.
- Omni Beacon telemetry unit has a battery backup.
- Poor lift station access.
- Missing water service near the station.

- Install seal-offs on any electrical equipment within 10 feet of the wetwell to return to conformance with current electrical codes.
- Repair the station and replace pumps and pump bases as necessary to return to standard operation.
- Install battery backups to provide redundancy for signaling to Operations staff.
- Replace or repair the high-level alarm to allow notification to Operations staff.
- Evaluate incorporating a dedicate access for Operations staff, including access for pump trucks.
- Evaluate incorporating a water service near the station.

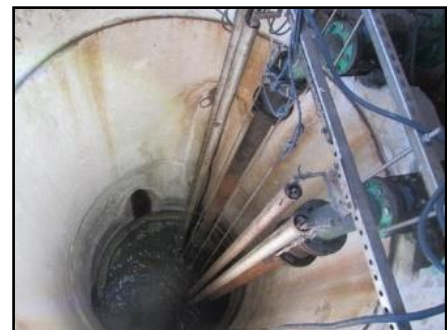
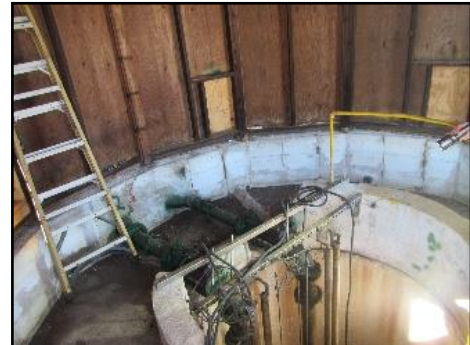
The station is not fenced but is housed in a wooden building that has dedicated lighting. The station does not have an odor-control system. During the site visit, we observed that the building needs to be aerated before entering. The power service to the station is 230-volts, 3-phase and is powered by a pad-mounted transformer at the driveway entrance leading to the lift station. The station has a SCADA system with a telemetry transmitter/receiver. The control panel does not have seal-offs but is equipped with

a portable generator receptacle. The mechanical interlock is on the dead front of the panel, allowing the potential for it to be accidentally overridden. No water service is provided at the site.

- Missing seal-offs from the control panel conduit.
- The lift station building needs to be aerated before entering.
- Mechanical interlock was secured to the dead front instead of behind it, allowing potential for it to be overridden.
- Uncovered wetwell provides safety concern and excess sulfide corrosion and exposure.

- Install seal-offs on any electrical equipment within 10 feet of the wetwell and perform a detailed electrical code review to return to conformance with current electrical codes.
- Evaluate the option of rehabilitating the lift station to meet standard codes.
- Secure the mechanical interlock behind the dead front to between the generator and the main breaker.
- Evaluate covering the wetwell temporarily until full rehabilitation or replacement of the station can be coordinated.

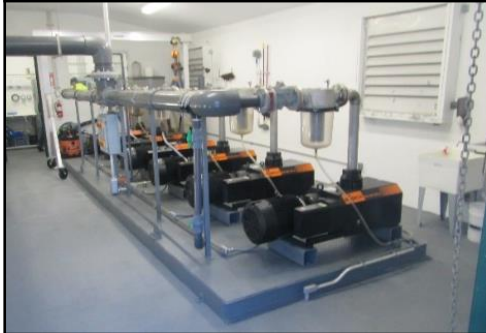
The building contains a dedicated pump crane for removing the discharge pumps and valves from the lower level. The crane appears aligned with the pumps but does not appear aligned with the valves. The discharge isolation valves are overhead in the lower level and only accessible by the dedicated overhead crane in the building.

- The crane pump on site is not aligned with the valves. Some of the valves are vertically below the common discharge line and meter, making them difficult to access with the crane.
- The access for tank maintenance is at the top of the tank without a dedicated access point. The County noted an access platform for this was being designed.

- Evaluate modifying the overhead crane with a trolley for lateral movement.
- Complete design to implement access to the top of the tank for maintenance.

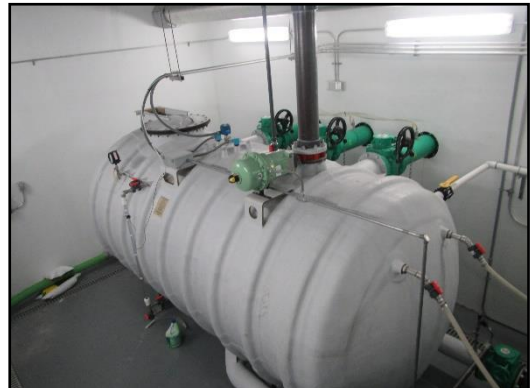
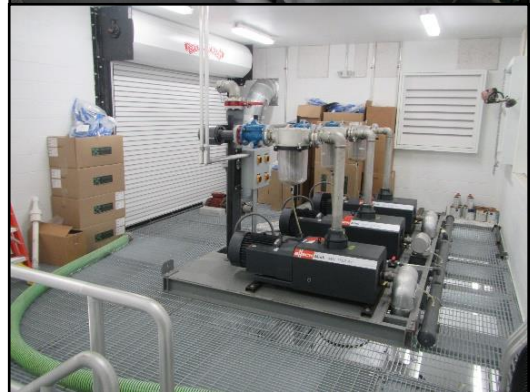
- The access for tank maintenance is at the top of the tank without a dedicated access point.
- The overhead door to pull the vacuum pumps is relatively short and has a low ceiling.

- Evaluate a catwalk or dedicated ladder for accessing the top of the tank for maintenance.
- Verify the vacuum station site is in accordance with Occupational Safety and Health Administration (OSHA) and County safety and confined-space requirements.
- Evaluate a portable hoist or dedicated overhead crane for easier access to the vacuum pumps.
- Evaluate fall protection needs while removing pumps for maintenance and repair.

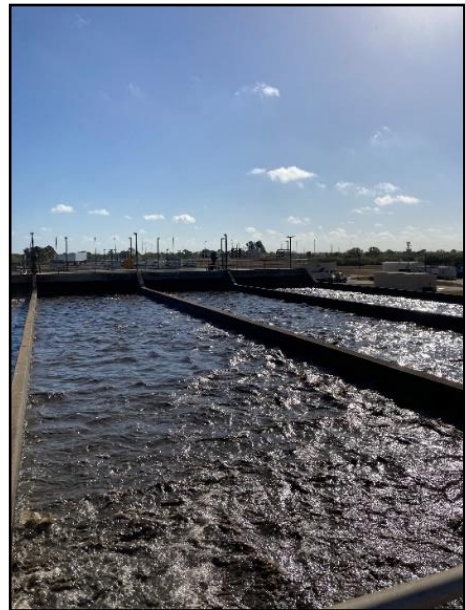
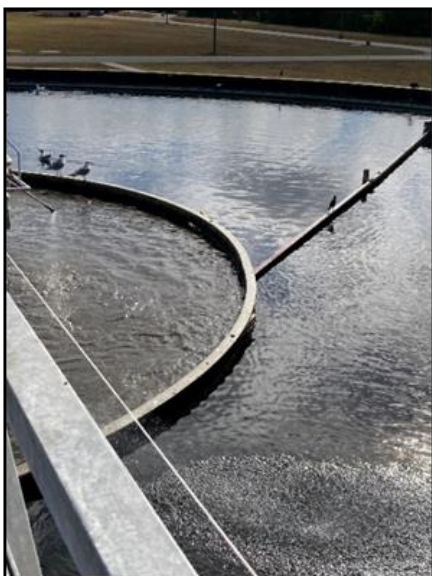
The overall condition and operation of the MLE process are good following the Stage 1 and 2 Improvements in 2016. Four VFD-controlled surface aerators are in operation in the oxidation ditches. The aerator speed is adjusted based on the DO probe at the end of the ditches. The aerators are well maintained. The DO-control system helps the WRF lower its power consumption and improve the denitrification process by minimizing DO carry-over to the anoxic zone. Six VFD-controlled IR pumps were replaced in the Stage 1 and 2 Improvements. These pumps are controlled by the SCADA based on operators' settings. The IR pumps are well maintained and in good working order. At the time of the site visit on February 4, 2022, Oxidation Ditch No. 2 anoxic zone was observed to have areas where a significant amount of floatable solids were gathered and forming an island on the water surface. A mixer may not have been in service at the time of the visit. Smaller areas were also observed at Oxidation Ditch No. 1. If this issue persists, we recommend adding plant water spraying to coax a better mixing zone and prevent floatable solids from collecting.

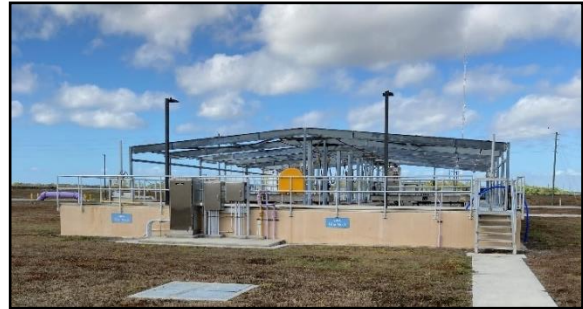
The overall condition of the effluent filtration system is excellent and well maintained. Filters were rehabilitated as part of the Stage 1 and 2 Improvements. The two-traveling bridge sand/anthracite filters were in operation and was backwashing at the time of the site visit. Turbidity results indicate that the filters are producing an excellent effluent for unrestricted public-access reuse water. A galvanized metal frame was installed over the filters in the Stage 1 and 2 Improvements to support a fabric roof constructed of UV shade cloth. However, the cloth rips in the wind and will be replaced with roof panels bolted to the galvanized frame for the 9-MGD expansion.

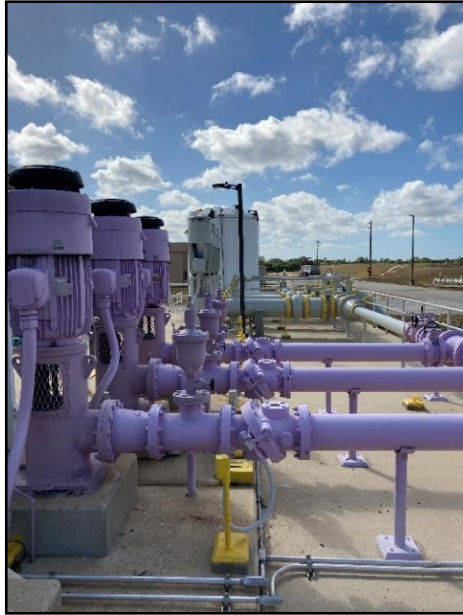
adjacent to CCC No. 1 into the WRF plant water system. The reclaimed water service pumps are well maintained and operated. The VFD controls allow the pumps to operate at high speeds to meet distribution system demand and at low speeds to provide non-potable water on site for O&M purposes.

The reclaimed water HSPS No. 2 has five VFD-controlled pumps, can pump 9.0 MGD at 108 psi, and was completed in 2019 as part of the Stage 5 Improvements. The system includes four 120-micron self-cleaning filters manufactured by ORIVAL and was submitted as a value-engineering substitution. The units are currently bypassed due to fouling issues. The bypass around these filters is not impacting reclaimed water quality to end users.

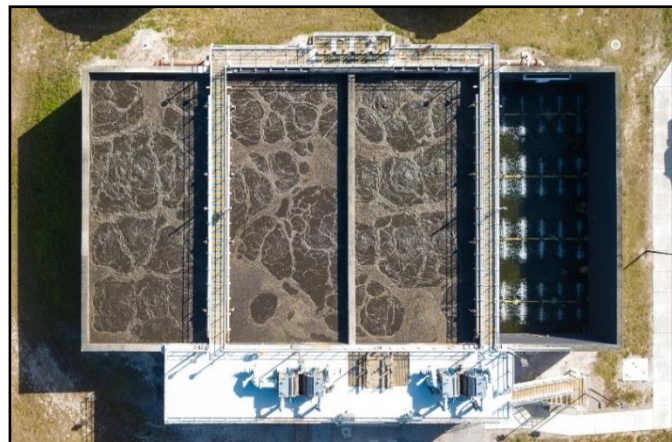
The overall condition of the activated-sludge facilities is good. The mixed liquor suspended solids (MLSS) are sampled every morning by the Operations staff. The WRF has four aeration basins—three were in service at the time of the site review. Basin No. 4 was out of service for cleaning and aeration improvements; the diffusers were serviced, and the concrete floor was visible as a result of the cleaning. New fine-bubble diffusers were

installed in all basins in 2013 and 2014. This has had a positive effect on the treatment process by providing a more even air flow distribution. However, the lack of grit removal continues to present a maintenance challenge since deposited grit levels rise to block the diffusers. Basin No. 3 was cleaned of grit and damaged aerators were repaired in FY 2016. The Chief Operator

indicated that by the end of FY 2022, each basin will be sequentially taken out of service, drained, inspected, and cleaned of grit.

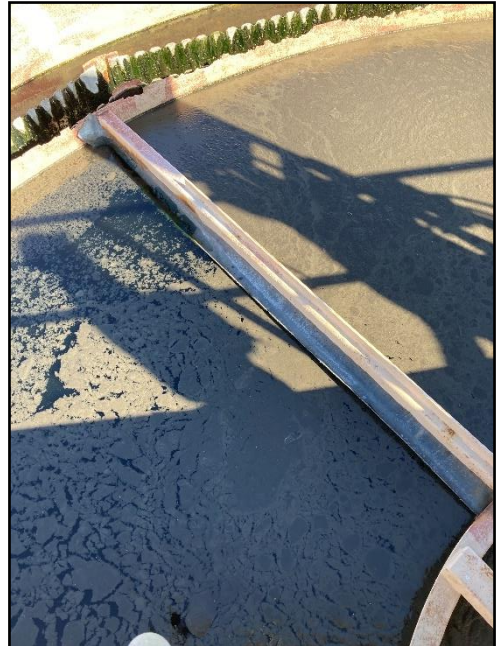
The rubber on the skimmer arms on most or all the clarifiers appeared to not evenly contact the water surface when it traveled around the clarifier which may indicate the skimmer arm and mechanism may not be level. At the time of the site visit, the Chief Operator indicated that an WRF expansion contract will be awarded in 2022 where new clarifiers will be designed, and that staff replaced some of the skimmer rubber in 2021 but intends to install new longer rubber to make better contact the water surface until the expansion. The feed well had noticeable foam that would occasionally exist from the feed well into the main part of the clarifier that would remain in the main clarifier area contained by the scum baffle but not sufficiently removed by the uneven skimmer arms.

Overflow weirs are hosed daily and brushed weekly to keep them clean. The overflow weirs were leveled in FY 2017. At the time of the site visit, water was not flowing over the effluent launder/overflow weirs as designed, at various locations on most or all the clarifiers, as indicated by visible algae growth. It was also observed that in some cases of algae growth, the weirs were already adjusted to the minimum effluent launder height and the launder may not be fully level as well as the skimmer arms. The Chief Operator stated that the effluent launder/overflow weir may be addressed prior to the plant expansion if issues with compliance occur. According to 2021 DMR data, West Port WRF effluent water quality complies with FDEP permit conditions. New weirs were installed in Clarifier No. 1 and Clarifier No. 2 in 2018. Clarifier No. 3 and Clarifier No. 4 received new weirs in FY 2020 and FY 2021, respectively.

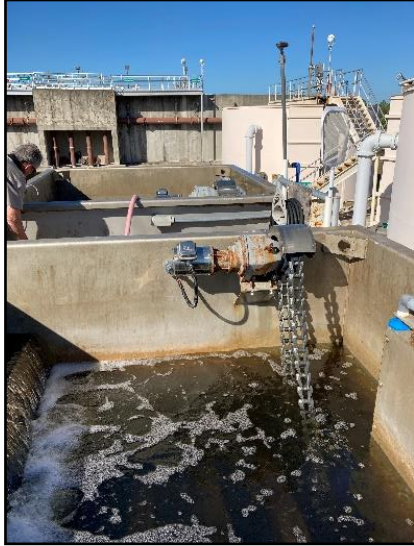
The filters are in good condition. The tanks are cleaned every month with 5 gallons of bleach. A UV cover was put on the filter tanks and then removed because access to the filters during maintenance activities was blocked. The filter water surface, exposed interior equipment, and interior tank walls are sprayed with a bleach solution one or twice a week by Operations staff to prevent algae growth. Regular bleach spraying mitigates algae growth but may cause long-term issues in with exposed components such as motors. The filter will likely be replaced as part of the future expansion.

Two filters were in operation at the time of the site visit and working properly. The third filter was out of service for routine cleaning. All three filters have been replaced with new 5-micron filter cloths. The Chief Operator stated that a higher-quality effluent is obtained when all three filters are operating in parallel.

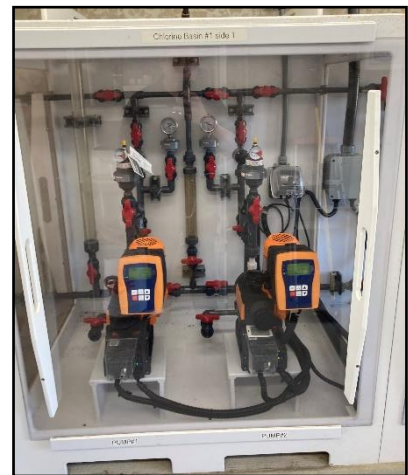
In June 2017, a new chlorine feed system with two chemical feed pumps for each CCC and new storage tanks was installed in a new chlorine storage and feed area between the two CCC structures. This will enable two parallel CCCs to operate when peak hourly flows exceed 955 gpm. The new dosing pumps have double-containment protection. The Chief Operator indicated that CCU plans to replace the chemical storage tanks and associated piping in 2022.

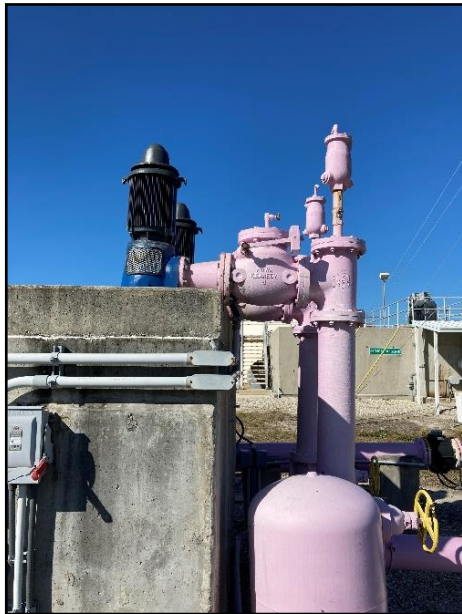
The West Port WRF reclaimed water pump station feeds part of the Master Reuse System that interconnects with the Rotonda WRF and the East Port WRF reclaimed water systems. The station contains two reclaimed water HSPs and one jockey pump. The two reclaimed HSPs were recently replaced in 2021. This provides flexibility to serve existing and future reclaimed water customers. The main customer for the reclaimed water produced at the West Port WRF is the Coral Creek Golf Club Golf Course, which receives reclaimed water through a 7-mile-long, 10-inch-diameter main constructed by the golf course owners. Chapter 7 provides additional information about the Master Reuse System.

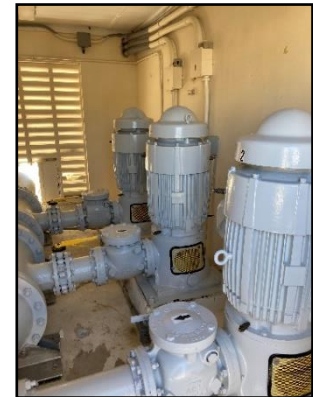
Effluent that does not meet public-access reclaimed water standards is conveyed to a clearwell for disposal via a deep injection well. Three new deep-well pumps are used to convey effluent through a 16-inch manifold pipe into the deep well. All compliance monitoring equipment and pumps were fully functioning and in good condition at the time of the inspection. The pumps, motors, and piping were re-painted in 2021.

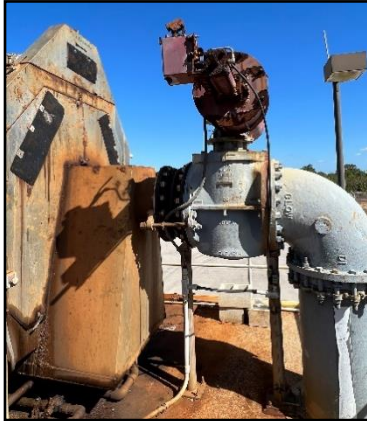
The overall condition of the headworks is fair to poor. The headworks is undergoing an improvement and rehabilitation/replacement project that will include new piping and fine screens as well other improvements to the headworks.

At the time of the site visit, both screens were operational. These screens are critical process units. Each screen rotates on four drum rollers that support the stainless-steel perforated screen as it rotates. The worn rollers were last replaced in 2016. The rate of rotation has been slowed to extend the life of mechanical components. In 2017, the drums were welded, and the roller wheels, chains, and drive gears were replaced. A wash water spray was added to the screening compactors, which improved operation and lengthened the life of the lower bearing units. The chain and sprockets of Screen No. 2 were replaced in FY 2019. The drum screen roller drive and drum gears were replaced in 2021 for each unit.

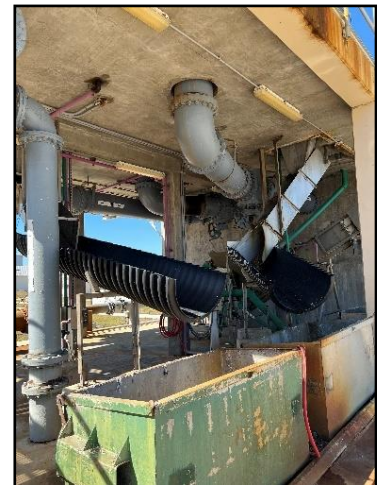
The grit removal process operates as intended. The organic wastewater component of the pumped mixture is returned to the wet wells. Separated grit slurry is pumped to two cyclone units where the grit is further concentrated. The separated grit passes to a grit "snail" washer before being deposited into a dumpster. The grit "snail" washer includes a conveyor system that allows the grit to shed water as it proceeds to the dumpster. In 2017, Grit Pump No. 2 was replaced, and the cyclones are scheduled for replacement in FY 2022 as part of the headworks improvement project.

The screenings and grit dumpsters are emptied once per week. The dumpster area is clean and with minor presence of odors.

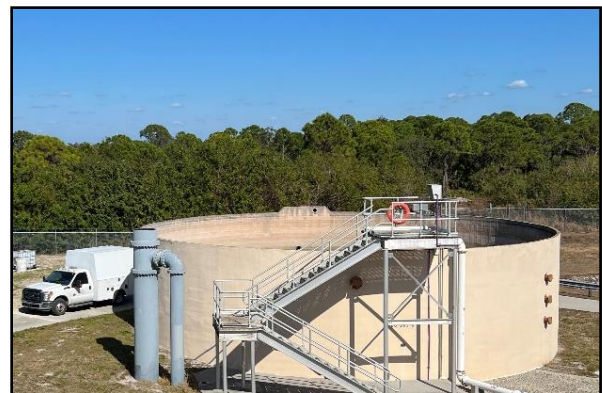
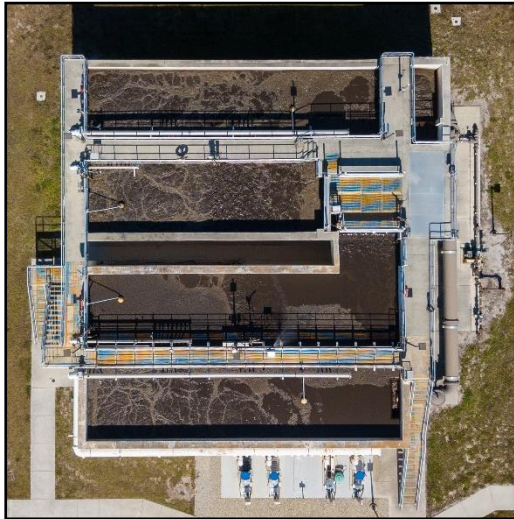
The overall condition of the 0.3-MG EQ tank is good. The EQ tank, which attenuates high hourly flows, is filled through a gravity system initiated by an overflow weir at the headworks structure. The EQ tank contents are returned to the headworks for treatment at a steady flow over 24 hours using VFD pumps. This has proven to be a valuable asset to the operation of the facility. The Chief Operator noted that Lift Station No. 801 sends 1,500 gpm to the Rotonda WRF for about 20 minutes and then

turns off for 20 to 30 minutes. The operation of the EQ tank has been adjusted to respond to the intermittent discharge from Lift Station No. 801. Dry-pit submersible pumps are used to return EQ tank contents to the treatment stream. The EQ tank positive displacement blowers are run intermittently to save power. Oil sight glasses and fill ports were added by CCU to improve maintenance. The EQ tank was painted in FY 2019.

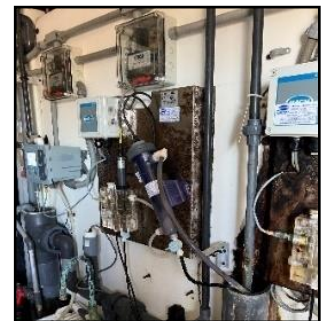
Replacement of Chlorine Storage Tank No. 3 began in 2017 and finished in 2018. Leaks were noted around chlorine pipe fittings due to the continuous exposure to sunlight. UV inhibitor coating should be applied to the piping. Two new storage tanks with secondary containment were installed FY 2021. All storage tanks feature polyethylene open-top tank secondary containment. Small-diameter corrugated HDPE drain piping coming from the secondary containments appeared to be in fair condition, and the in-line valves were open during the site visit. The tank piping to the feed pumps is exposed to the sunlight and did not appear to have secondary containment piping. A pipe break to one of these pipes could result in the tank fully draining and spilling on the ground and create environmental concerns. We recommend that CCU review the drain piping to ensure operations follows applicable regulations or add secondary containment piping (double walled piping).

Prominent Feed Pumps Nos. 1 and 3 were replaced in FY 2018. Prominent Feed Pump No. 2 was replaced in FY 2019. Prominent Feed Pump No. 1 was replaced in FY 2021. The two total chlorine analyzers were replaced in FY 2019. The metal backplates for the chlorine analyzers have experienced substantial corrosion and staining and should be replaced. The chlorine feed line from the in-plant road was replaced in 2018.

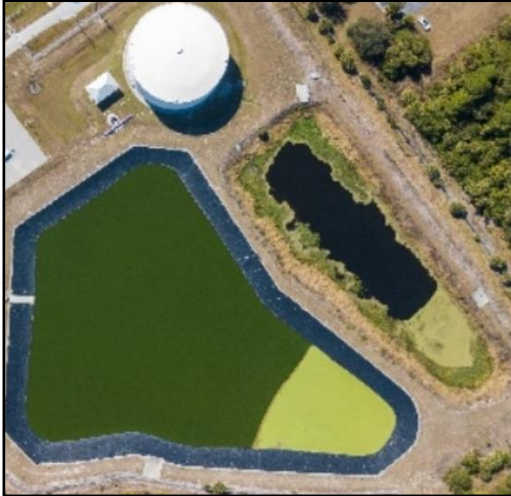
Reclaimed water meeting public-access water quality is sent to the Master Reuse System using the HSPs at HSPS No.1 and HSPS No.2. HSPS No.1 uses three vertical turbine pumps with VFDs to provide reclaimed water to golf course storage ponds north of the Rotonda WRF. The golf course's high-pressure pumps then increase pressure for irrigation system use. HSPS No.2 contains 2 HSPs and 1 jockey pump which are primarily used to convey reclaimed water to golf courses south of the WRF. One of the two HSPs was replaced in FY 2019. The HSP No. 2 was rebuilt and replaced in FY 2021. The jockey pump was replaced in FY 2018. Both HSPSs and above ground piping were repainted in FY 2021.

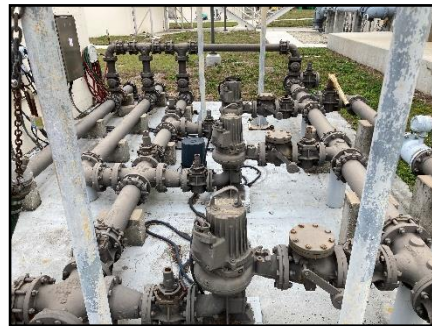
- The blower assemblies adjacent to the SPR tank uses flexible conduit to provide power to the motor operated valves. This conduit is longer than 6 feet and is unsupported.

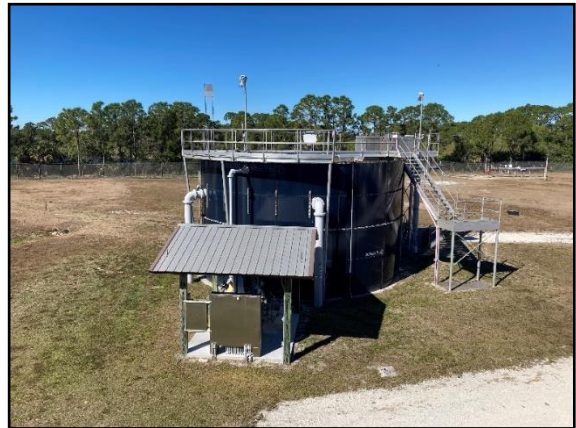
The Aquastore EQ tank is in poor condition. The EQ tank has signs of rust around the upper steel rim, which likely originates from the RO WTP waste line. Internal piping is in poor condition with leaks at flanged fittings, and one of the drop diffusers inside the EQ tank has been damaged and is no longer secure. Since no grit-removal facilities are provided, grit accumulation occurs in the EQ tank and reduces treatment capacity. The grit accumulation is currently being managed by having a vendor periodically pump out the grit in the EQ tank while in operation.

Due to these operational concerns and the condition of the headworks and EQ tank, CCU is re-designing the Burnt Store headworks as part of the Burnt Store expansion project.
