Charlotte County Utilities Department

2021 Annual Report
March 2022

2021 ANNUAL REPORT

Jones Edmunds Project No.: 03405-029-05

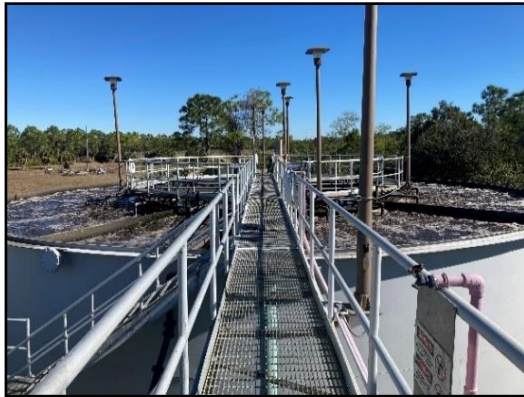
The activated-sludge facilities are steel-ring package plants consisting of two aeration tanks and two secondary clarifiers. At the time of the site visit, the aeration basins appeared to have adequate air distribution throughout the tank. All blowers were rebuilt in 2017. The operation of the blowers is based on timers, but no DO sensors are provided to adjust blower operation. The hinged sluice gates separating the two aeration tanks are not functioning as intended, allowing wastewater to flow to the adjacent tank during maintenance. The tanks

have minimum free-board (<1 foot), creating concerns of overflowing during high-flow conditions or if a downstream flow obstruction occurs.

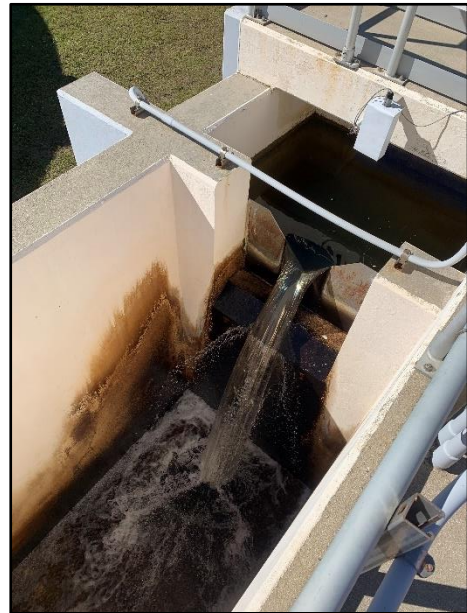
The overall condition of the chlorination system is good. CCC No. 2 is not in service since it does not provide sufficient contact time due to the chlorine injection location. The concrete CCCs are in good condition. A UV cover has been installed over CCC No. 1. At the time of site visit, it was in poor condition and appeared to be torn, but the Chief Operator indicated that installation of a new UV cover was pending shipping. A submersible mixing pump is used to enhance chlorine mixing. A sampling pump is used to pump CCC effluent to the chlorine analyzer for compliance monitoring, which replaced an old gravity-fed system and improved reliability.

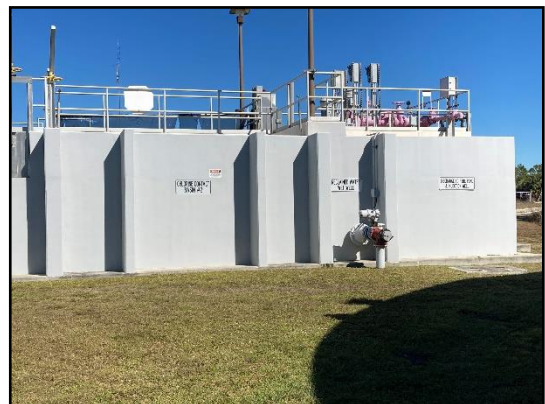
The Burnt Store WRF reuse facilities include a reclaimed water pump station and clearwell, which are in overall good condition. The reclaimed water pump station is located above the clearwell following the CCCs. Two HSPs and two booster pumps are used to convey up to 0.5 MGD AADF of reclaimed water to customers. The booster pumps are currently used to satisfy demand in the reuse system, but the two large HSPs are working properly and are tested regularly. The reclaimed water HSPs and jockey pumps are well maintained and show no signs of deterioration. Flow to the reclaimed water pump station is monitored by an ultrasonic flow meter and primary weir device, which became obsolete when the WRF began transferring flow to the deep injection well system. A new flow meter is needed to monitor the pump

discharge line and measure reclaimed water flow. In addition, no on-site reclaimed water storage is available, which will require future major reclaimed water users to be served through direct distribution to the user’s reclaimed water holding facility or require storage to be added on site. These limitations will be addressed in the design of the Burnt Store WRF expansion project. Chapter 7 provides additional information about the Burnt Store Reuse System.

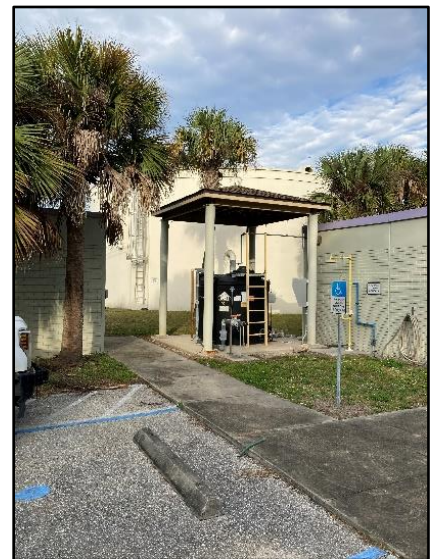
The electrical room equipment, pump room equipment, and tank were found in good condition. The piping was painted purple but needed repainting. At the time of site visit, the grounds had heavy overgrowth that requires attention.

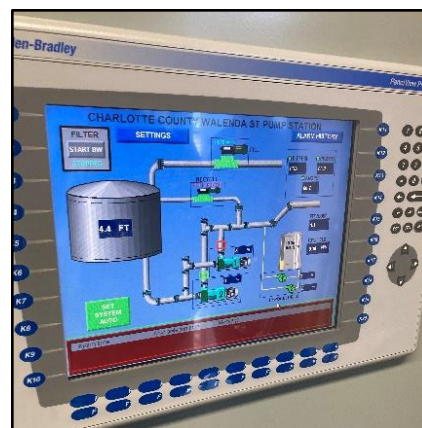
The electrical room equipment, pump room equipment, and tank are in good condition. The piping was painted purple but needed repainting. The grounds are well maintained. A small leak in the recirculation valve requires repair.

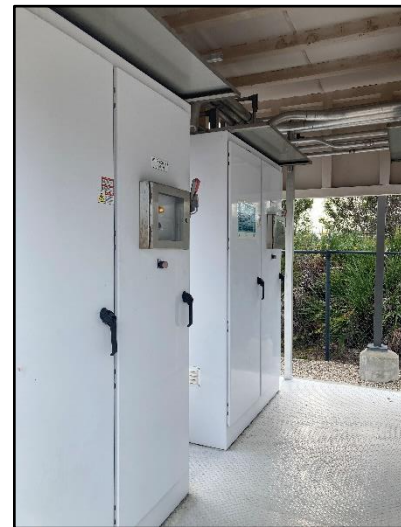
The physical condition of the RWBS was excellent except for HSP No. 2, which was out of service, and minor pipe painting that is scheduled for FY 2021. The RWBS is scheduled to be painted in 2022.
